# Landslide Triggered by Orthogonal Tunnel Excavation and Prevention Measures in Jimei Village, Sichuan Province, China

## Research Article

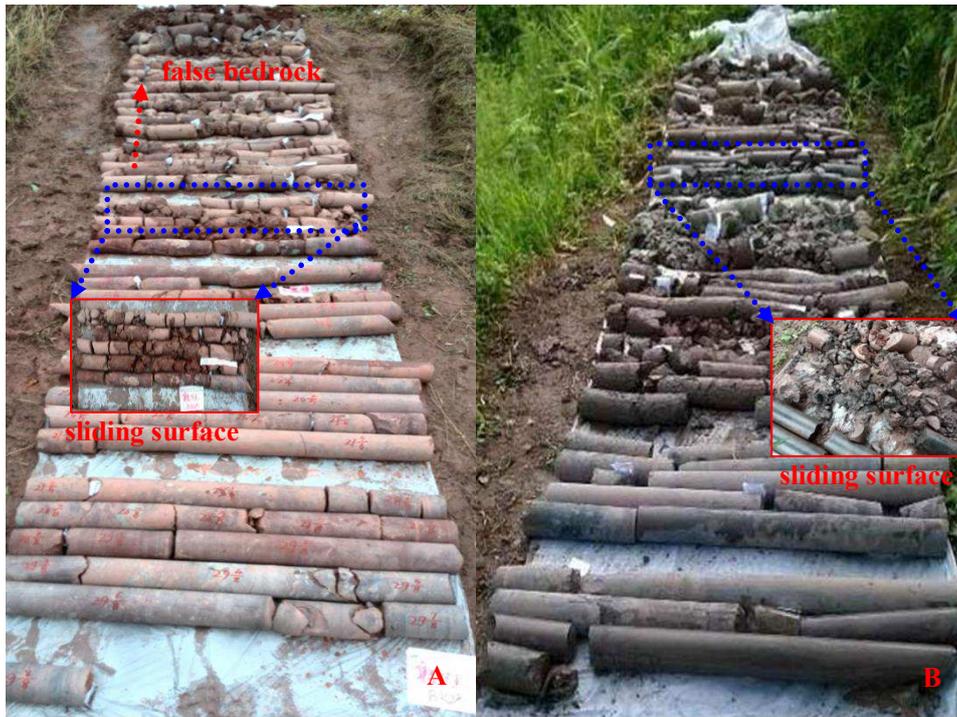
**Fig.3** Core from (A) borehole BK23; (B) borehole BK14.

incomplete disintegration after slope failure (Fig. 3 and Fig. 4). However, zone II is greatly

According to drilling (Fig.3 and Fig.4), supplementary investigation data by on-site survey

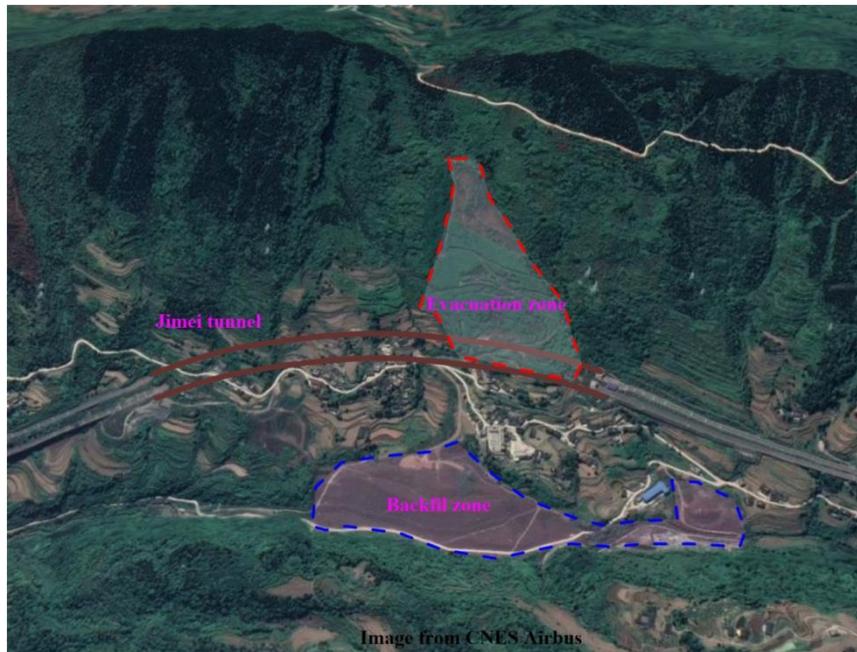
373 **Fig.18 Bird view of construction site after soil removal**

369 piles would need very high cost and larger length of up to 80m. However, the lower landslide is  
370 thick and upper landslide is thin, and hence it is suitable to stabilize the landslide by removing soil  
371 from upper part into slope toe and conducting some reinforcement at lower part.

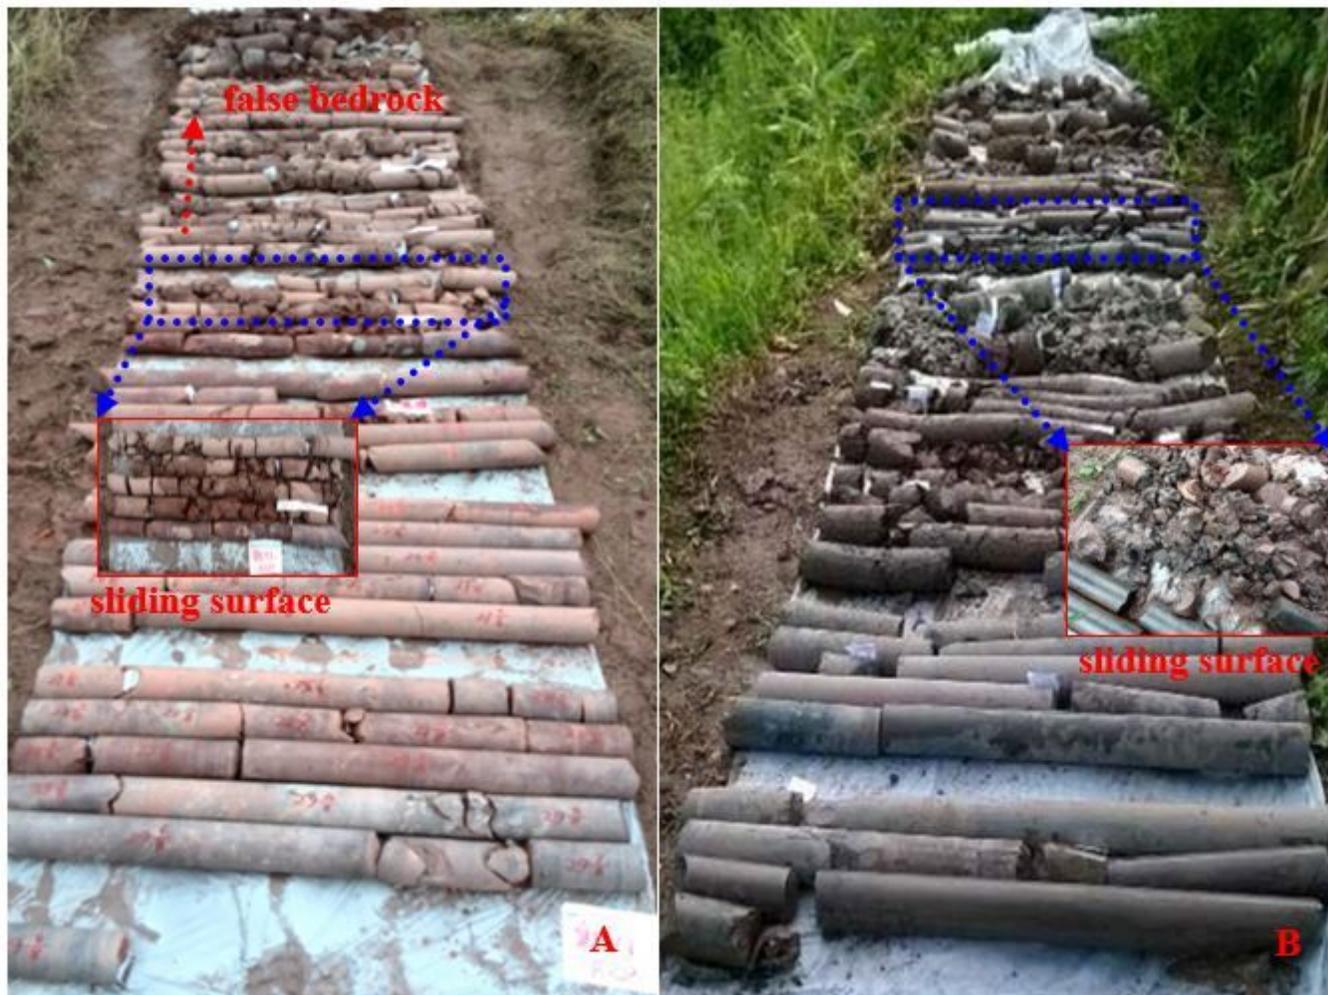
Figure 3

Core from (A) borehole BK23; (B) borehole BK14.

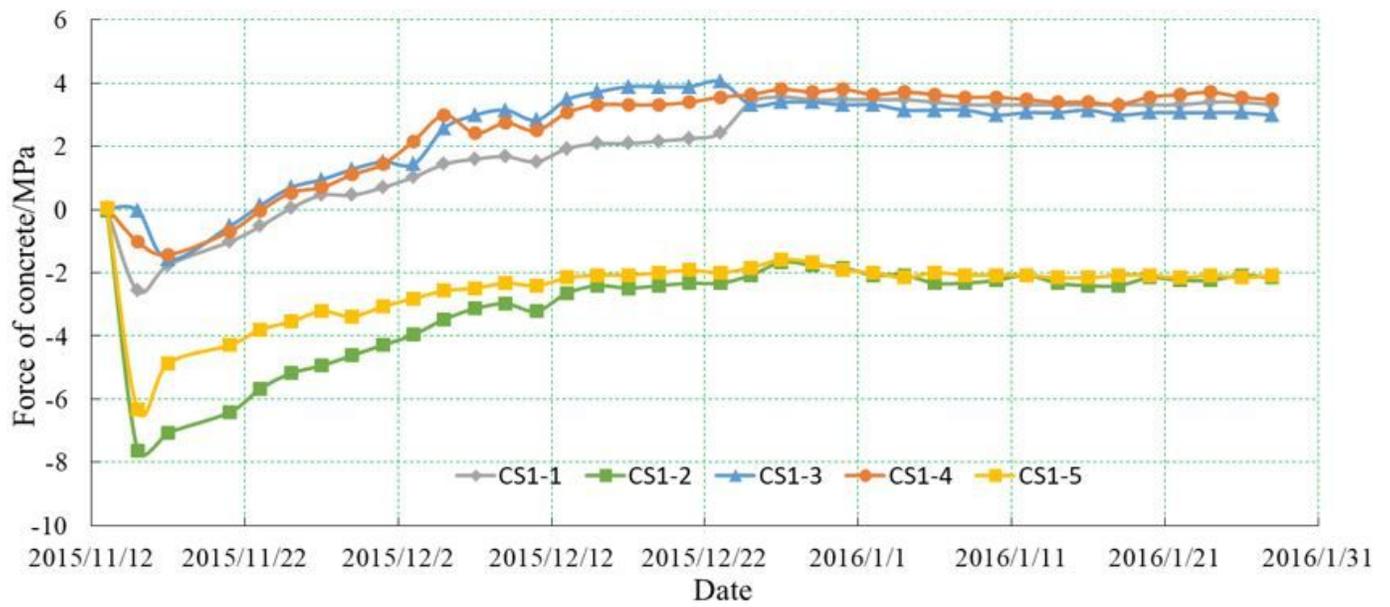
Figure 11

Stress curves for concrete of secondary lining at K12+554

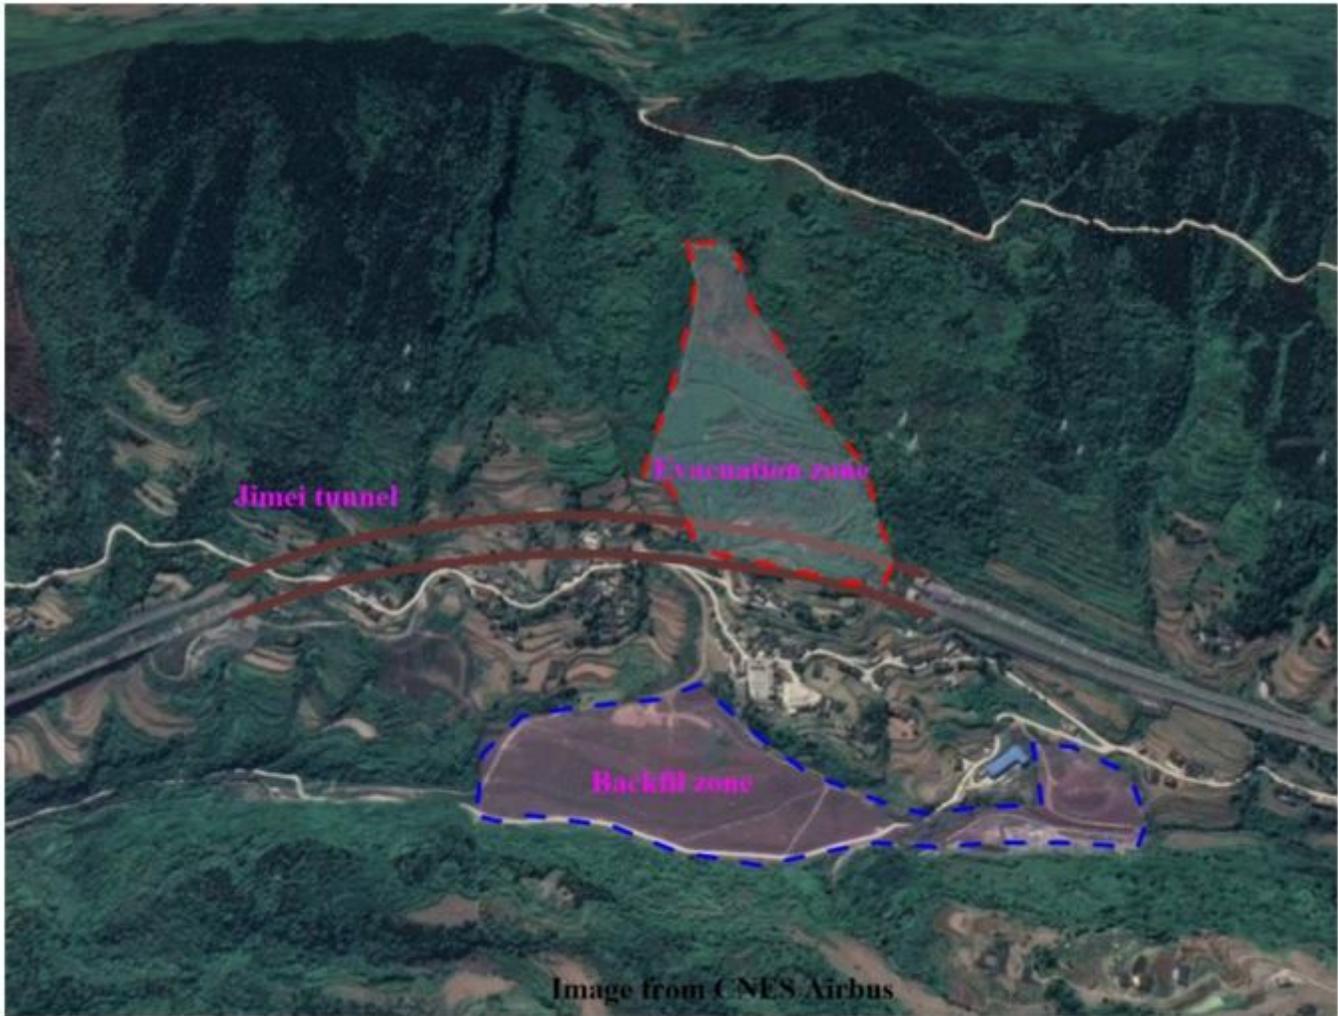
**Figure 18**

Bird view of construction site after soil removal Note: The designations employed and the presentation of the material on this map do not imply the expression of any opinion whatsoever on the part of Research Square concerning the legal status of any country, territory, city or area or of its authorities, or concerning the delimitation of its frontiers or boundaries. This map has been provided by the authors.
