Dhauliganga, Uttarakhand, India Coalescent Natural Disaster: A Geoinformatics Perspective

Research Article

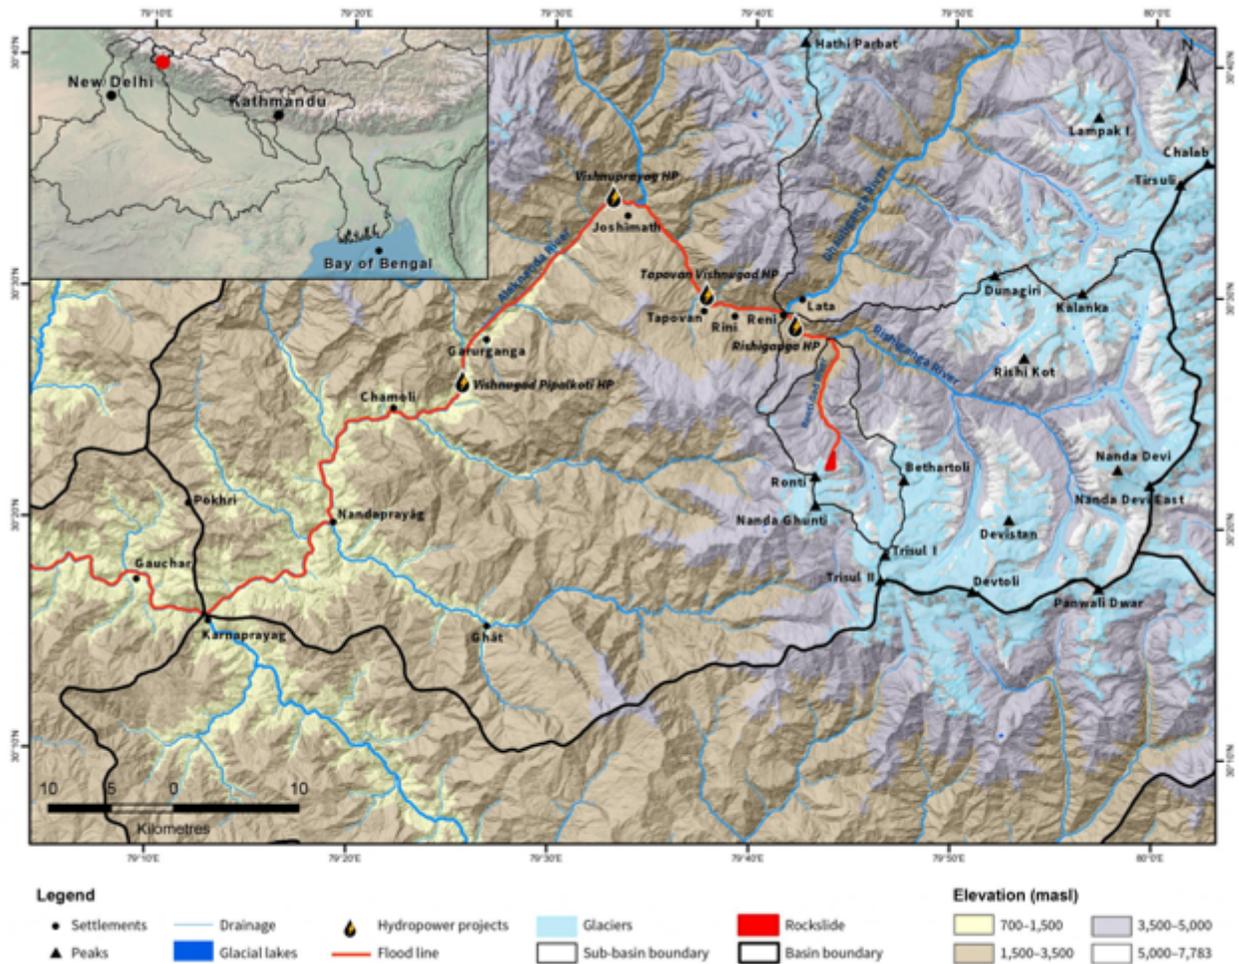
Figure 1

Depicts landslide / rockslide origin and flash flood path along the Raunthi Gadhera, Rishiganga and Dhauliganga Rivers (Source: Shrestha et. al., 2021). Note: The designations employed and the presentation of the material on this map do not imply the expression of any opinion whatsoever on the part of Research Square concerning the legal status of any country, territory, city or area or of its authorities, or concerning the delimitation of its frontiers or boundaries. This map has been provided by the authors.

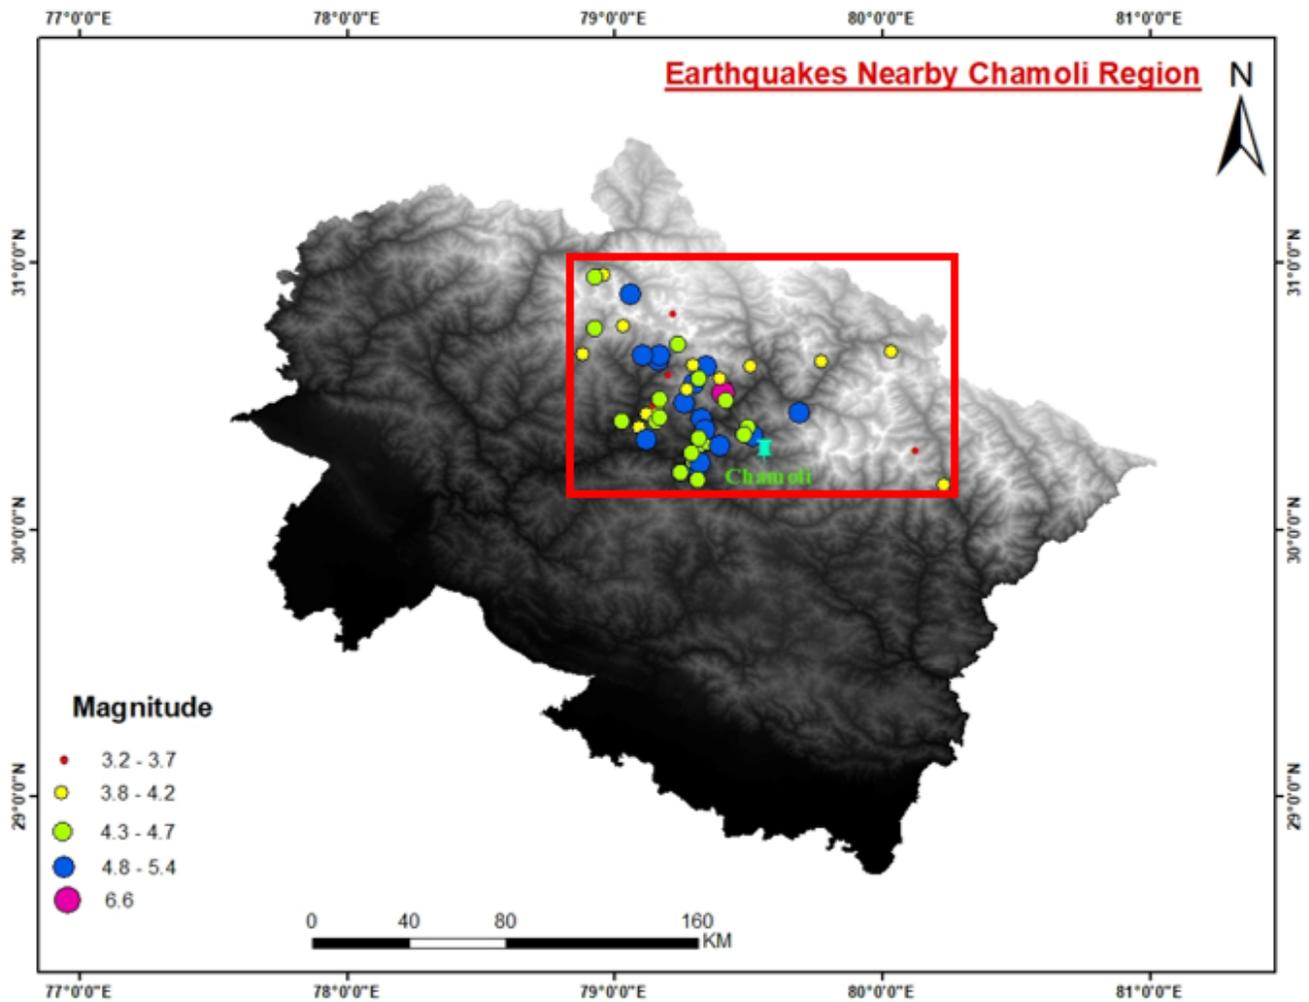
Figure 2

Earthquakes occurred (within 100km) in the region during 1990-2021. Pink coloured filled circle depicts Chamoli Earthquake of 29 March 1999, 6.6 Mw. Note: The designations employed and the presentation of the material on this map do not imply the expression of any opinion whatsoever on the part of Research Square concerning the legal status of any country, territory, city or area or of its authorities, or concerning the delimitation of its frontiers or boundaries. This map has been provided by the authors.

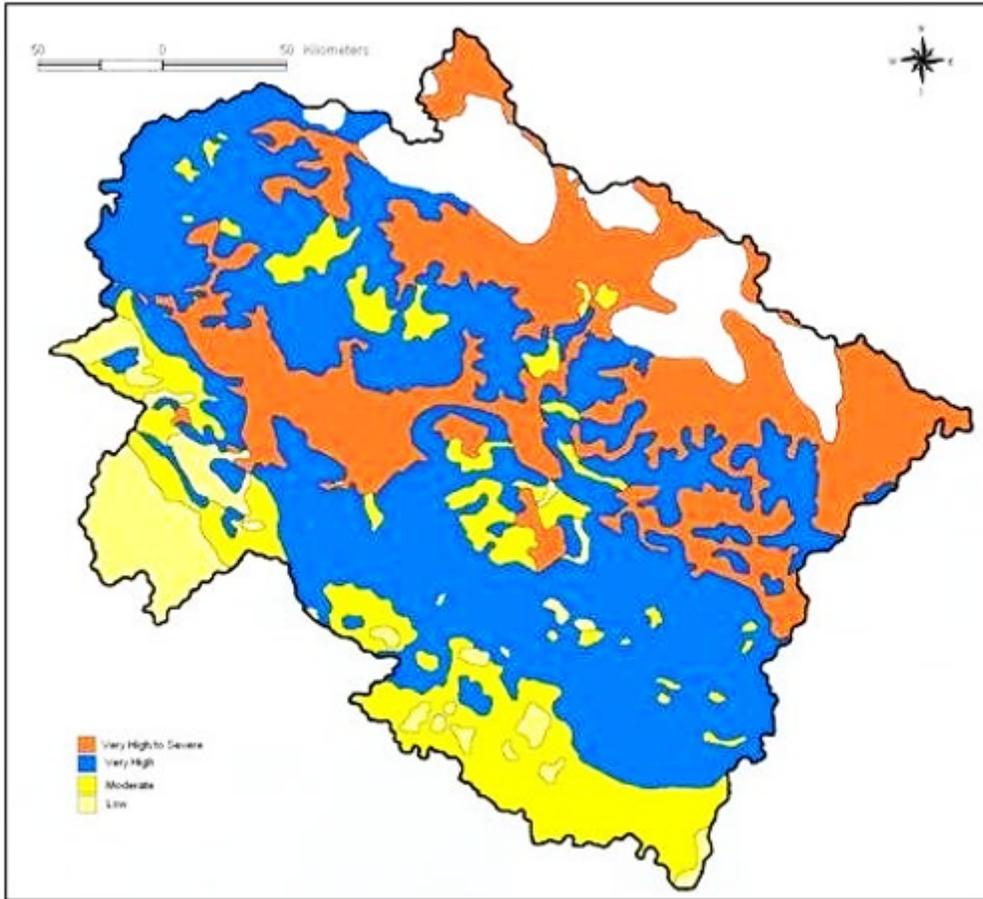
Figure 3

Landslide Hazard Zonation Map of Uttarakhand (Source: Pant & Pande, 2012). Note: The designations employed and the presentation of the material on this map do not imply the expression of any opinion whatsoever on the part of Research Square concerning the legal status of any country, territory, city or area or of its authorities, or concerning the delimitation of its frontiers or boundaries. This map has been provided by the authors.

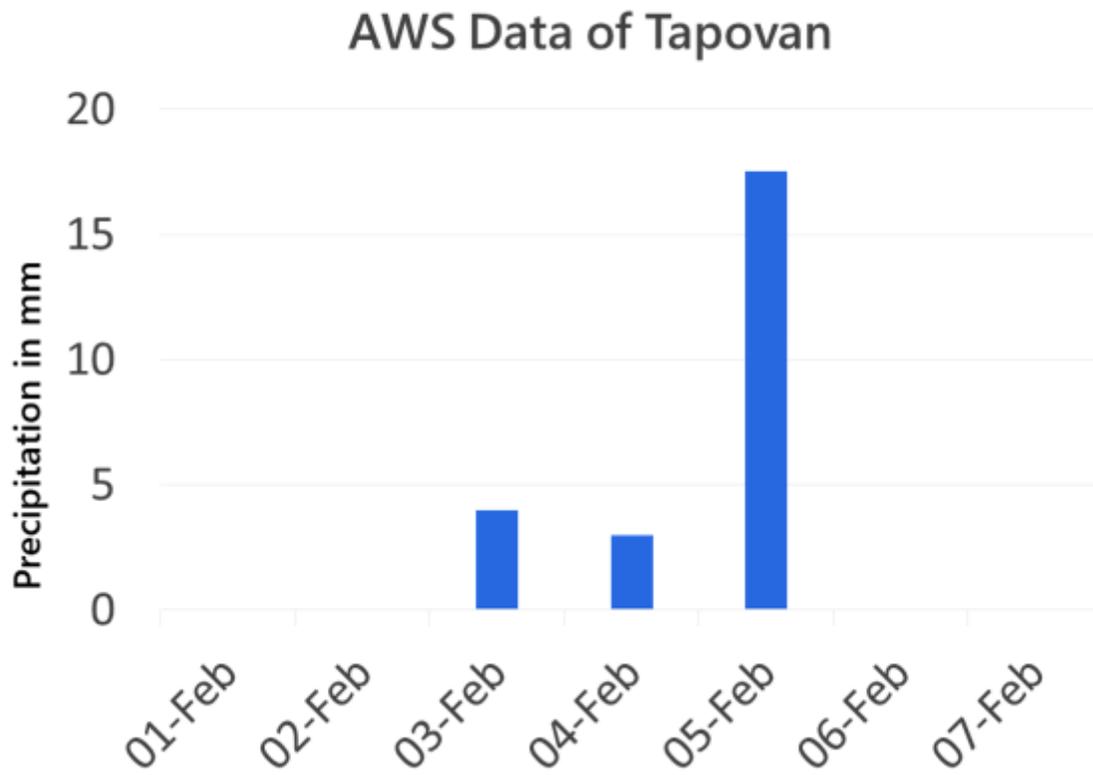
Figure 4

Total precipitation (snow and rain) occurred in the region. Data recorded at Automatic Weather Station, Tapovan)

Initially, amid 03-05th February 2021 the Dhauliganga River region received heavy snow fall (Fig. 4) which overloaded high vulnerable very steep slopes and in the morning of 07 February 2021, a north facing triangular shaped slope (Figs. 5 and 6) failed which was also supporting a small hanging glacier, this has been assessed through time series high spatial resolution remote sensing images of various satellites. This landslide and consequently massive debris flow into the Raunthi Gadhera initially blocked flow of Dhauliganga near Rini village which later failed around 10:15 hrs (local time) on 07 February 2021 and has brought a catastrophic flash flood in the Dhauliganga river. It is important to note that there is no information about the exact timing of triangular shaped slope failure due to lack of availability of regular time series high spatial resolution satellite images. However, analysis of two images from different satellites revealed that definitely just before 10:33 hrs. (local time) on 07th February 2021 a huge dust cloud in the Raunthi Gadhera has been observed and another satellite image of 10:58 hrs. On the same day that dust cloud has moved towards Rishiganga and Dhauliganga valleys (Fig. 7). In the present study, it has been further investigated to assess changes occurred before and after the 07th February 2021 flash flood event by employing (i) high resolution images of 06th February 2021 and 07th February 2021 of Pléiades satellite and (ii) a change detection pseudo colour transformation (PCT) technique developed by (A. Saraf, 1998). Later, the efficacies of the PCT for change detection have been successfully demonstrated by (A. K. Saraf et al., 2002; Sharma et al., 2018) for the purpose of damage assessments / change detection. The conventional PCT technique facilitates the combination of various bands in different colour schemes, such as RGB, IHS and CMY. However, instead of using the different bands of same date data, an approach developed by (A. Saraf, 1998) has been adopted in the present study to map the landslides / rockslide induced ground changes using available high resolution pre- and post-event datasets of Pléiades satellite. Both pre- and post-event Pléiades scenes were georeferenced

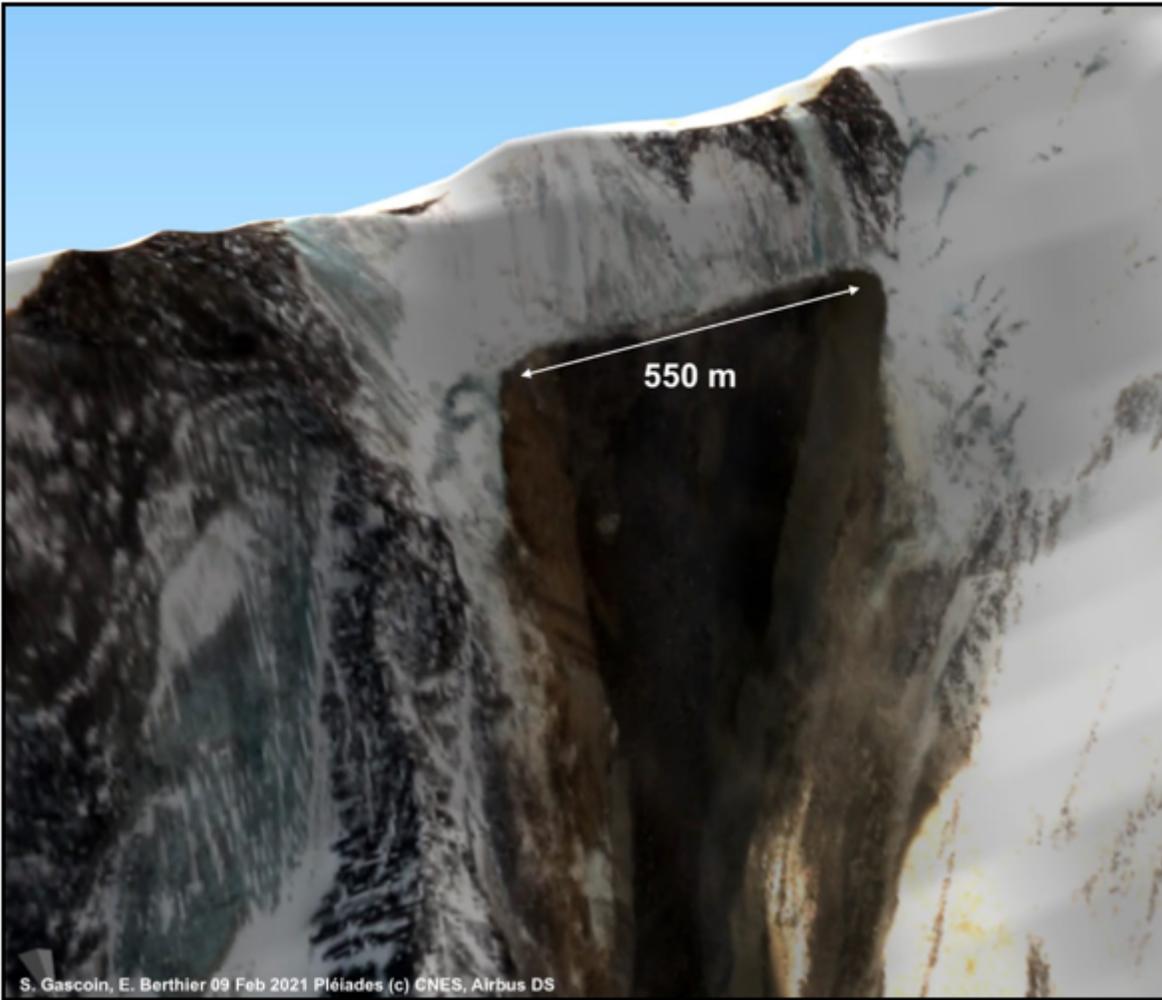
Figure 5

Pléiades image of 09th February 2021 [Source: Pléiades images of the Uttarakhand disaster, (2021)]

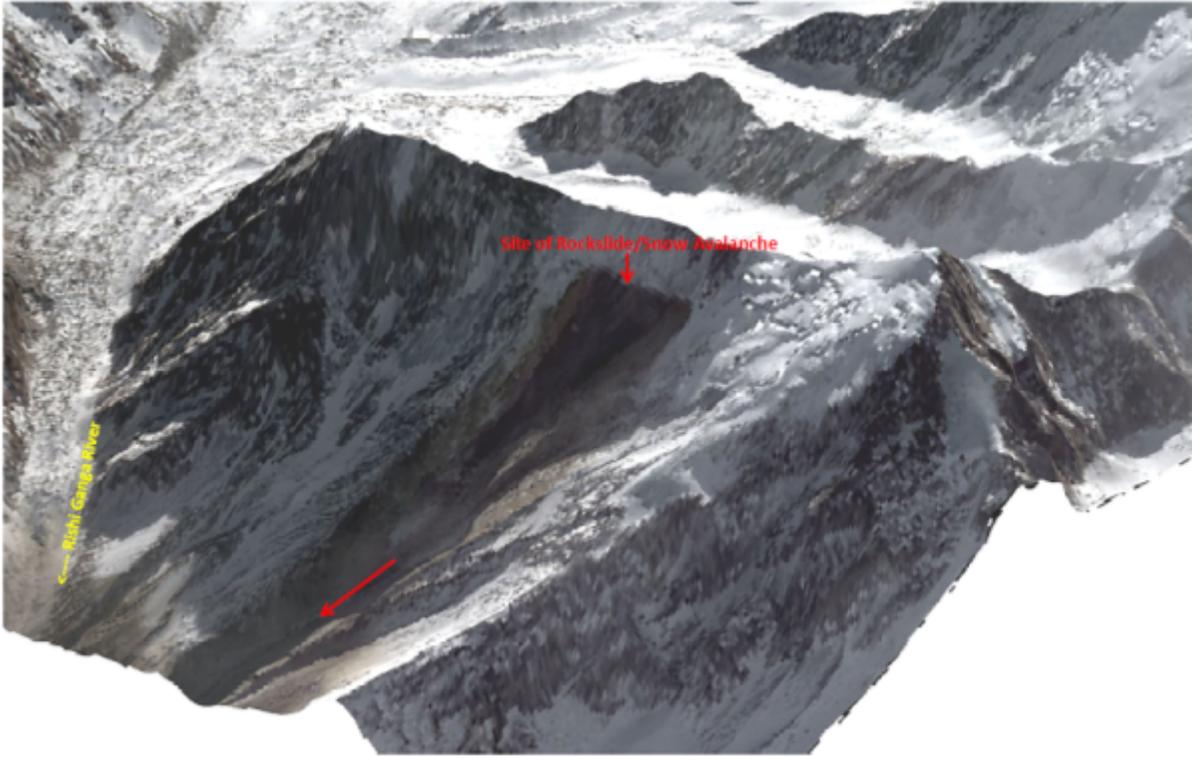
Figure 6

Three dimensional perspective view of rockslide / landslide area based on Pléiades image of 09th February 2021 (Source: NRSC, 2021)

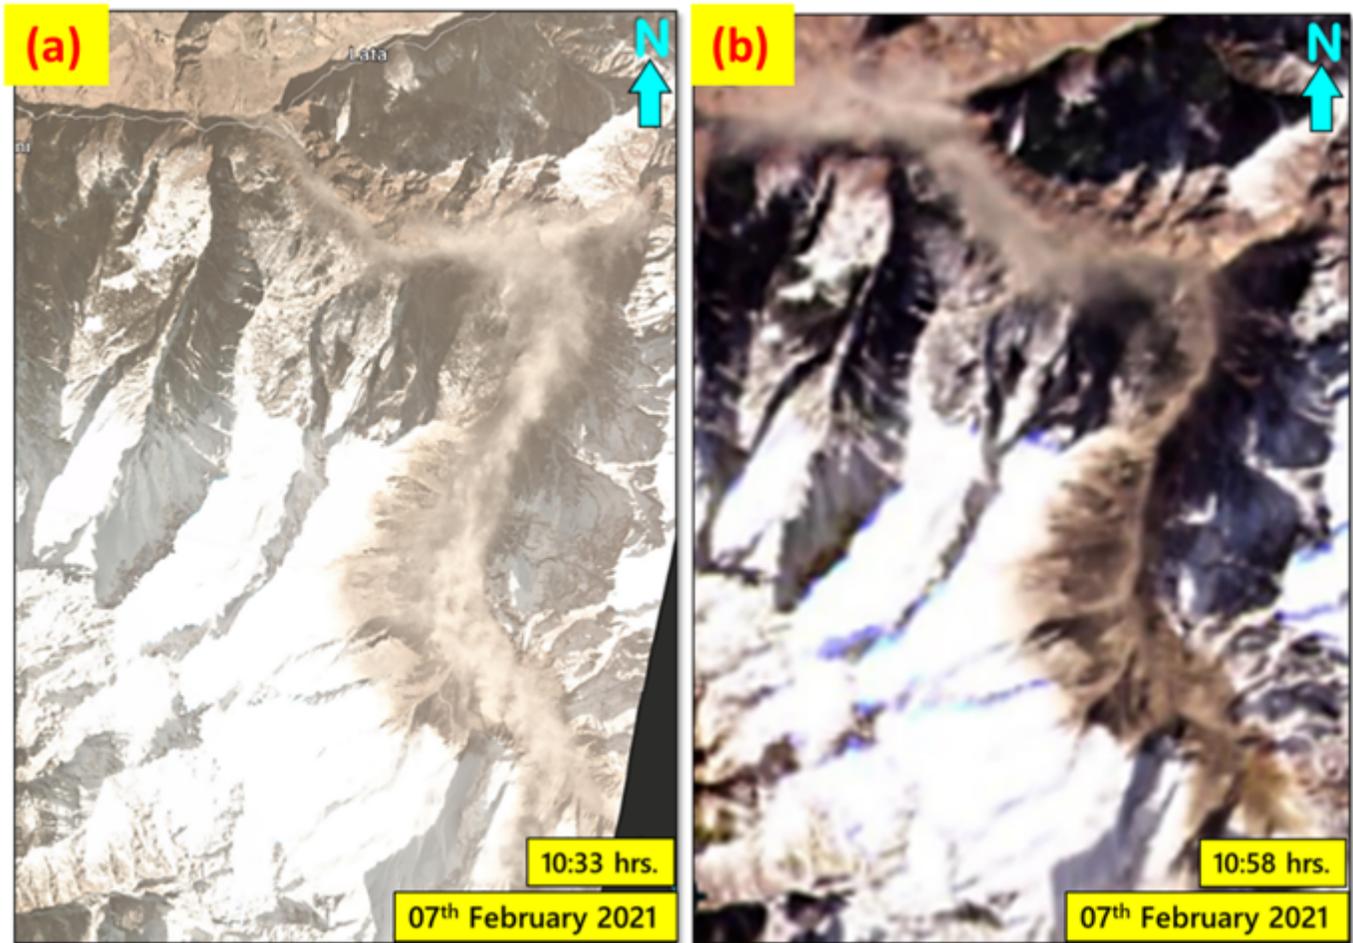
Figure 7

Satellites images of 07th February 2021 Left image (a) acquired at 10:33 hrs (local time) and at 10:58 hrs later right image (b) has been acquired. A comparison between (a) and (b) clearly deciphers the movement of dust cloud towards downstream valleys which also indicates that perhaps dust particles were moist and heavy and in the absence of wind settled naturally (Source: Planet, 2021)

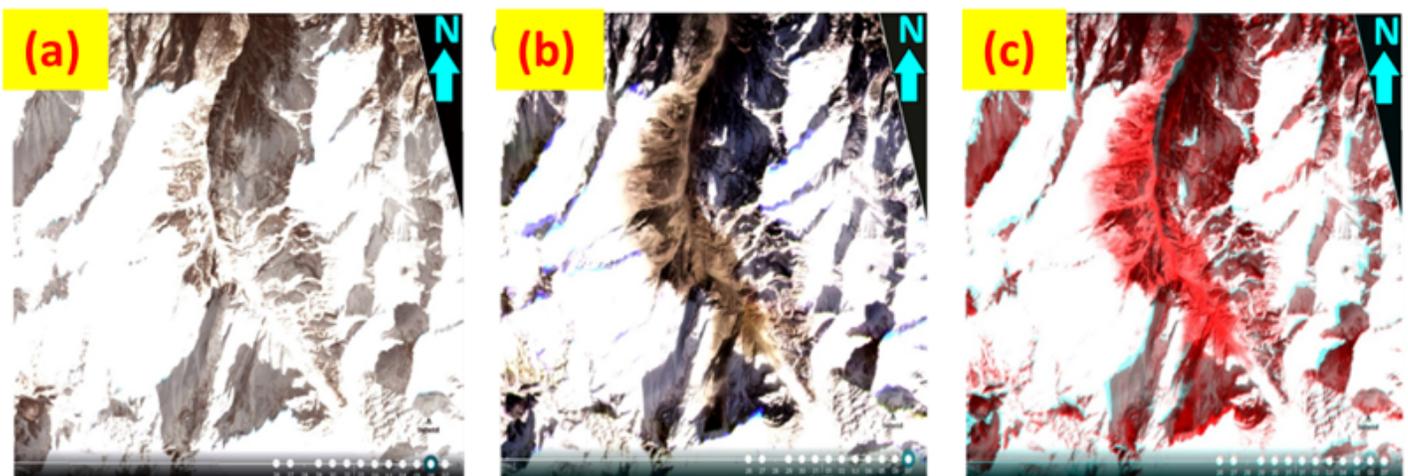
Figure 8

Pre-event Pléiades image of 06th February 2021 (a); Pléiades image of 07th February 2021, just after rockslide event (b); Pseudo Colour Transformed (PCT) image of Band 3 (c) depicts changes (in red colour) occurred between 06-07th February 2021 images. White areas decipher no changes, Cyan coloured areas in PCT image (c) are due differential shadows between images (a) and (b). Dust clouds in (c) along Raunthi Gadhera can be seen very evidently in red colour

using an image-to-image rectification technique. Since the available Pléiades images were in false colour composite (FCC) format and therefore first splitting of FCCs were done into their original colour components i.e. red, green and blue (RGB), the pre-earthquake scene is kept in the red channel and the post-earthquake scene in the green and blue channels (Fig. 8). This has provided a change index with red depicting positive change in terms of reflectance between two dates, blue and green depicting negative change, and black and white depicting no change.

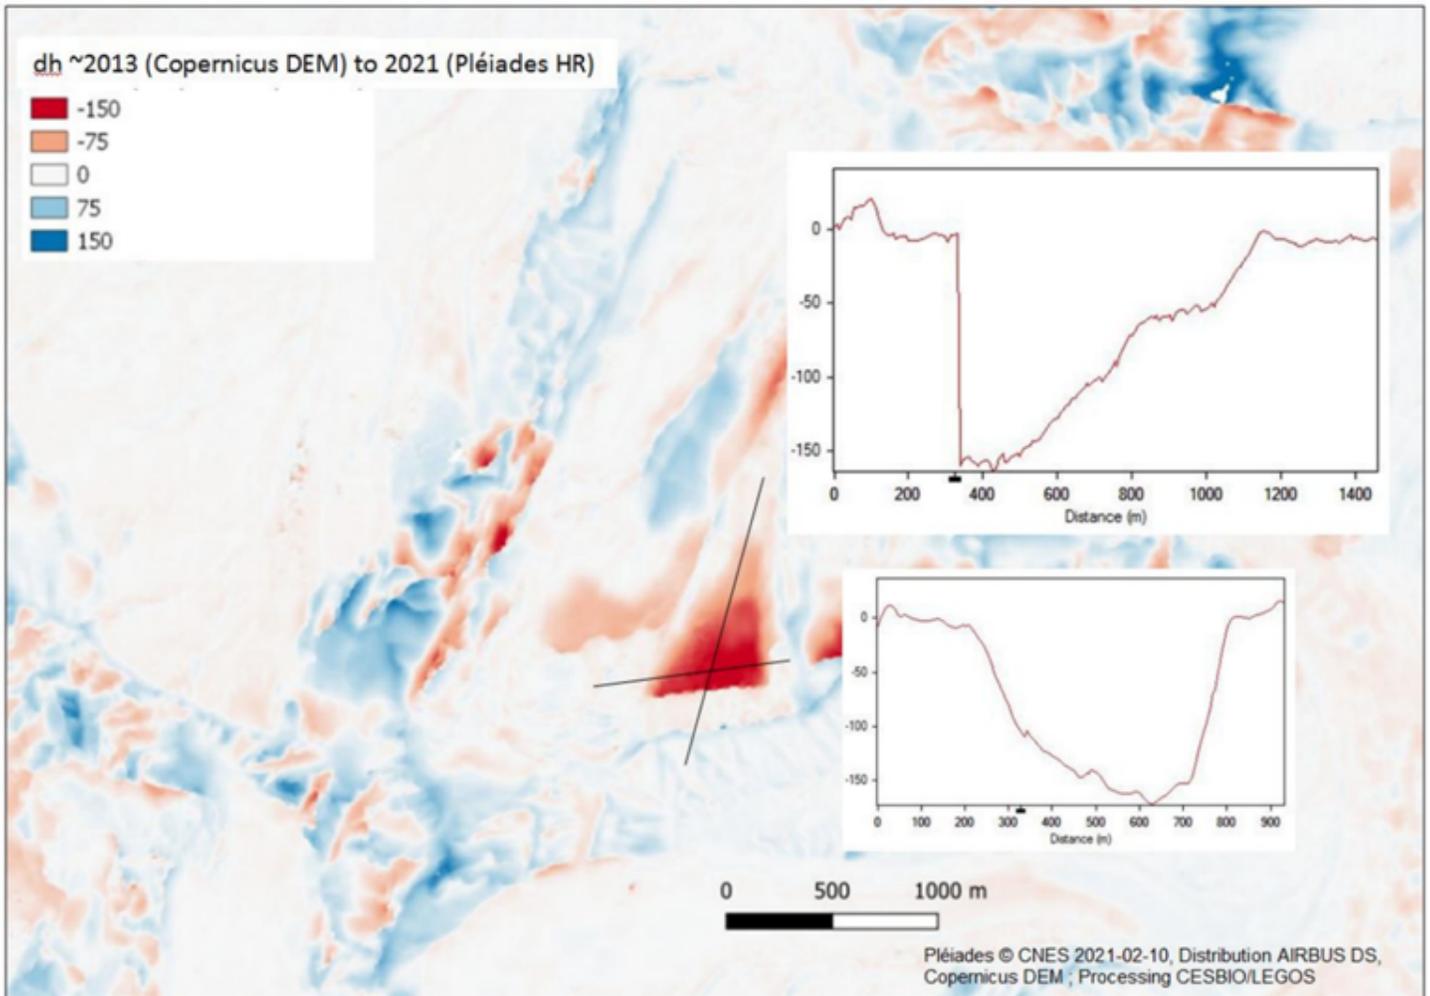
Figure 9

Area and volume estimation of triangular shaped failed slope based on analysis of high spatial resolution 10 February 2021 Pléiades DEM and Copernicus 30m DEM of 2013. Both along slope and across slope profiles depicts maximum depth about 150m (Source: Pléiades images of the Uttarakhand disaster, 2021)

High spatial resolution satellites images and later Google Earth images (including in background digital elevation model of the same) of Dhauliganga disaster event, it has been possible to estimate the area and volume of triangular shaped failed slope. Based on various data sets and limited field inputs, the area of triangle has been estimated equal to about 363000 m² (considering 660m base and about 1100m height of the facet). If an average thickness considered to be 50m (maximum being about 150m) (Fig. 9) thus total estimated volume would be about 18.1 million m³ (which includes rocks, snow and ice) (Fig. 10).

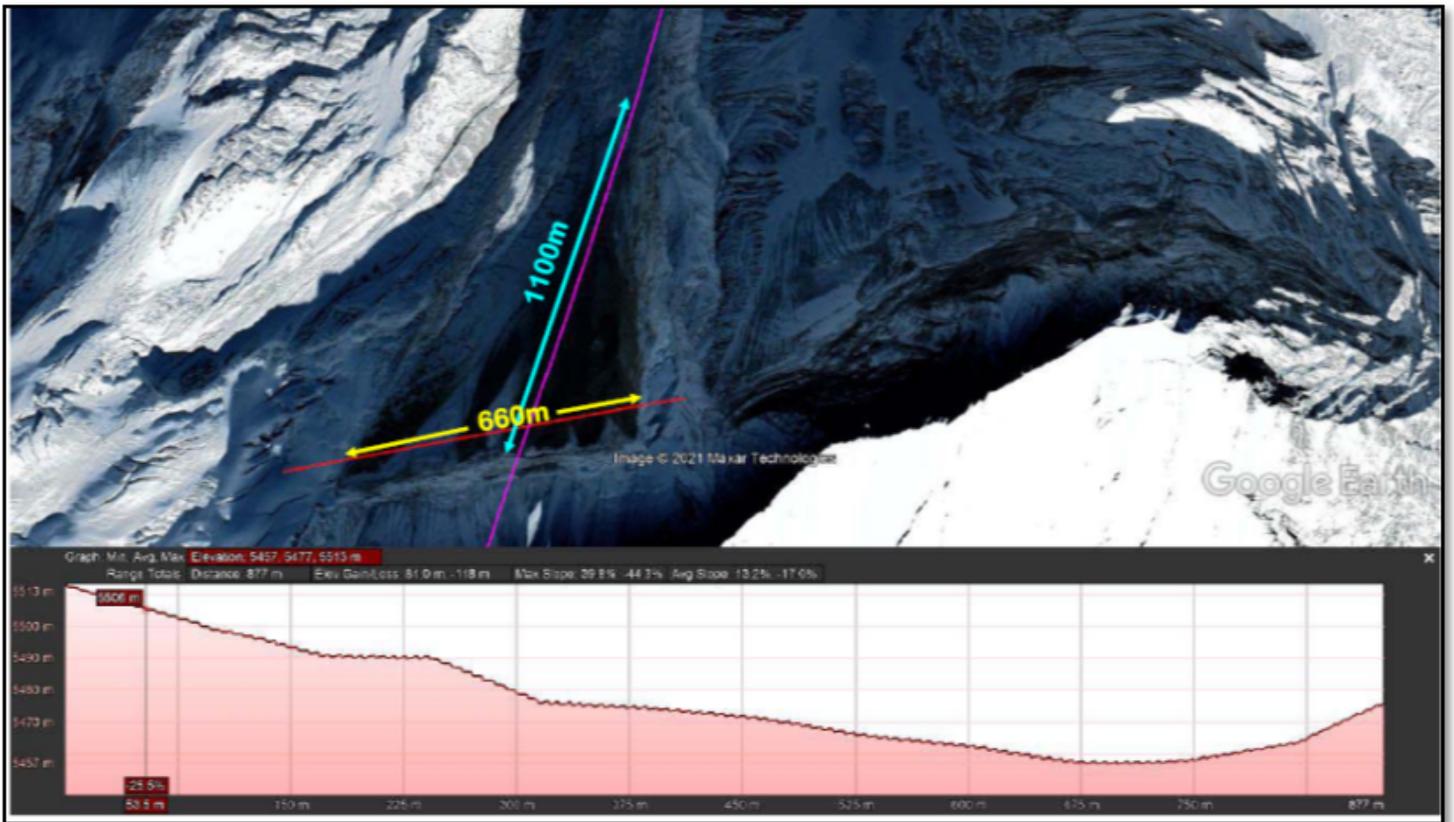
Figure 10

Dimensions of triangular shaped failed slope as estimated employing Google Earth datasets (both high resolution image and digital elevation model in the background). Across slope topographic profile (red coloured line with 660m width as annotation). The topographic profile (bottom figure) depicts depth of the failed slope before the event

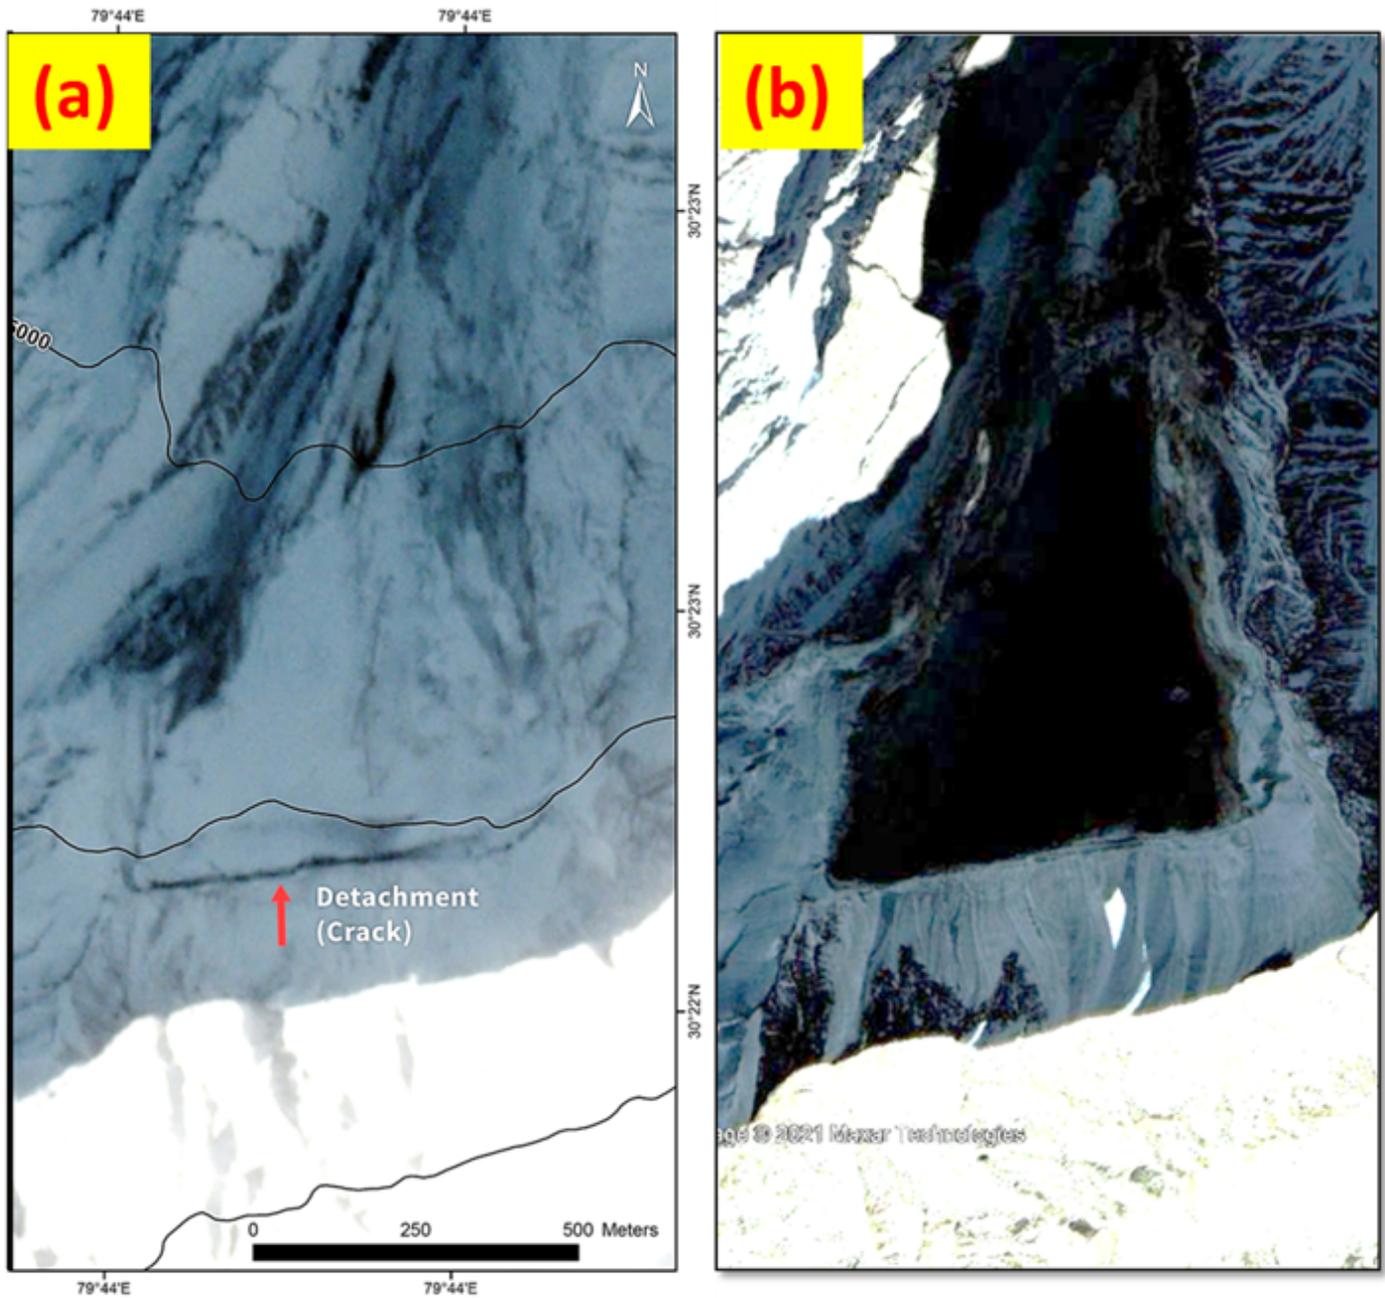
Figure 11

Sentinel-2A image of 06th February 2021 (a) Google Earth image of 10th February 2021 (b) Evidently a detachment crack can be seen in the left image (marked with red arrow), just one day before the event. Further, thick snow on 6th February can also be seen in image (a) Comparison of both the images clearly demonstrates once again that there are early signatures of slope failure.

(A. K. Saraf, 2000; A. K. Saraf et al., 2009; Sharma et al., 2018) have evidently demonstrated that there are generally early signatures of slope failure. Any triggering factor e.g. heavy precipitation, an earthquake, anthropogenic activities etc. can fail such vulnerable slopes, as happened in the present study area (just below of Ronti Peak, the origin of Raunthi Gadhera) a triangular shaped slope could not sustain heavy and swift snow overloading. Time series satellite images undoubtedly depicts that there were early signature of slope failure (Fig. 11). Comparison of both images [(a) and (b) images of Fig. 11] clearly establishes the fact of early signs of slope failure. Here it is important that if regular monitoring would have been employed then perhaps loss of life could have been completely avoided.

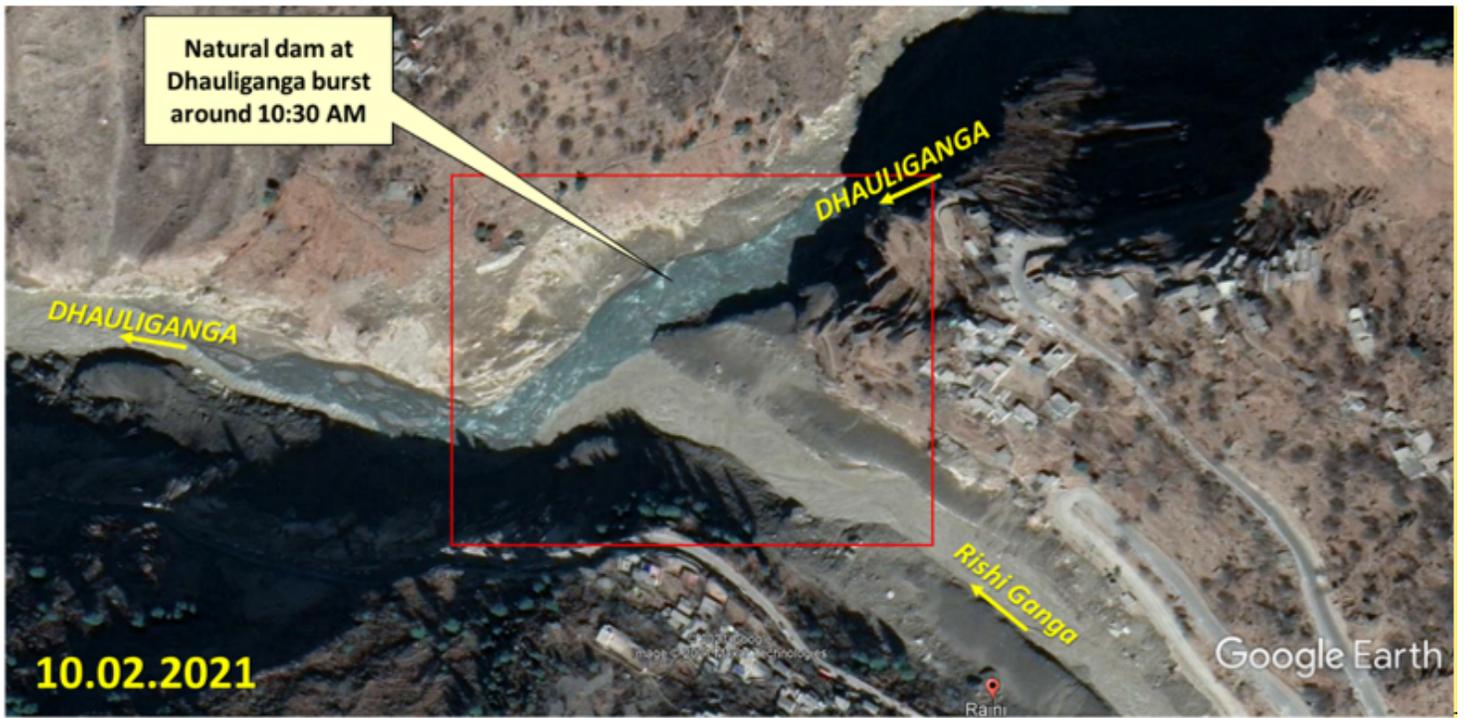
Figure 12

Google Earth image of 10th February 2021 brings remnant of broken natural dam which can be realized clearly across Dhauliganga River. As can be seen that heavy and abrupt moraine sediments (initially Rishiganga brought dark grey sediments as can be seen on both banks of Rishiganga River and later it brought light grey sediments) were brought by the Rishiganga which initially blocked the flow of Dhauliganga. However, due to heavy flow in the Rishiganga the temporary natural dam could not sustain and has broken quickly causing devastating flash flood in the downstream stretch of Rishiganga. Note: The designations employed and the presentation of the material on this map do not imply the expression of any opinion whatsoever on the part of Research Square concerning the legal status of any country, territory, city or area or of its authorities, or concerning the delimitation of its frontiers or boundaries. This map has been provided by the authors.

Rapid and colossal glacial debris flow into the Raunthi Gadhera initially blocked flow of Dhauliganga near Rini village which later failed around 10:30 hrs (local time) on 07 February 2021 and has brought a calamitous flash flood in the Dhauliganga river which killed 79 people and about 125 people are still missing. Due to heavy flow of moraine sediments, both Rishiganga and Dhauliganga rivers were blocked. However, as clearly evident in post-event satellite images that natural damming at Dhauliganga river near Rini village which broke around 10:30 hrs on the same day and has caused devastating flash flood in the Dhauliganga river (Fig. 12). Further, remote sensing images acquired around 10:33 hrs of 07th February 2021 revealed a large dust cloud (Figs. 7 and 8) which clearly unravels the sequence of events from high-altitude landslide, collapse of a small hanging glacier, snow avalanche to catastrophic flooding. Even after the catastrophic flash flood of 07th February 2021, an elongated lake (length about 800m, width at the front is about 100m and having depth of about 46m including freshly deposited debris and silt of about 10m, an estimated total volume of water might be ≈ 800000 m³) was created due to blocking of flow of Rishi Ganga River which still postures flash flood hazard for the downstream areas.

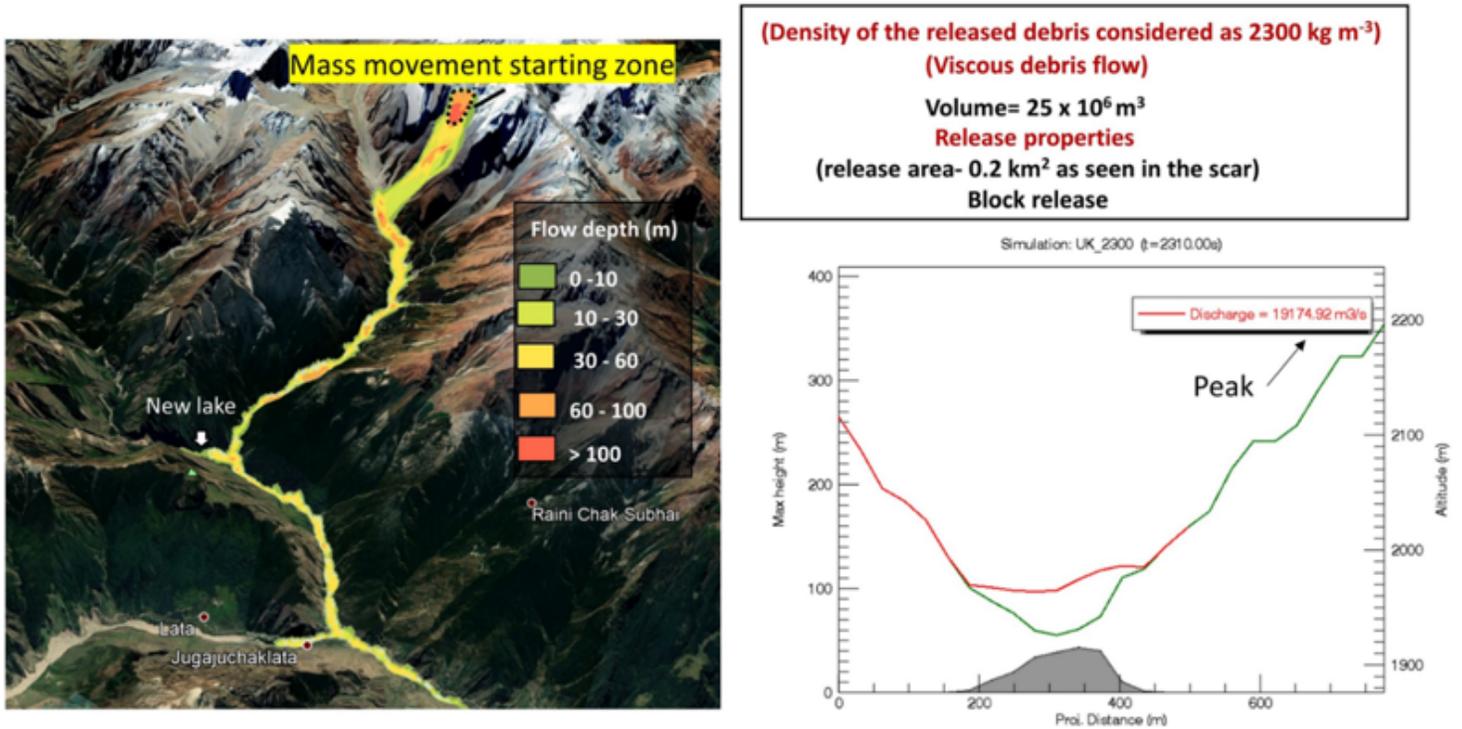
Figure 13

Reconstruction of flow depth and flow velocity with the RAMMS model, for an assumed 25 million m³ (20 million m³ of rock and 5 million m³ of ice) rock and ice avalanche (Source: Sattar, 2021). Note: The designations employed and the presentation of the material on this map do not imply the expression of any opinion whatsoever on the part of Research Square concerning the legal status of any country, territory, city or area or of its authorities, or concerning the delimitation of its frontiers or boundaries. This map has been provided by the authors.

(Sattar, 2021) modelled flow depth and flow velocity with the RAMMS (rapid mass movement simulation). In this modelling approach total volume of rock and ice has estimated about 25 million m³ involving 12.5m spatial resolution ALOS-PALSAR DEM. This model clearly brings insight about the flow depth and upslope entry of sediments into Rishiganga and Dhauliganga Rivers which blocked flow of water and created temporary dams (Fig. 13).

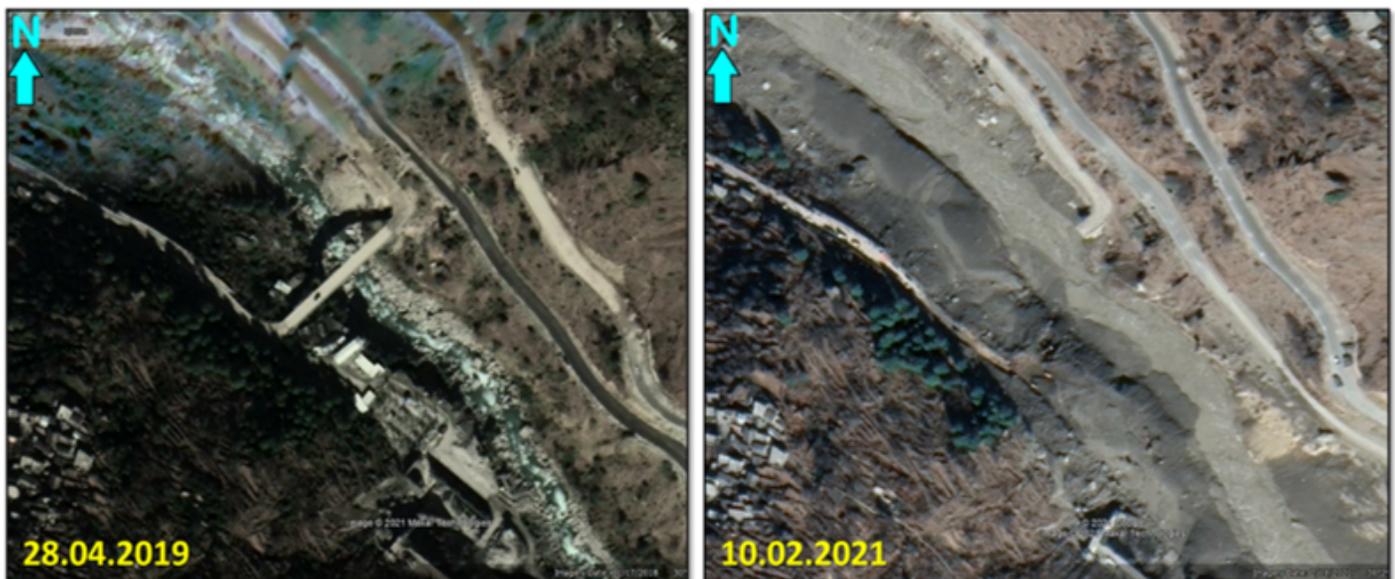
Figure 14

Pre- and post-event Google Earth images of Rishiganga Hydro Power Project (13.2 MW) clearly shows complete washout of the operational hydro power project due to devastating flash flood of 07th February 2021. Note: The designations employed and the presentation of the material on this map do not imply the expression of any opinion whatsoever on the part of Research Square concerning the legal status of any country, territory, city or area or of its authorities, or concerning the delimitation of its frontiers or boundaries. This map has been provided by the authors.

Further, there were two run-of-river hydroelectric power Rishiganga Small Hydro (13.2 MW) at 1975m above msl and Tapovan Vishnugad (520 MW) at 1795m above msl projects which were also severely damaged due to the devastating flash flood (Figs. 14, 15 and 16). More than 150 workers were trapped in the under-construction power tunnel (Fig. 15) of Tapovan Vishnugad project. A visual comparison of images and field photographs shown in Figs. 14 and 15 emphatically brings the extensive damages caused by the flash flood which were caused in few minutes. The damage to all kind of structures along the Rishiganga-Dhauliganga Rivers runs beyond these project sites. In fact, any structure along these rivers were completely destroyed within few minutes time even beyond Vishnuprayag town.

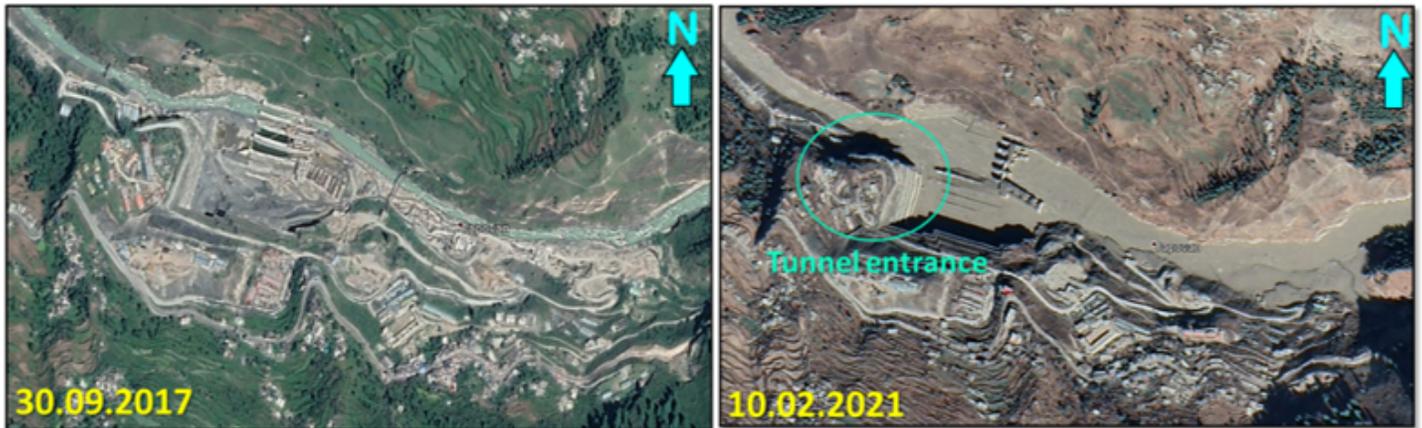
Figure 15

Pre- and post-event Google Earth images of Tapovan Vishnugad Hydro Power Project (520 MW) clearly shows severe damage of under construction hydro power project due to devastating flash flood of 07th February 2021. Note: The designations employed and the presentation of the material on this map do not imply the expression of any opinion whatsoever on the part of Research Square concerning the legal status of any country, territory, city or area or of its authorities, or concerning the delimitation of its frontiers or boundaries. This map has been provided by the authors.

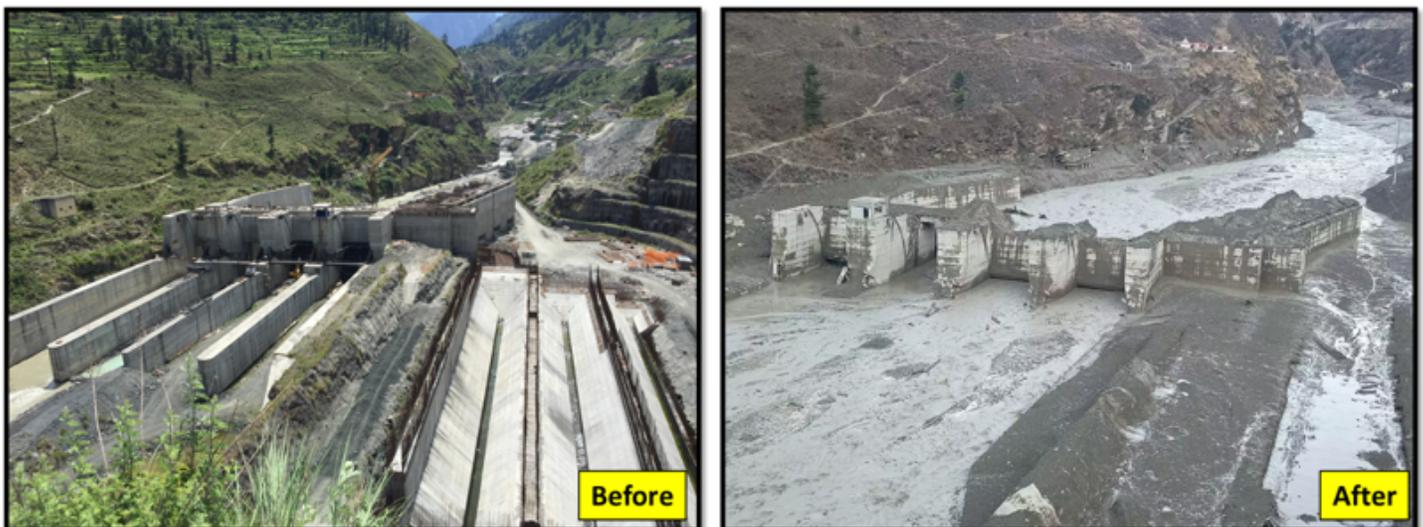
Figure 16

Before and after flash flood conditions of Tapovan Vishnugad Hydro Power Project (520 MW) of clearly shows severe damage of under construction hydro power project due to devastating flash flood of 07th February 2021 (Source: Before

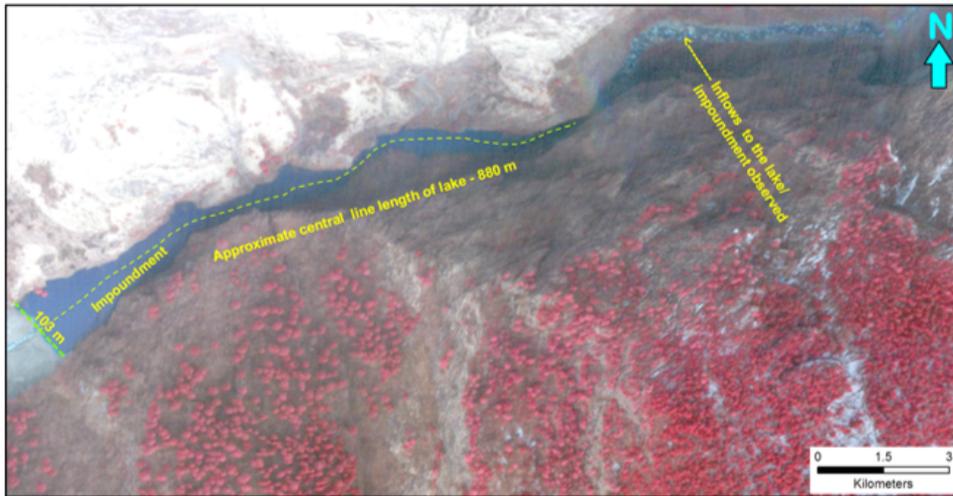
Figure 17

Planet (Skysat-4) image of 23rd February 2021 depicts newly formed lake on Rishiganga River near Rini Village (NRSC, 2021b). Large and sudden supply of moraine debris due to rockslide / landslide blocked Rishiganga River on 07th February 2021. It is important to note that the lake was formed on 07th February 2021 during the flash flood event, however, due to complete shadow conditions in the area, the lake was not clearly seen till 23rd February 2021 (Source: NRSC, 2021b)

As discussed earlier that immediate consequent of the catastrophic flash flood of 07th February 2021, an elongated lake has formed due to blocking of flow of Rishiganga River. This water impoundment can be seen very clearly on the Planet (Skysat-4) satellite image of 23rd February 2021 (Fig. 17) (NRSC, 2021b).

The Planet (Skysat-4) image of 23rd February 2021 (Fig. 17) evidently shows the elongated shape of the lake. Therefore, it is easy to map the size of lake (length about 880m, width at the front is about 103m). The average width of the lake can be estimated to about 59m and therefore the area of the lake would be about 25,000 m². Further, based on limited field data, the average depth of the lake can be taken about 36m (excluding freshly deposited debris and silt of about 10m), an estimated total volume of water in lake might be ≈ 900000 m³.

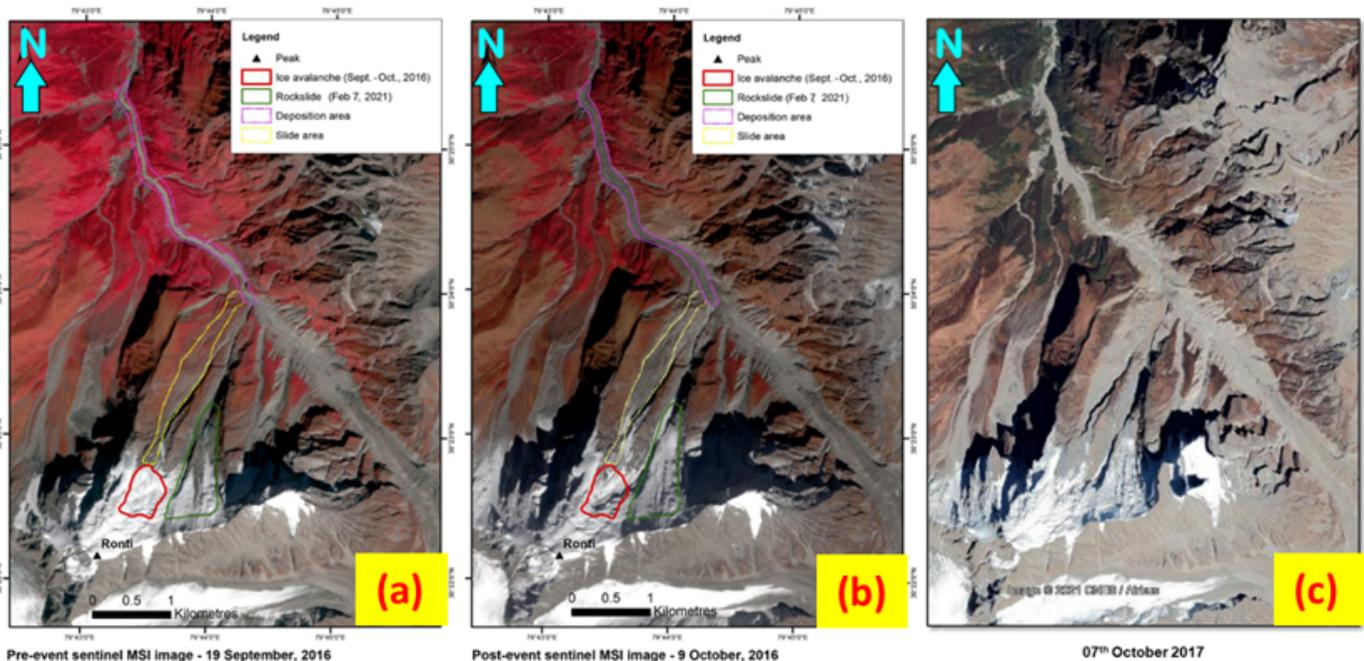
Figure 18

The ice avalanche breakoff between 19th September and 9th October 2016 (solid red outline) with the area covered by resulting moraine deposits along the Raunthi Gadhera (dotted pink line) and flow surface (dotted yellow line). The green outline shows the present rockslide scarp (after Shrestha et al., 2021). Image (c) of 07th October 2017 further reveals that there were continuous activities of breaking off of rocks and additional deposition of sediments in the Raunthi Gadhera valley (Source: Shrestha et al. 2021)

(Shrestha et al. 2021) have discussed ice avalanche breakoff near to triangular shaped rockslide area of 07th February 2021. September-October 2016 time series images clearly reveals such ice avalanche

breakoff which brought moraine deposits along Raunthi Gadhera (Fig. 18). Fig. 18(c) image of 07th October 2017 further conveys evidences of breakoff of ice and rocks and bringing additional sediments in the Raunthi Gadhera, which visibly specifies that there were continuous such activities in that area. Later, the same area (just east of September-October 2016 area) (Fig. 18) broke and caused coalescent natural disaster of 07th February 2021.
