Dhauliganga, Uttarakhand, India Coalescent Natural Disaster: A Geoinformatics Perspective

Research Article

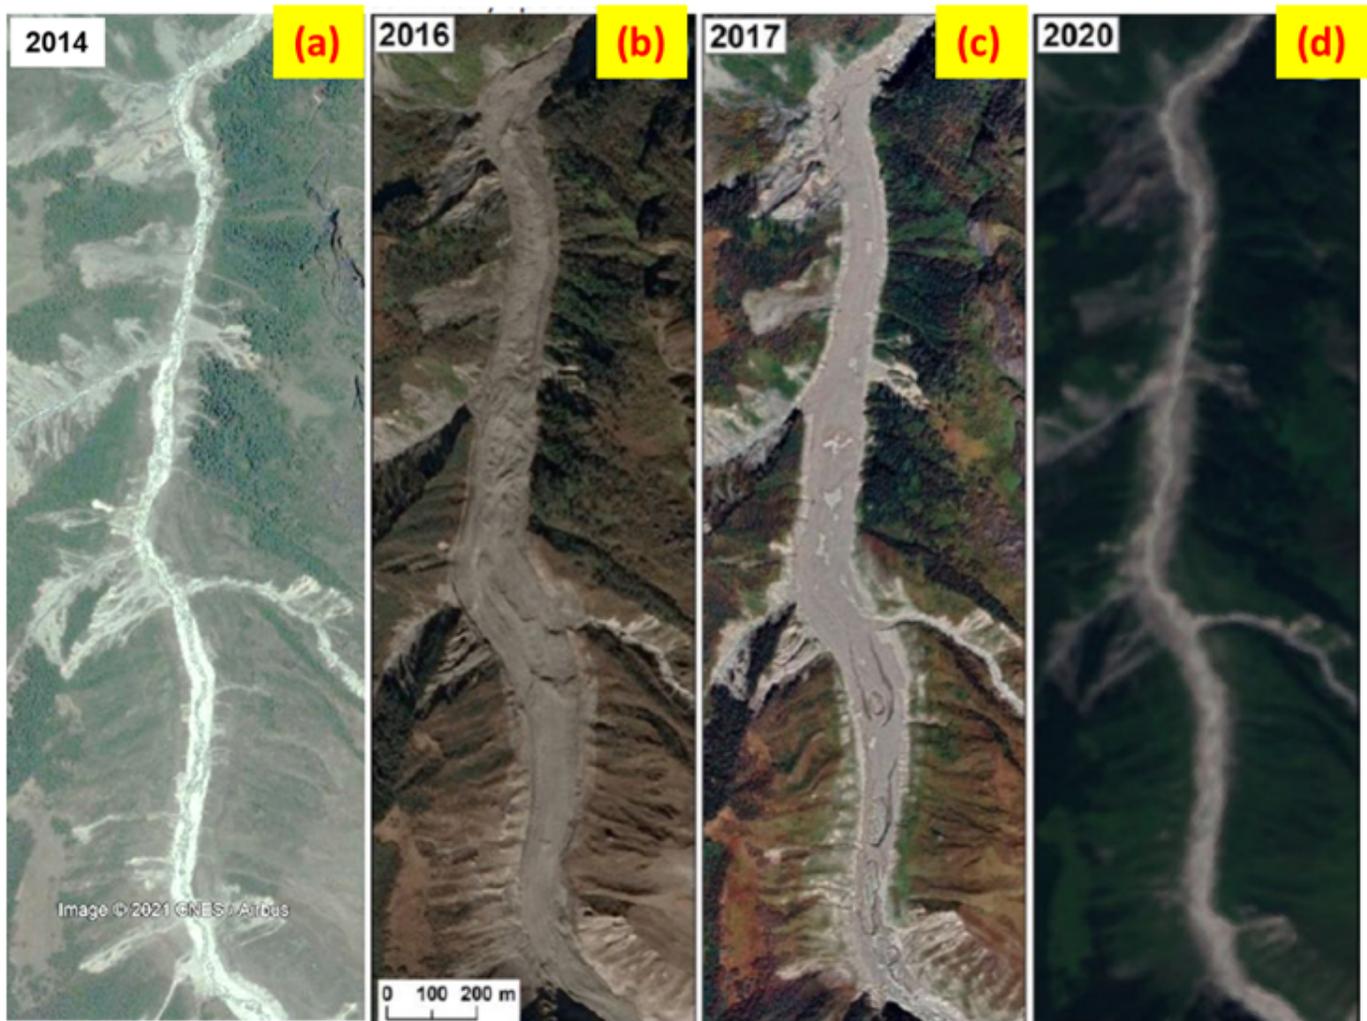
Figure 19

Moraine deposits of the September-October 2016 ice avalanche from the neighbouring glacier. The 2020 pre 07th February 2021 event Sentinel-2 image (d) indicates normal flow of the river, similar to Google Earth image of 2014 (a). The debris-covered ice, visible in the (b) and central panel (c) from 2016 and 2017, seems to have disappeared in the year 2020, much before the 2021 avalanche (GAPAZ, 2021). Note: The designations employed and the presentation of the material on this map do not imply the expression of any opinion whatsoever on the part of Research Square concerning the legal status of any country, territory, city or area or of its authorities, or concerning the delimitation of its frontiers or boundaries. This map has been provided by the authors.

It is stimulating to note that the ice avalanche breakoff / rockslide moraine sediments do not stay long in the Raunthi Gadhera. Time series images shown by (GAPHAZ, 2021) (Fig. 19) emphatically shows that in 3-4 years' time, the monsoon rains in the area can flush out such sediments. Such rapid flushing of sediments from the streams also indicates that the sediments deposited due to the 07th February 2021 events will also flush out soon. However, comparatively the latest event has deposited more sediments not only in the Raunthi Gadhera, but also in along Rishiganga and Dhauliganga Rivers. Inevitable heavy rains in the coming Monsoon seasons will be flushing out the newly deposited debris from these streams which may become source of various other problems in the downstream areas. Further, latest images of the triangular slope failure area of 07th February 2021 evidently specifies about the future disaster due to failure of ice covered slopes (Fig. 20). Clear cracks top of ice / snow covered surface indicate about repeating of such events originating from the same area in future.

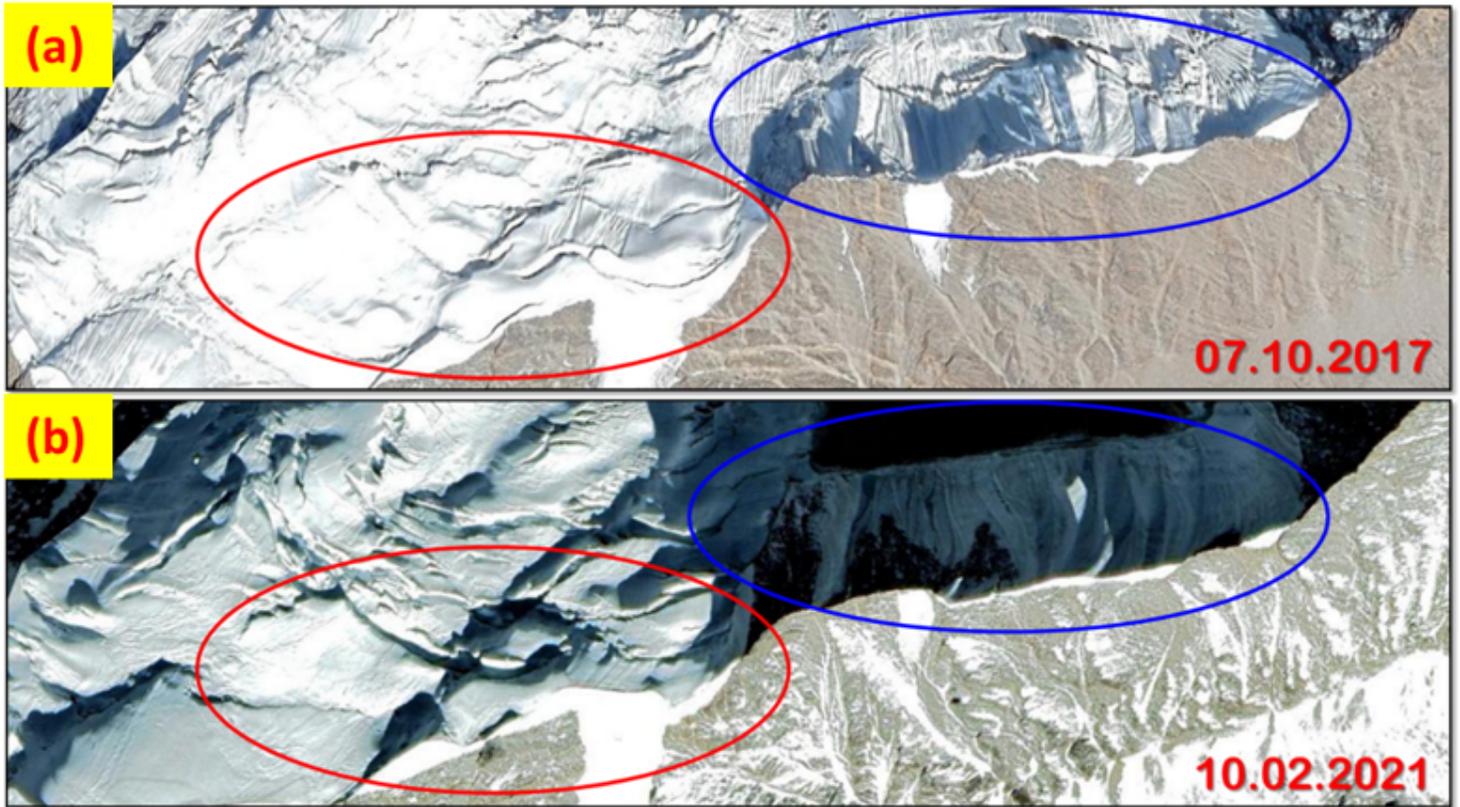
Figure 20

Google Earth images of 07th October 2017 (a) and 10th February 2021 (b). Developments of cracks can be seen (blue ellipse) emphatically indicating imminent possibilities of slope failures which has really happened on 07th February 2021 (also seen in Fig. 11). The red ellipse are now indicating about future slope failures which may be triggered due to heavy snow / rains as happened in the neighbouring areas during February 2021 which brought devastating coalescent disaster in the downstream areas. Note: The designations employed and the presentation of the material on this map do not imply the expression of any opinion whatsoever on the part of Research Square concerning the legal status of any country, territory, city or area or of its authorities, or concerning the delimitation of its frontiers or boundaries. This map has been provided by the authors.
