Analysis of Pigments and Damages for the 19th Century White-Robed Water-Moon Avalokitesvara Painting in Gongju Magoksa Temple, Korea

Research Article

Abstract

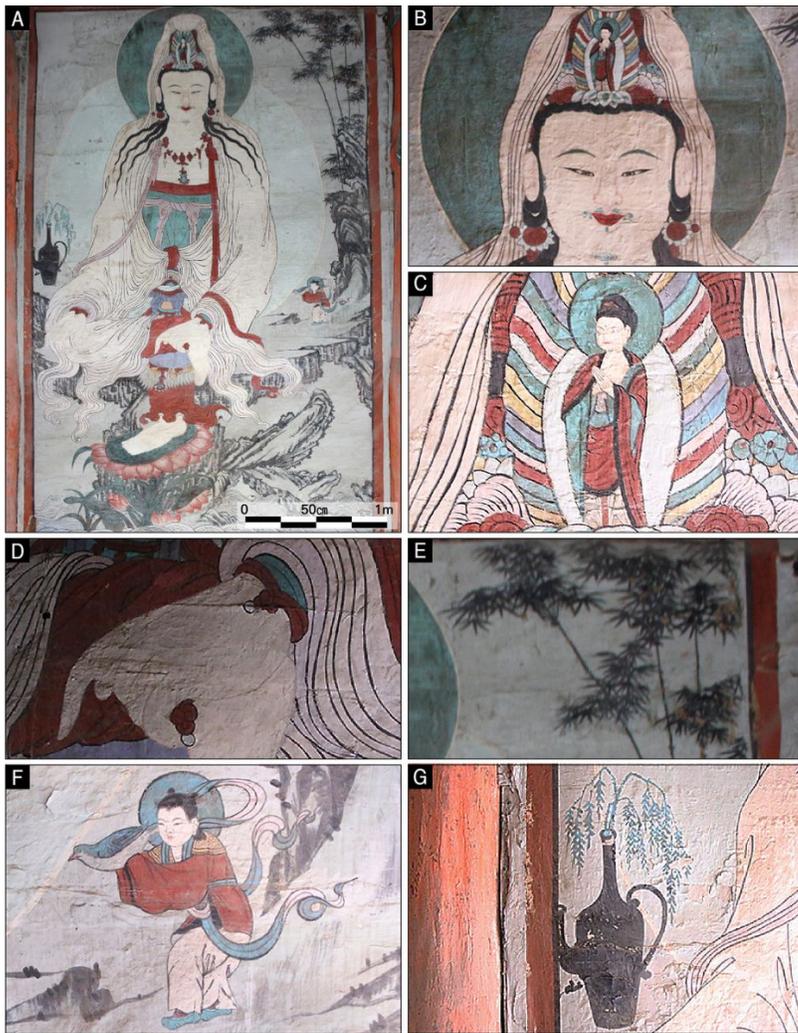
Figure 1

The present status of the White-Robed Water-Moon Avalokiteshvara painting in this study. (A) Foreground of the painting. (B) Face part of the painting. (C) Nirmāna-Buddha on crown. (D) Left hand of the painting. (E) Bamboo in the upper right corner. (F) Seonjae Dongja (priestling) in the center right. (G) Kundika and willow branches in the middle left.

This *White-Robed Water-Moon Avalokiteshvara* painting is a colossal mural measuring 515cm in length and 296cm in width, with *Gwaneum Bosal* (Avalokiteshvara) in a white robe sitting on a lotus pedestal above a rippling wave and a strange rocky stone, with her left leg hanging down. She is at the center of the painting surface and facing the front in a half-lotus position, her right leg placed on her left (Fig. 1a). *Gwaneum Bosal* wears a white robe from her head to below knees and red bottoms having a green bottom with red hem and tied with a pink belt inside the white robe (Fig. 1a).

In addition, *Gwaneum Bosal* wears a crown on her head with a standing Amitabha statue in the middle to indicate identity as *Avalokiteshvara* (Figs. 1b and 1c). Her right hand rests comfortably on right leg, and her right ankle is held with left hand. Her hands and feet are large and realistically depicted (Fig. 1d). Behind *Gwaneum Bosal*, four bamboo trees are rising from the rough rocks on the left side (Fig. 1e); *Seonjae Dongja* (priestling) stands thereunder, leaning toward *Gwaneum Bosal* (Fig. 1f); and a *kundika*, in which a willow branch is arranged, is placed on the opposite rocks (Fig. 1g).

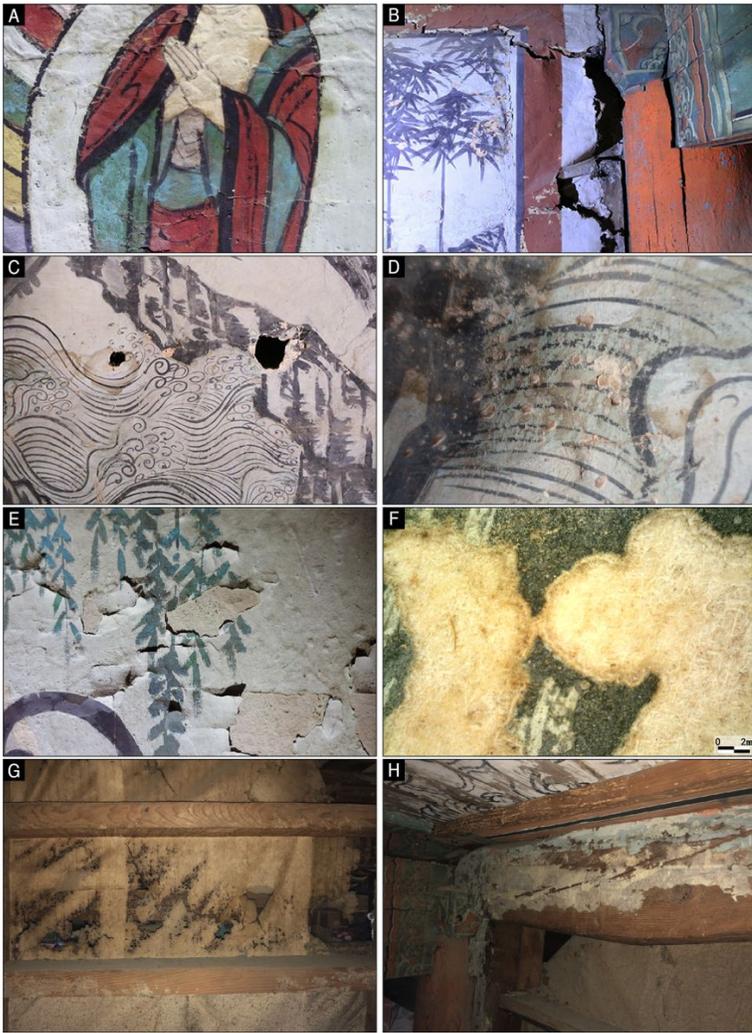
Figure 3

The types of damage observed on the painting surface of *White-Robed Water-Moon Avalokiteshvara* are typically divided into microcracks (Fig. 3a), separation (Fig. 3b), fragmentation (Fig. 3c), contamination (Fig. 3d), and blistering and exfoliation of the pigment layer (Figs. 3e and 3f). Overall, although the contour lines and colored surfaces of this painting remain undamaged, damage appears on the painting surface along with blistering and exfoliation of some pigment layers, cracks and separation of the pigment layer, and cracks and separation of the wall (Fig. 3).

The blistering and exfoliation of the pigment layer are mainly observed around the face and on the red bottoms of the *Gwaneum Bosal*, which is believed to be accompanied by contraction, expansion, and cracking due to moisture. Moreover, after completely stripping the painting, the preservation condition of the wood materials on the rear wall were checked. As a result, it was found that the deterioration of the front lining paper and the wooden frame had severely progressed due to decomposition by wood-decay fungi and insect damage (Figs. 3g and 3h).

Photographs showing the representative damages of the studied painting. (A) Microcracks. (B) Separation. (C) Fragmentation. (D) Black contamination. (E) Blistering and exfoliation of the pigment layer. (F) Stereoscopic photographs of the exfoliation part on the pigment layers. (G) Deterioration of wooden frame after stripping the painting. (H) Residual pigments and cracks in the wooden frame.

The structural condition of the wooden frame constituting the painting wall was found to be relatively stable, and while there were cracks and separation along the edge of the wall, the preservation condition of the mural painting as a whole was fair. In addition, because the blistering, exfoliation of the colored

layer, contamination, and fragmentation were found to be scattered throughout the painting surface, it was recommended that appropriate measures for long-term preservation be taken.
