Dynamic Evolution Mechanism of A Rock Slope with Discontinuities Under Earthquake Motions Using Shaking Table Tests

Research Article

To clarify the dynamic evolution and failure mechanism of rock slopes with complex geological structures, shaking table tests are designed and carried out in this study based on the engineering background of the slope response of the Jinsha River Bridge. The tests imitate the slope, including its penetrating weak structural surface and steep structural surface on the trailing edge. The dynamic

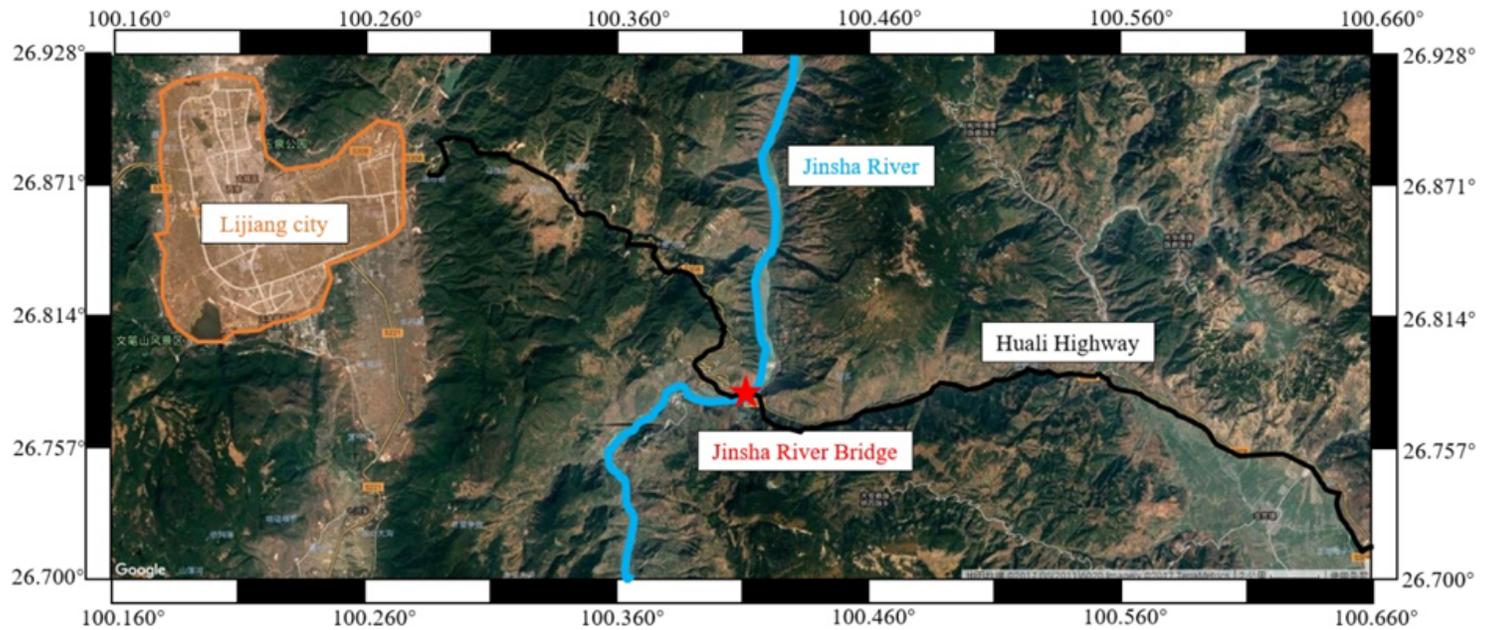
Figure 1

Location of Jinsha River Bridge

The Jinsha River Bridge crosses the Jinsha River. As shown in Fig. 1, it is an important bridge on the Huali highway connecting the cities of Lijiang and Huaping. The route crosses the Jinsha River at a vertical angle from east to west (as shown in Fig. 2). As the key project of the HuaLi highway, the main pile cap of the bridge is located in the middle of the slopes near the Jinsha River. The bank slope, on which the main pile cap was built, has a stepped topography due to the dip structure and flow along the river. The Huaping coast is along the bank slope, with a gradient of 20° – 30° . The exposed strata of the project area are mainly a Permian basalt formation (P2 β 3), basalt almond-shaped lithological volcano, breccia lava, and tuff. The site of the slope has a tuff structural surface and a step structural surface on the trailing edge (as shown in Fig. 3). This area can resist an earthquake with an intensity of VIII. Combined with the actual situation of the bridge, the main factors affecting the stability of the slope are the topography, stratigraphic lithology, combination of the structural surfaces, and seismic loads.

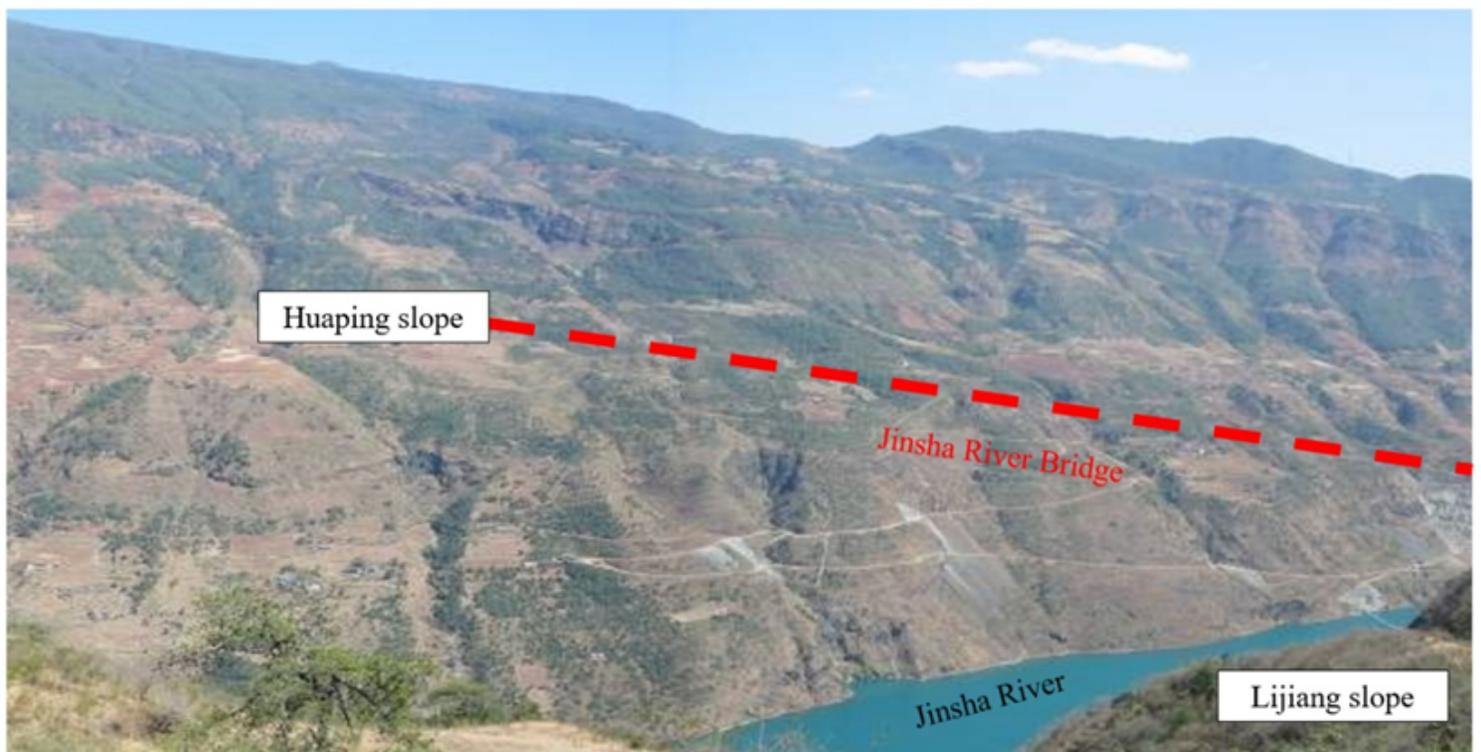
Figure 2

Topography and geomorphology of Huaping bank slope

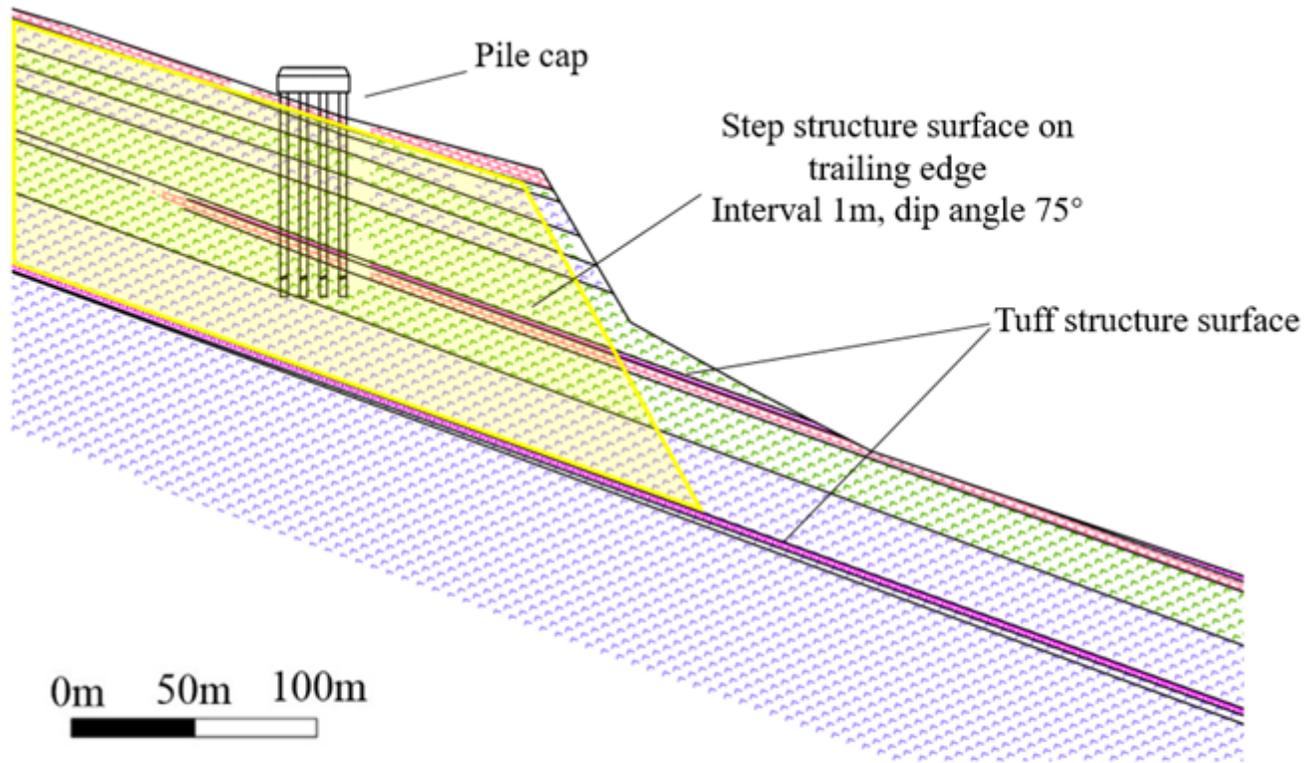
Figure 3

Basalt				Breccia	Tuff
Massive	Amygdaloidal	Phenocryst	Breccia	Volcanic	Volcanic

Stratigraphic distribution of the slope

To clarify the dynamic response of the rock slope, a simplified model was established and simulated. The model slope had a size of 280×140 cm and a height of 130 cm (shown in Fig. 3). The slope model was constructed with prefabricated blocks, which were assembled in seven layers. The angles of the structural plane and trailing edge of the steep structural surface slope in the model material were 30° and 75°, respectively. The slope model is shown in Fig. 6.

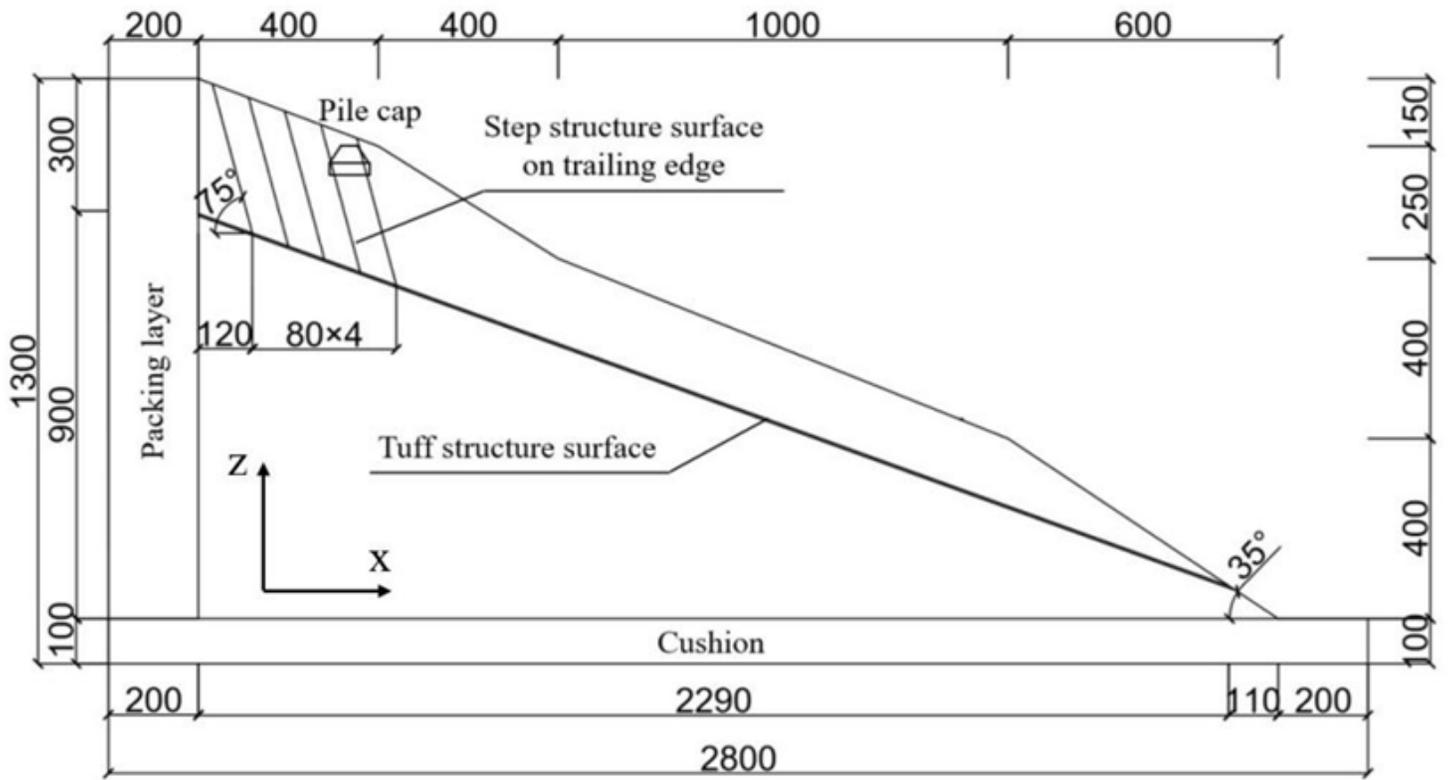
Figure 4

Scaled model (mm)

The model is 1.3 m in height and weighs more than 7 tons (as shown in Fig. 4). There are many challenges in construction of a model of this size. If the model is poured as a whole, the curing time will be excessively long. Because different areas in the model have different curing times, it is difficult to control the strength of the simulation material. In addition, it is difficult to place the sensor in the center of the model. Therefore, a special construction method is used to address these problems. The model is split into 224 blocks, and each block is poured with a corresponding mold. The curing times of all blocks are then precisely controlled. Typical blocks are shown in Fig. 5. To simulate the tuff structural surface, a PVC expansion sheet was inserted in the block during the corresponding stage. A typical block containing the tuff structural surface is shown in Fig. 5b. To simulate the step structural surface in the trailing edge, sand was inserted in the block during the corresponding stage. A typical block containing a step structural surface in the trailing edge is shown in Fig. 5c. After completion of the model, the PVC expansion sheet is connected to form the same shape as the tuff structural surface. Some cracks are used to simulate the step structural surface on the trailing edge, as shown in Fig. 5c. These cracks are cut with a 5-mm-thick iron sheet and filled with sand. After the block is poured, it is cured for 5d in a dry, cool environment.

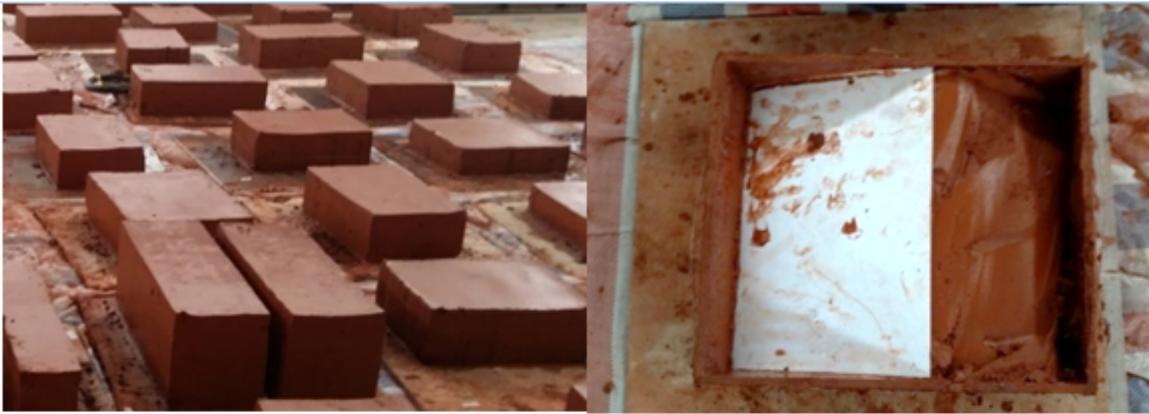
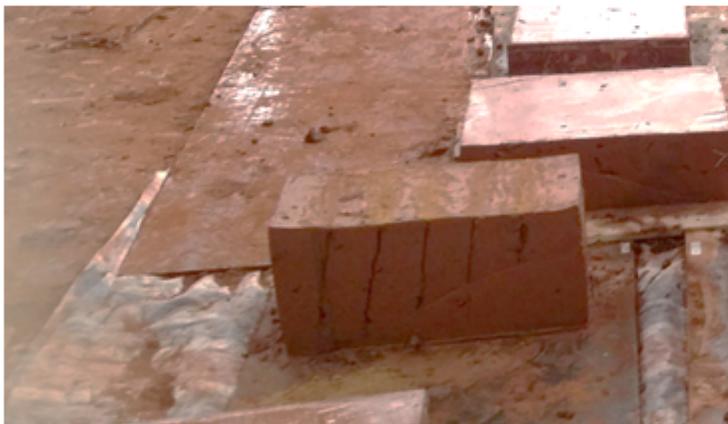
Figure 5

(a) Normal blocks (b) Tuff structure surface

(c) Step structure surface on trailing edge

Photo of the testing blocks

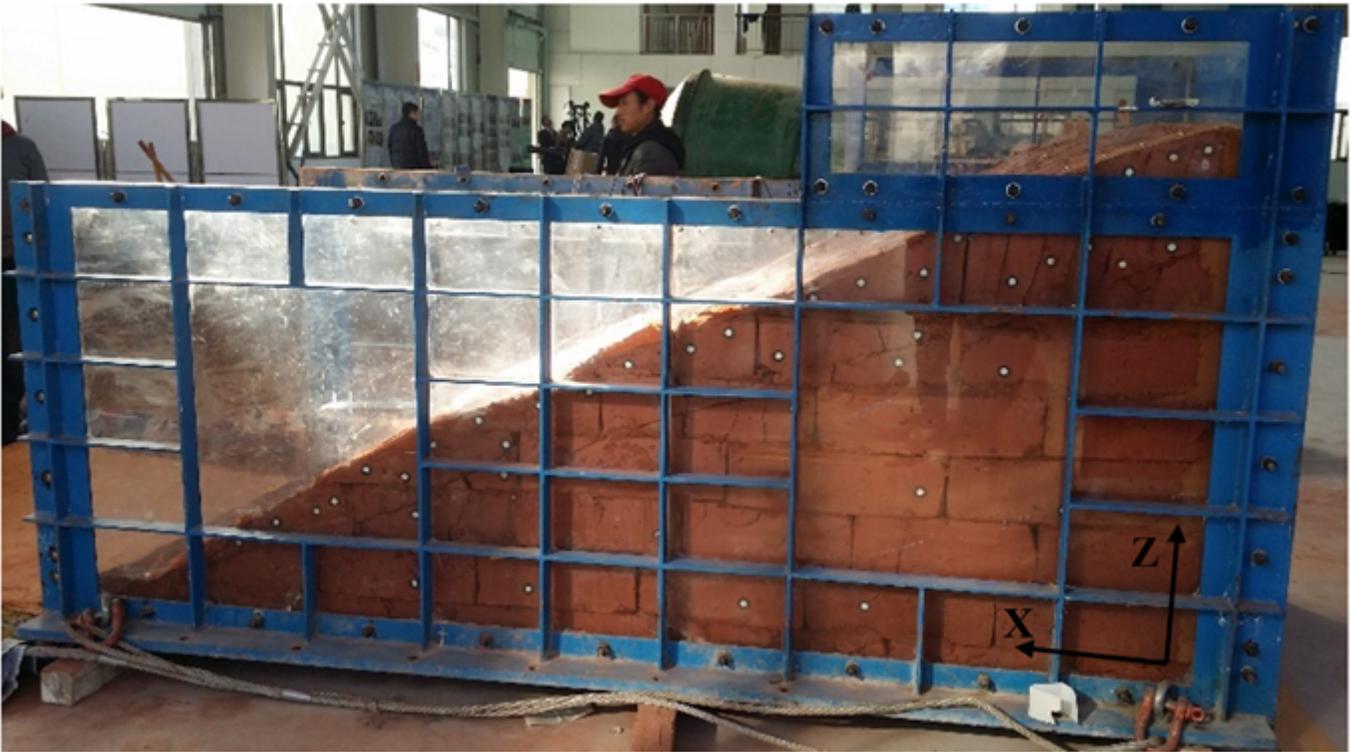
Figure 6

Photo of the scaled model

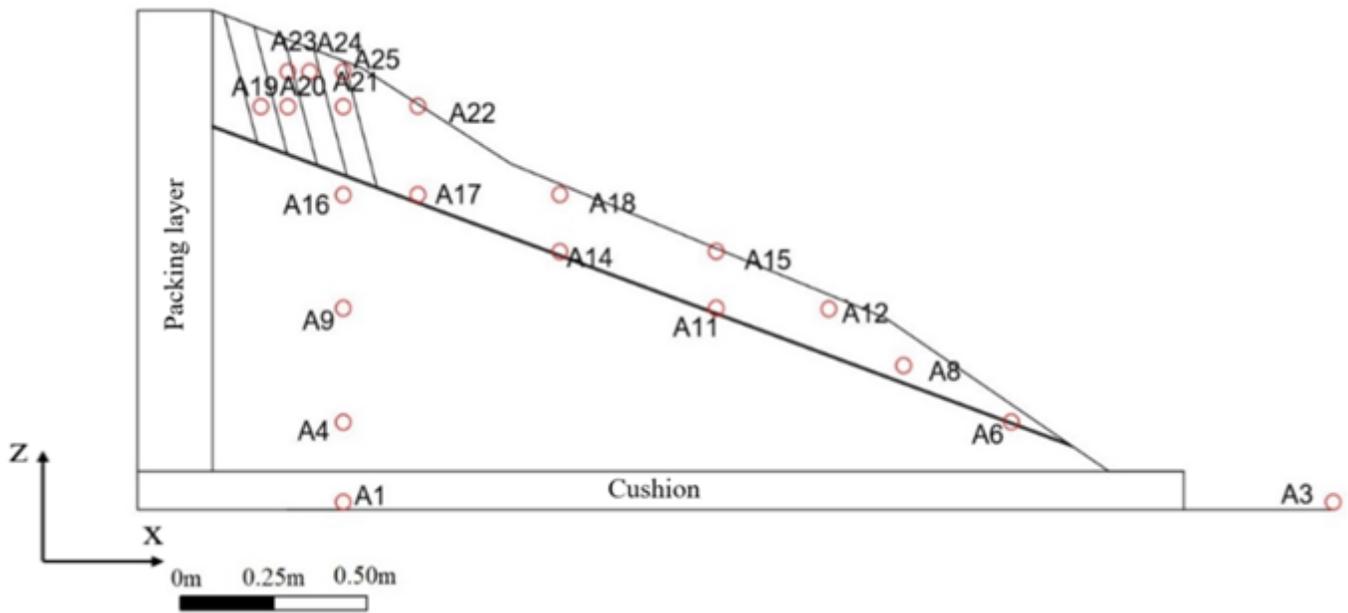
Figure 7

Measurement points

The acceleration measurement setup is shown in Fig. 7. First, 20 accelerometers were arranged in the slope; accelerometers A8, A12, A15, A18, A22, A23, A24, and A25 were placed on the slope surface, while the other accelerometers were embedded at various depths in the slope. The accelerometers used are able to collect acceleration data in three directions simultaneously (as shown in Fig. 8). The frequency range of the acceleration sensors is 0–1500 Hz in the horizontal direction and 0–800 Hz in the vertical direction; the sensitivity is approximately $66 \text{ mV/m}\cdot\text{s}^{-2}$ with a range of $\pm 20 \text{ m/s}^2$. An additional buffer layer with a thickness of 10cm was designed to minimize the effects of the bottom boundary.

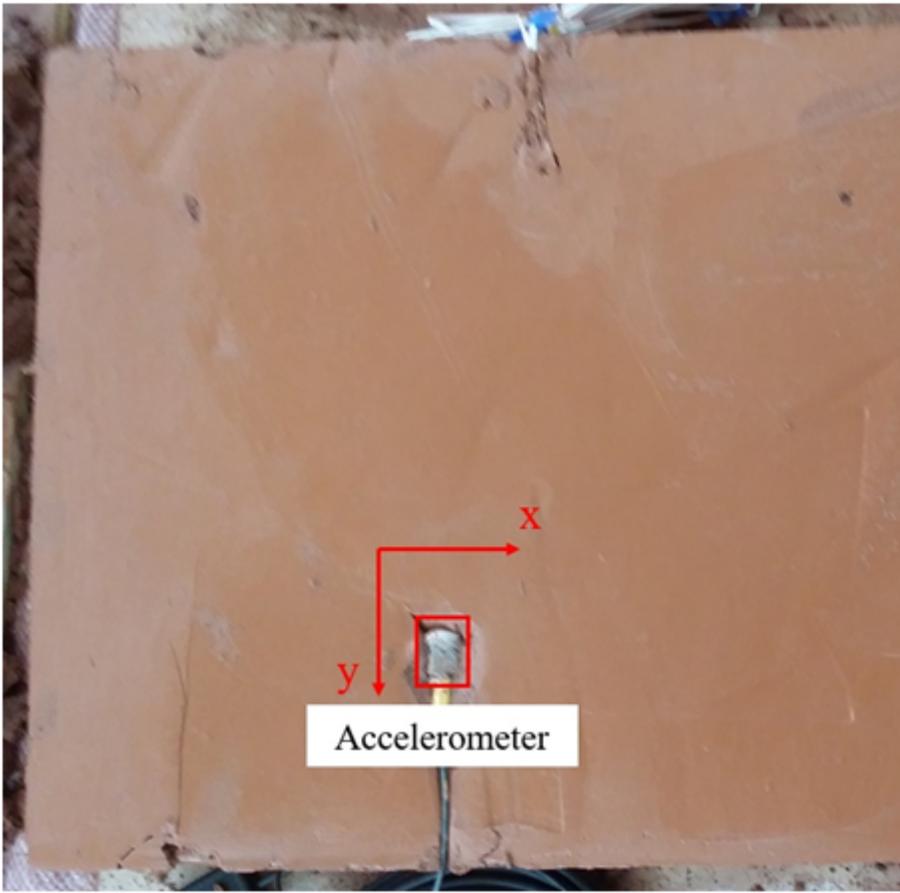
Figure 8

Install of the accelerometer

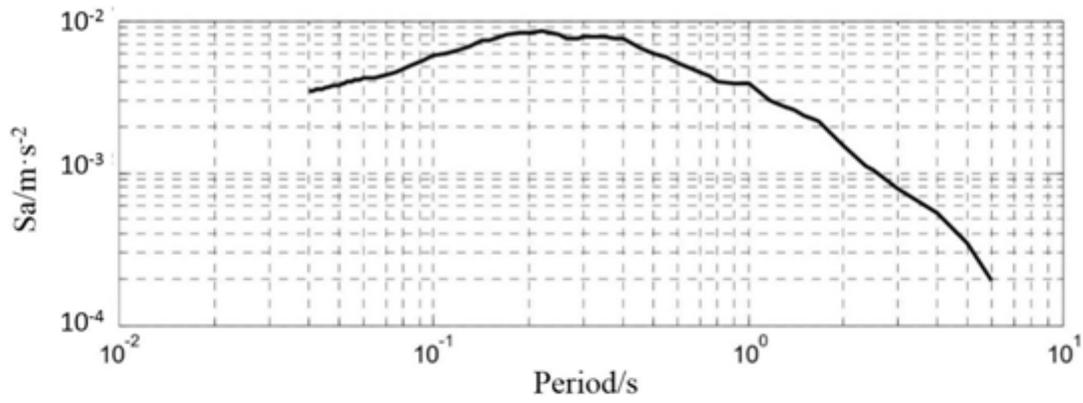
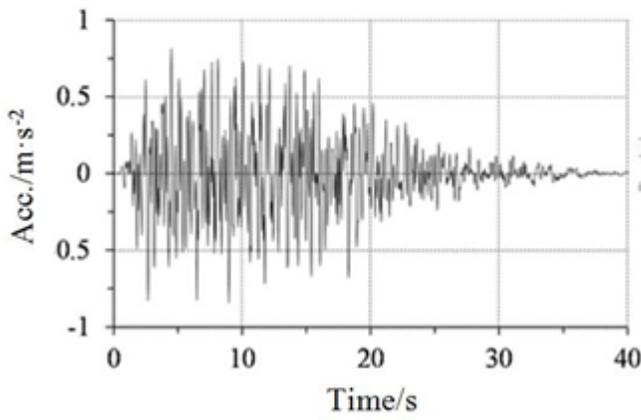
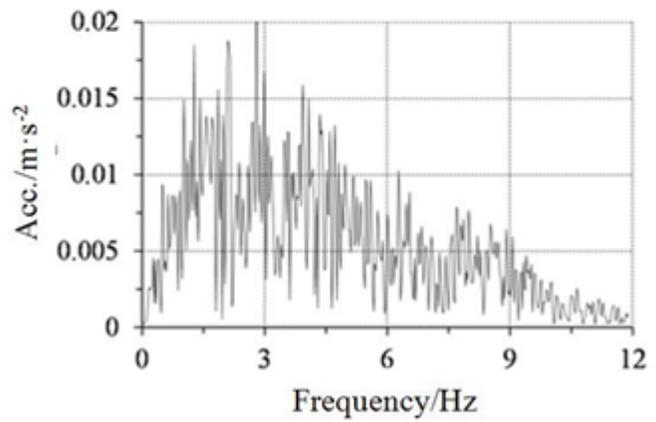
Figure 9

(a) The responsespectrum

(b)Thetimehistory(c)TheFourierspectrum

The input artificial synthetic wave

The waveform was synthesized by a local earthquake prediction department based on local historical earthquake data and geological characteristics. The time history and response spectrum are shown in Fig. 9. The dominant frequency of the artificial synthetic wave was 4.5–5.5 Hz. The seismic waves were loaded horizontally in the tests. The working conditions of the tests are summarized in Table 3.

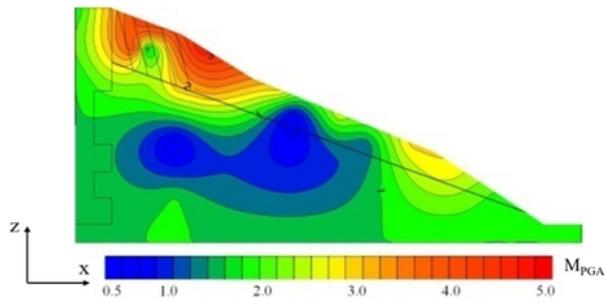
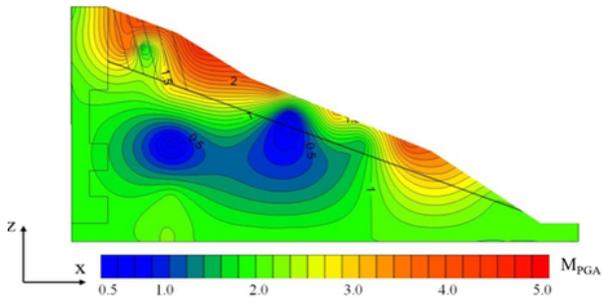
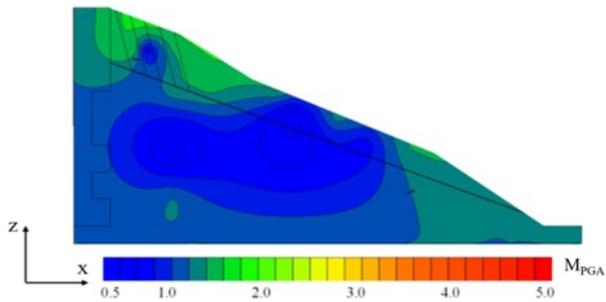
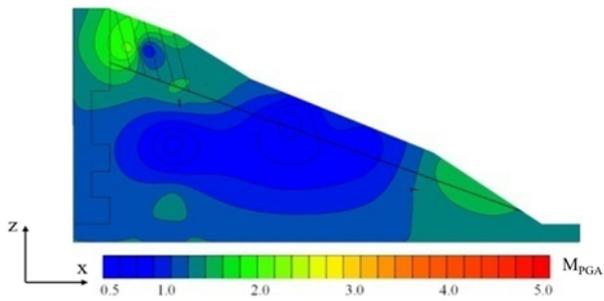
MPGA distribution under artificial input motion

Figure 10 shows that the acceleration amplification effect mainly occurs on the slope surface, and the maximum acceleration occurs at the top of slope. It can be concluded that the seismic wave propagation is affected by the structural surface in the bedrock body with discontinuous structural planes such as weak inter layers, cracks, and faults. The seismic wave field is superimposed on the structural surface and the slope surface. As it is affected by the stepped slope, the acceleration amplification factor alternates with the slope size.

The M_{PGA} value reached 3.7 at the top of the slope when the seismic wave was loaded in the horizontal direction. By comparing the PGA distribution with different earthquake motions, it can be observed that the amplification effect area is upwards from the slope surface to the top of the slope. Therefore, an amplified area of dynamic response occurs at the top of the slope, which means that the materials were unstable. Cracks and failure will first appear at the top of the slope under seismic loading. The M_{PGA} is smaller under the structural surface than above the surface. Thus, the existence of the structural surface can be considered to cause a mutation in the position of the acceleration response, which is not conducive to the slope stability.

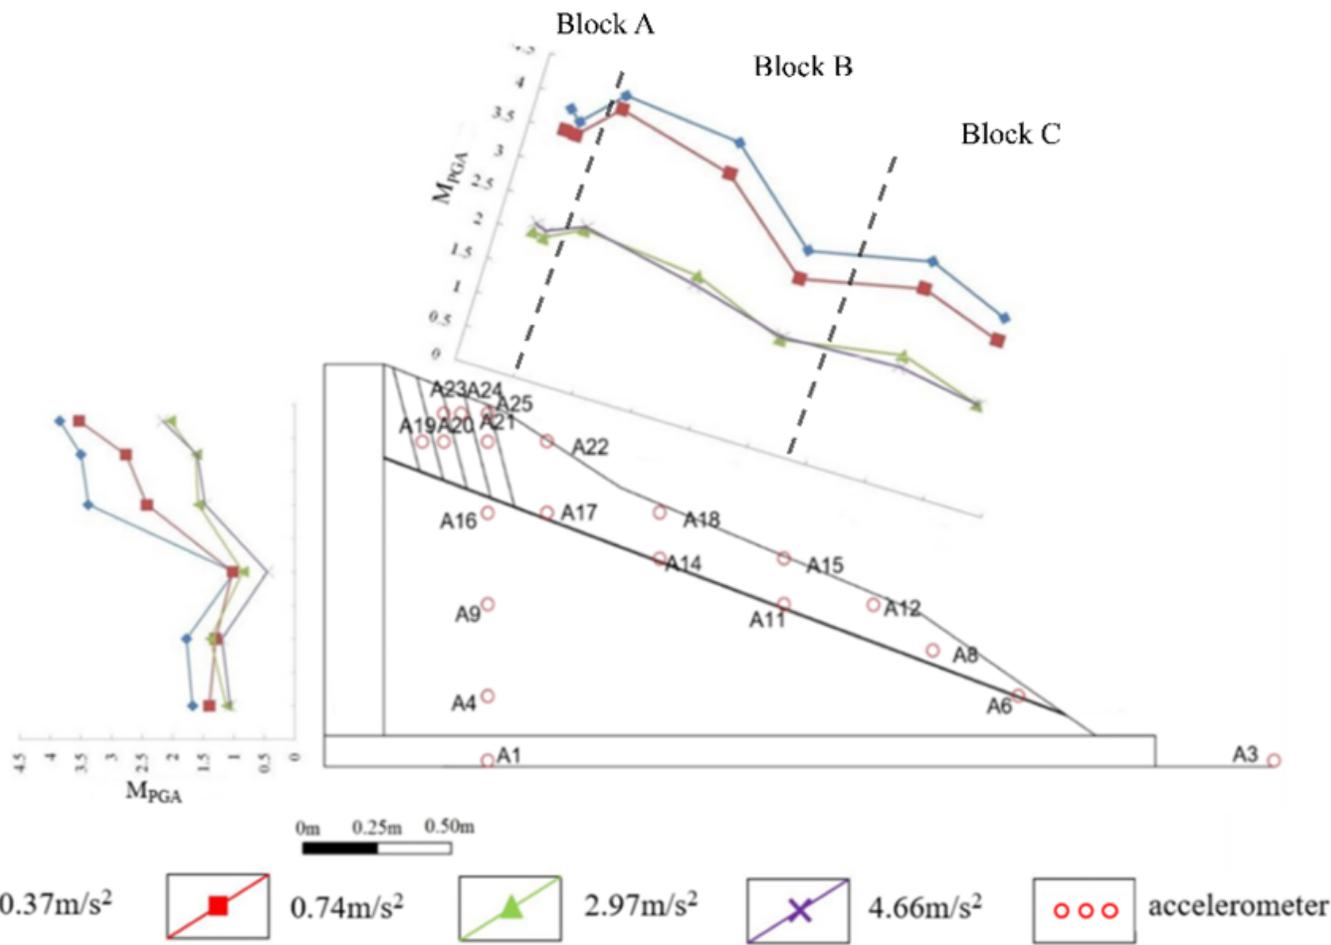
Figure 11

Acceleration response along slope

The M_{PGA} distribution only reflects the distribution of the acceleration response of the slope for each case. In order to make a quantitative comparison between the dynamic responses of different cases, the history line for the M_{PGA} of the accelerometers in different cases is plotted, as shown in Fig. 11. The M_{PGA} gradually increases along the height and the surface of the slope. With a gradual increase in the input

seismic wave, the acceleration response of the slope decreases. When the intensity of the input wave reaches an intensity of VIII, the acceleration amplification coefficient of the slope no longer changes. Thus, the slope rock mass can be considered to have entered the plastic deformation stage under an earthquake of intensity VIII.

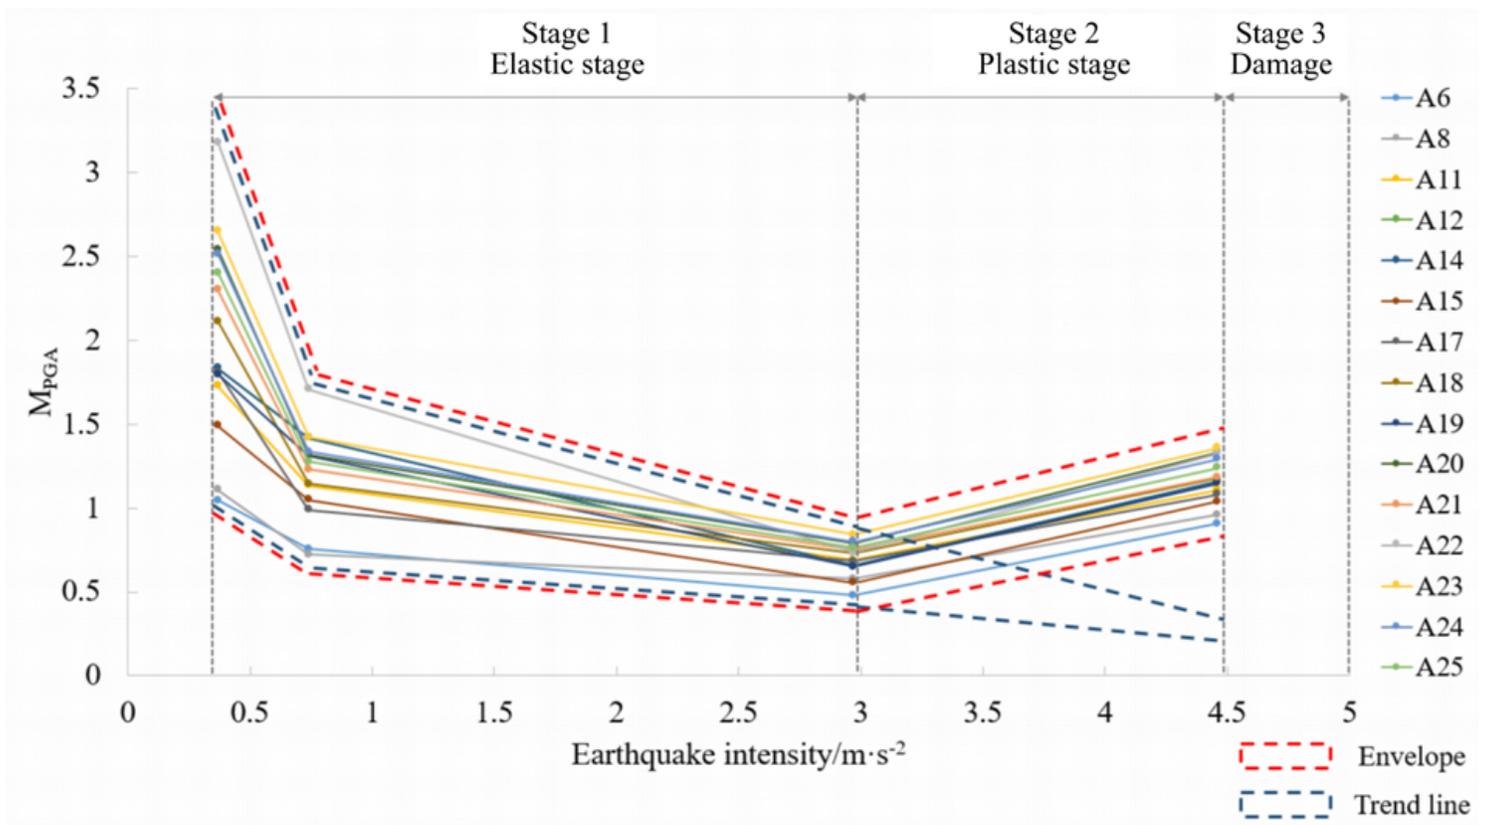
Relationship between MPGA and earthquake intensity

Figure 12 shows the relationship between M_{PGA} and earthquake intensity (amplitude of the input wave) in the horizontal direction. To clarify the dynamic evolution and failure process of the rock slope, the slope body above the tuff structural surface was selected as the research object. The M_{PGA} of the slope body were then analyzed. Figure 12 shows the evolution process of the failure and an inflexion point can be observed when input motion is 2.97 m/s^2 , which can be considered to comprise three stages: Stage 1 is the elastic stage ($< 2.97 \text{ m/s}^2$), Stage 2 is the plastic stage ($2.97\text{--}4.46 \text{ m/s}^2$), and Stage 3 is the damage stage ($> 4.46 \text{ m/s}^2$). It can be observed that the rate of decrease of M_{PGA} gradually slows with increasing earthquake intensity. In Stage 1, the M_{PGA} decreases rapidly because no deformation or damage occurs in the slope. When the M_{PGA} has decreased to a certain degree, numerous cracks appear in the slope surface. These cracks then extend, deepen, and tend to connect. Finally, in Stage 3, the M_{PGA} exhibits a sudden increase, which indicates the beginning of the occurrence of failure damage.

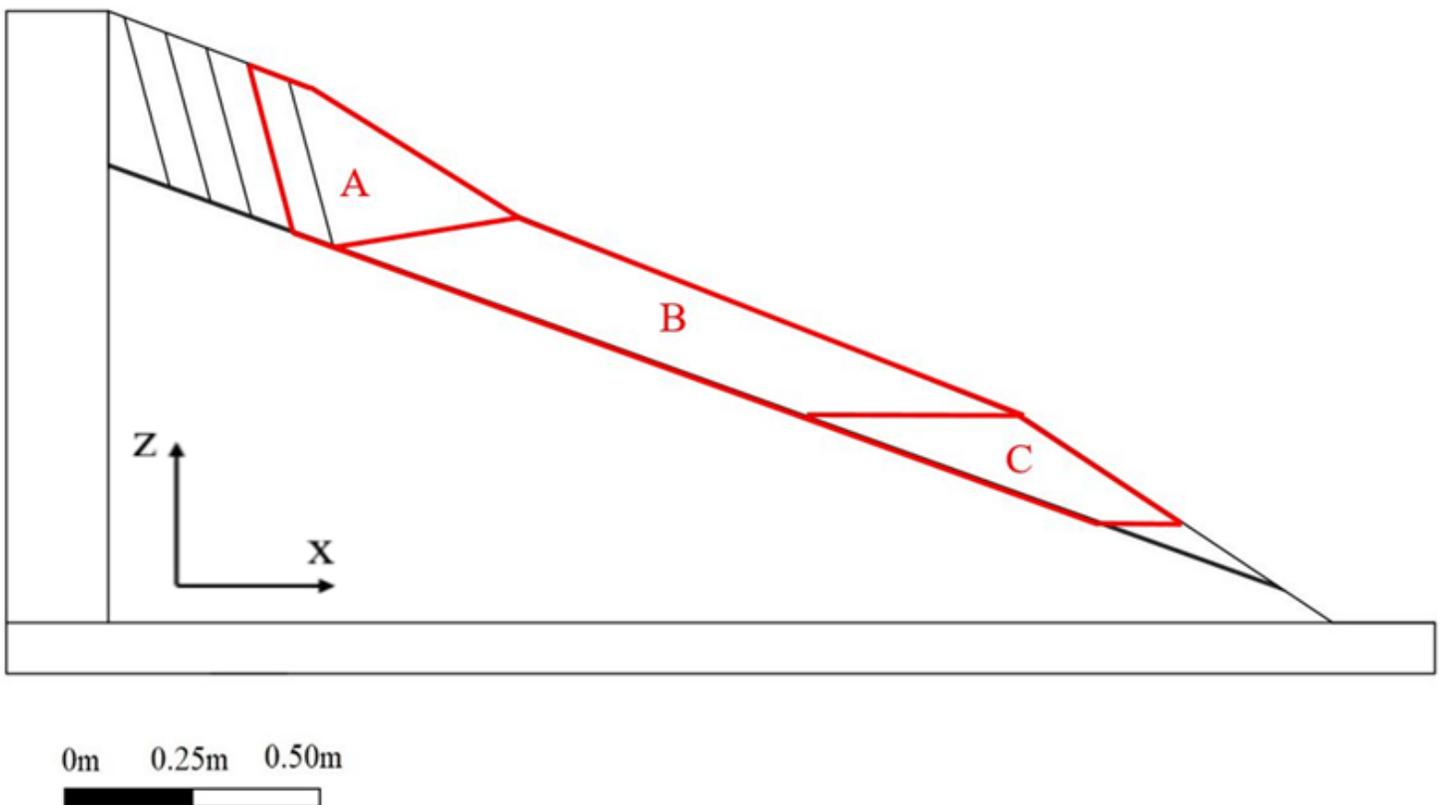
Figure 13

Divide for calculating the safety factor

In the shaking table tests, the sliding surface and landslide body of the model are clear. The safety factor can be calculated by considering the inertial force. In this method, the safety factor for the occurrence of sliding on the landslide body is used to analyze the stability of the rock slope. The slide failure movement patterns mainly include sliding along the surface and sliding along the two sides. In the tests, the landslide body is subjected to gravity, inertial force, and friction. The safety factor of the landslide body can be estimated when the geometry, failure mode, and sliding surface of the rock slope have been identified. The sliding body is divided into several blocks for calculation of the safety factor based on the amplification effect difference of slope body above structural surface, as shown in Fig. 11. The difference in the amplification effect represents the inequivalent force of slope body at different positions. The inertial force of each block can be obtained from one of the acceleration sensors in the block. Based on the M_{PGA} distribution, the landslide body is divided into three parts, as shown in Fig. 13. The forces between blocks can be neglected. The anti-slip force can be obtained from the normal force and the friction angle of the PVC expansion sheet. Calculating the inertial force at each moment, the maximum value obtained represents the most dangerous moment for each case. The safety factor is calculated using the equation below:

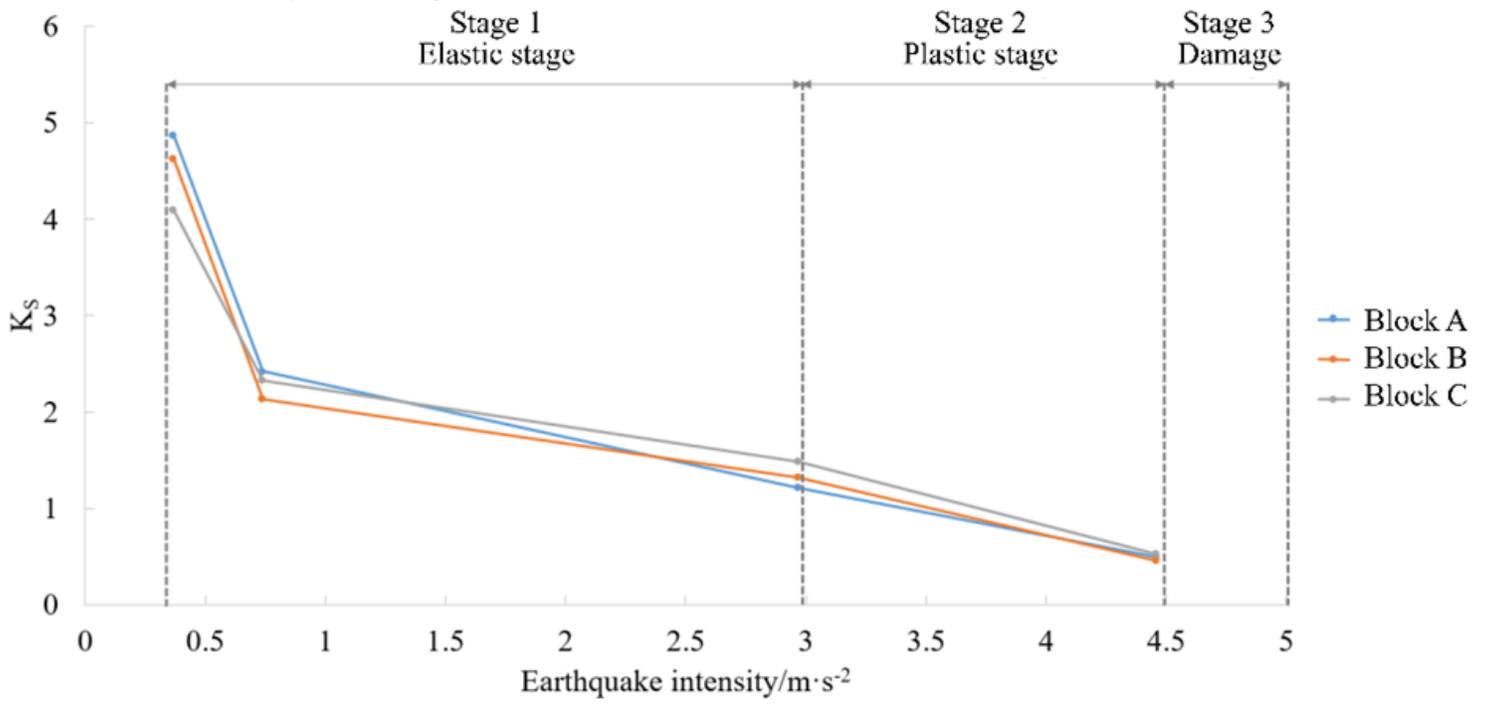
Figure 14

Relationship between K_s and earthquake intensity

Calculation of the safety factor is based on three different values obtained from the accelerometers. The safety factor (K_s) is calculated from the most dangerous moment. The evolution of the safety factor is shown in Fig. 14. It can be seen that K_s decreases sharply when input motion changes from 0.37 m/s^2 to 0.74 m/s^2 , while it decreases gradually from 0.74 m/s^2 to 2.97 m/s^2 , with $K_s > 1.0$. Additionally, the safety factor calculated for the three segments are quite similar, which means that segmentation method does not significantly affect the calculation results. Moreover, K_s for the three blocks are all less than 1.0 when the acceleration reaches 4.46 m/s^2 , which means the surface slope is unstable. Compared to the failure mechanism of the model, the safety factor is a good reflection of the failure mode of the slope. Based on these results, the evolution process of the landslide can be divided into three stages. The first stage is an elastic stage ($K_s = 1.6\text{--}4.7$). In this stage, the rock materials of the slope are in an elastic state. The second stage is a plastic stage ($K_s = 0.8\text{--}1.6$), which indicates a dangerous moment for the slope. Low magnitude earthquakes or rainfall can easily cause landslides in this stage. The last stage is the damage stage ($K_s < 0.8$), in which landslides occur.

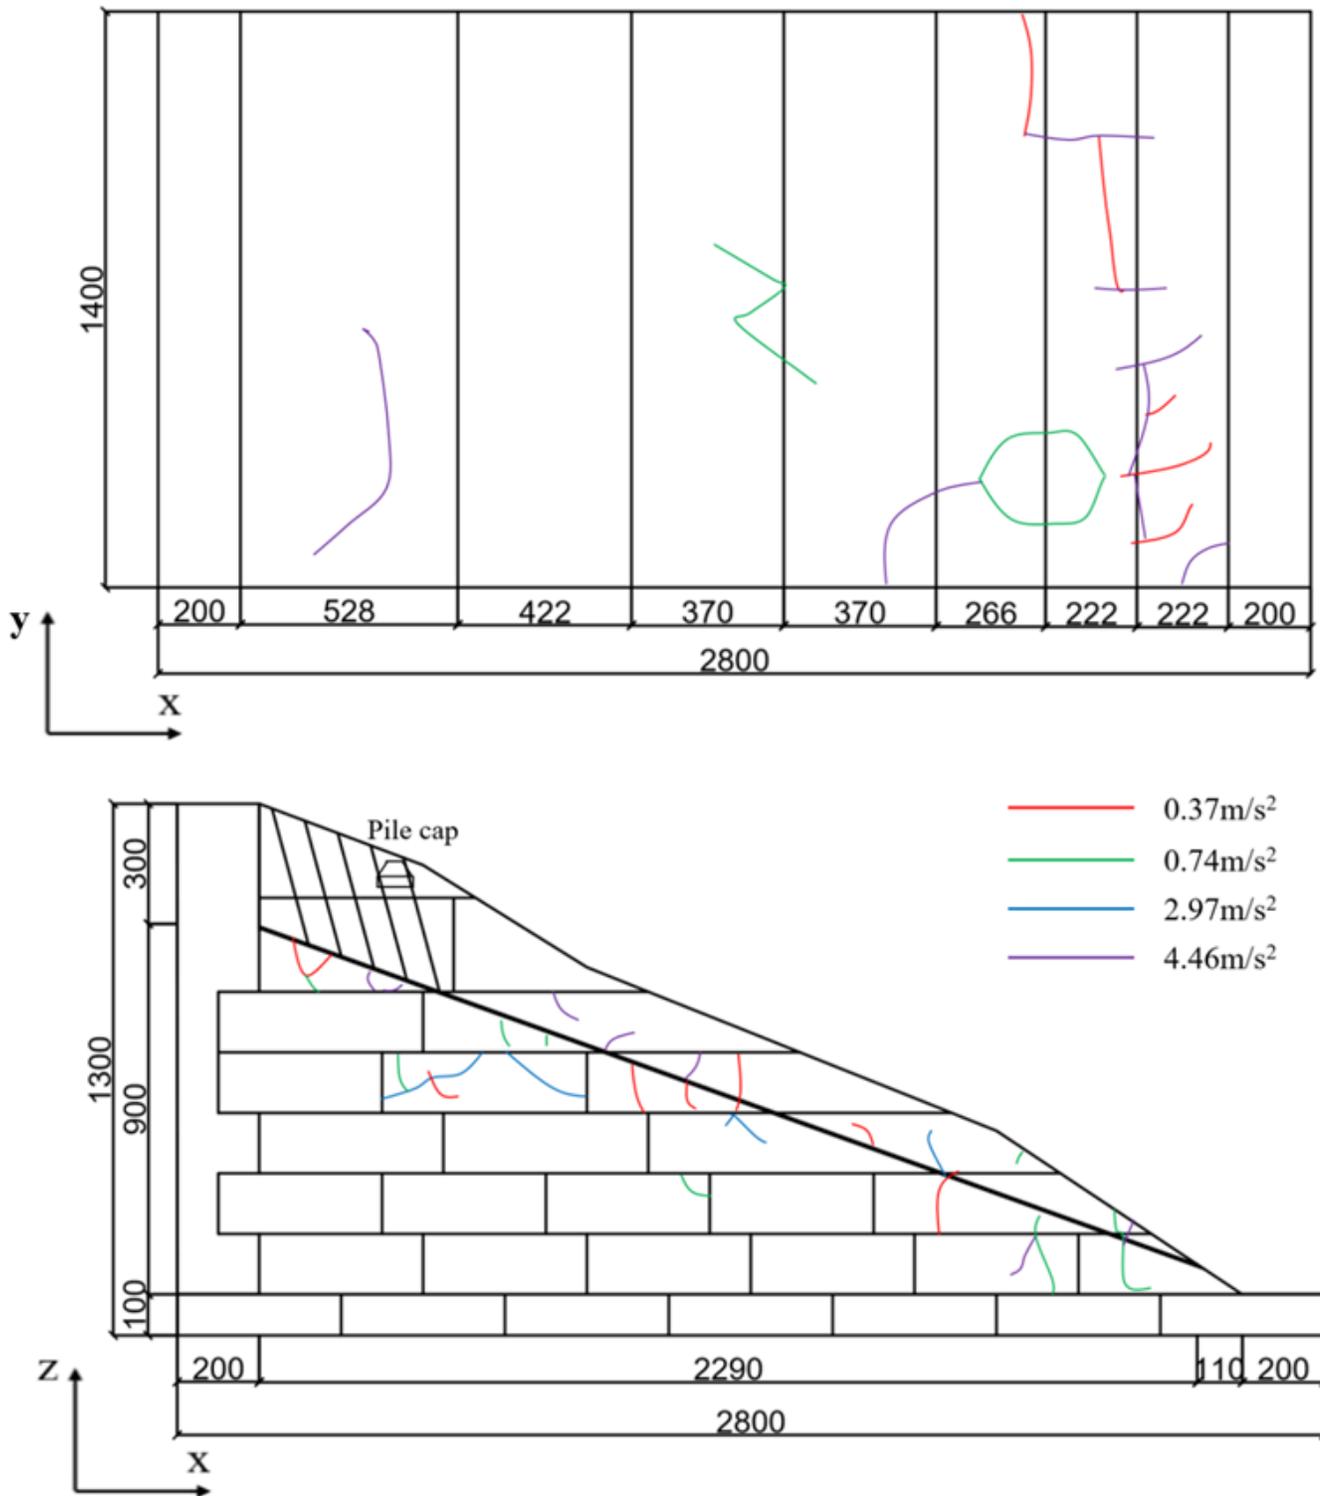
Figure 15

Description of failure process

Based on the similar failure processes observed in various models, the failure process of a rock slope can be characterized by three notable features (Huang et al., 2013). First, a crack near the top surface is observed. Second, with increasing input acceleration, the cracks extend and tend to connect. Finally, the top area of the slope will collapse and landslides will occur. To describe the failure mode of the model, any cracks or deformation present are recorded by photographs at the end of each test. The development of cracks at accelerations of less than 4.46 m/s^2 is shown in Fig. 15. Before the input acceleration reaches 0.74 m/s^2 , a few cracks can be identified near the slope surface. The failure modes of the slope model are mainly caused by the occurrence and deepening of these cracks. When the input acceleration is between 2.97 m/s^2 and 4.46 m/s^2 , the cracks continue to deepen and extend gradually, and a few penetrating cracks occur with local spalling occurring near the slope surface. A large number of cracks can be identified near the tuff structural surface, indicating a significant shear failure mode.

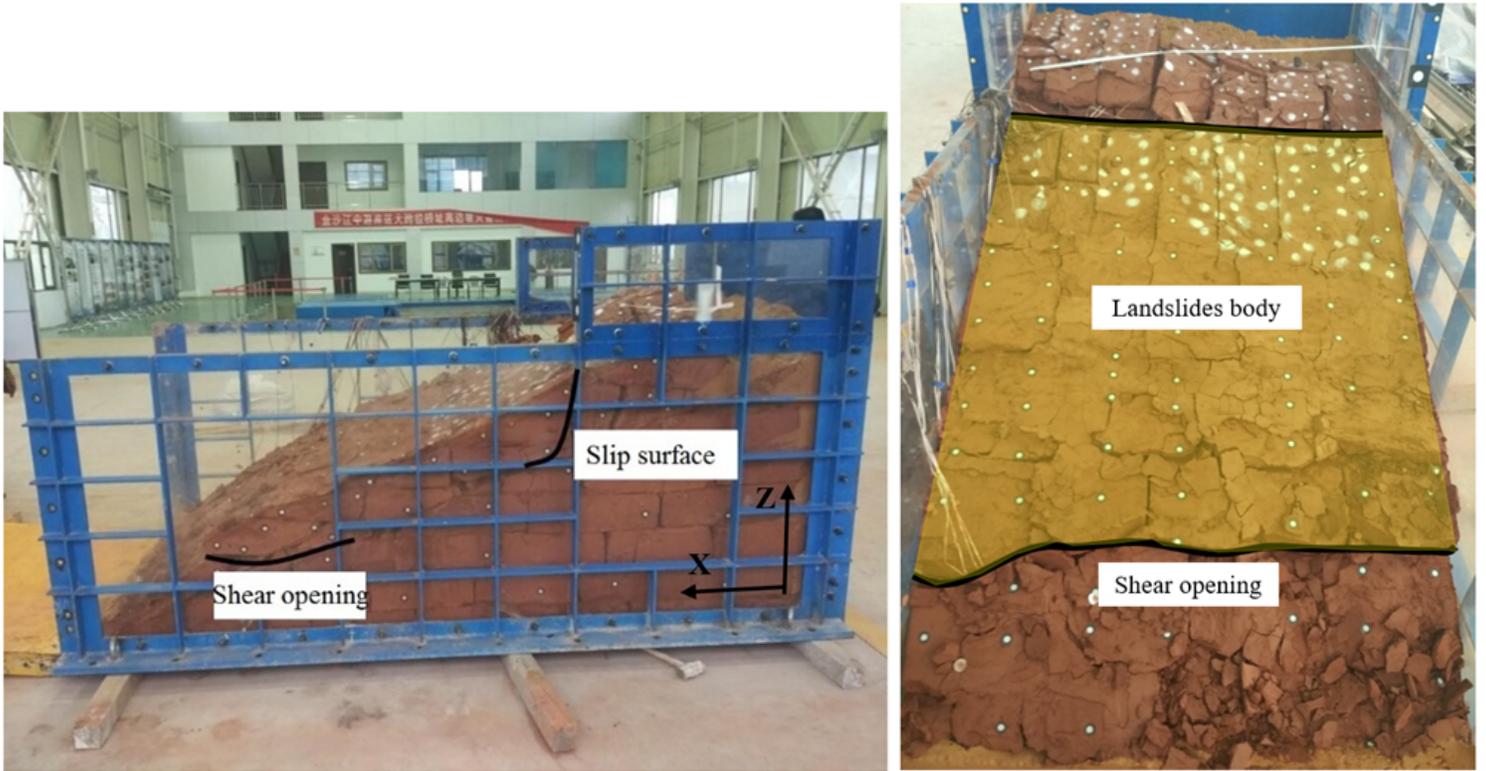
Figure 16

Photograph of model after shaking

Failure occurred in the model when the horizontal input acceleration reached 4.46 m/s^2 , and a photo of the model after failure is shown in Fig. 16. The cracks and deformation in the model observed during the process of removal are the main basis for judging the sliding surface, as shown in Fig. 17. Figure 17 shows that the shear outlet position is located on the slope surface 60 cm above the bottom of the slope.

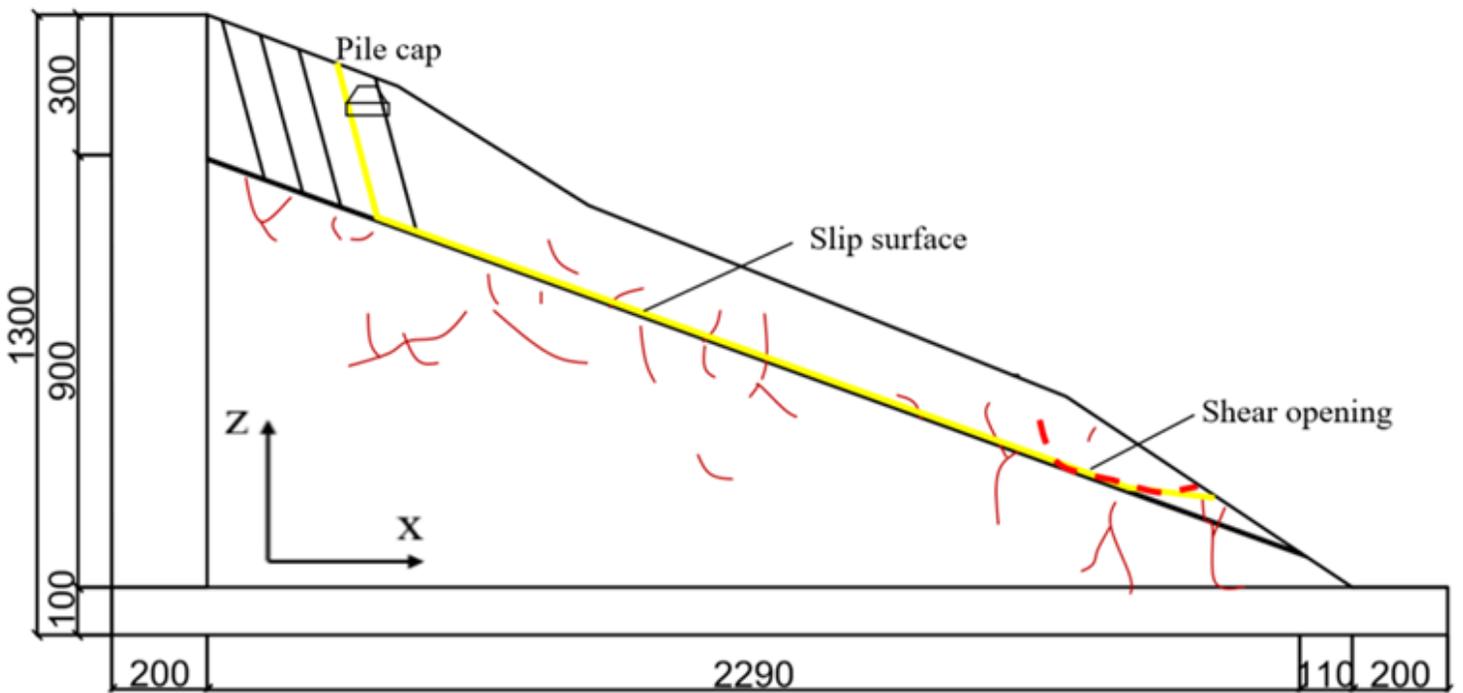
Figure 17

Deformation characteristics of the slope

There are dense transverse and longitudinal cracks along the slip surface, and distinct downward dislocations have formed at the top of the slope. The location of the slip surface and the tuff structural surface are very similar. It can be concluded that the tuff structural surface plays a controlling role in the position of landslides and cutting.
