# Characteristics of the Disastrous Debris Flow of Chediguan Gully in Yinxing Town, Sichuan Province, on August 20, 2019

## Research Article

**Abstract:** On August 20, 2019, at 2 a.m., a disastrous debris flow occurred in Chediguan gully in Yinxing town, China. The debris flow destroyed the drainage groove and the bridge at the exit of the gully. In addition, the debris flow temporarily blocked the Minjiang River during the flood peak, flooding the Taipingyi hydropower station 200 m upstream and leaving two plant workers missing. To further understand the activity of the debris flow after the Wenchuan earthquake, the characteristics of this debris flow event were studied. Eleven years after the Wenchuan earthquake, a disastrous debris flow still occurred in the Chediguan catchment, causing more severe losses than those of earlier debris flows. In this paper, the formation mechanism and dynamic characteristics of this debris flow event are analysed based on a drone survey, high-definition remote sensing interpretations and other means. The catastrophic debris flow event indicates that debris flows in the Wenchuan earthquake area are still active. A large amount of dredging work i

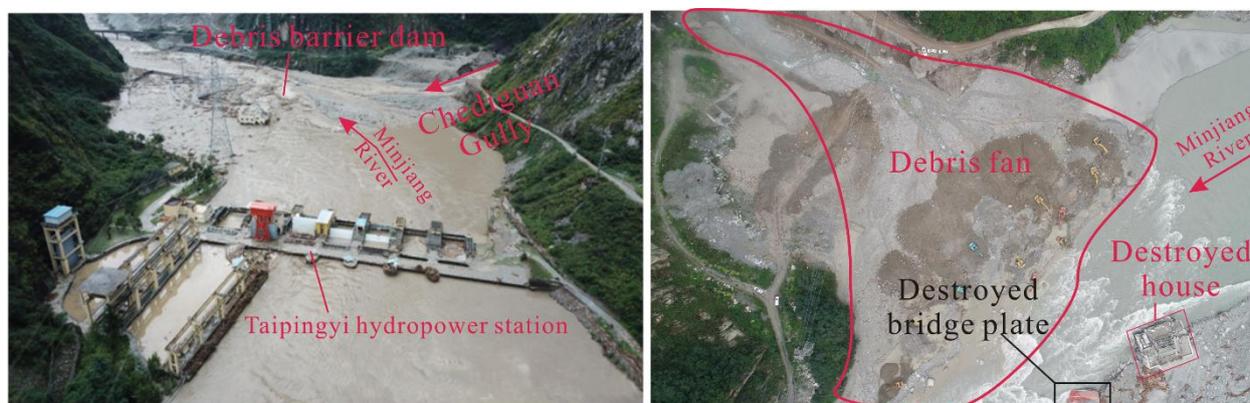
288  
289 **Fig.11** Debris fan and barrier lake formed in the "8.20" debris flow event

278 In the '8.20' event, debris flow material was transported to the gully mouth and formed a large debris flow fan.  
 279 (Fig. 11). The fan was 300 m long and 260 m wide, with an average depth of 8 m (Fig 4). The aerial photos show  
 280 that the debris flow fan area was  $3.1 \times 10^4 \text{ m}^2$  and the volume was about  $63.8 \times 10^4 \text{ m}^3$ . The debris flow destroyed the  
 281 bridge at the mizoguchi, destroyed many houses at the opposite bank of the Mingjiang River, and finally silting into  
 282 a debris fan. Figure 12 shows the significant changes that occurred in the middle-lower gullies and gully mouth  
 283 before and after the "8.20" debris flow event. The debris flow consists mainly of erosion before the C6  
 284 cross-section and mainly of deposition after the C6 cross-section. The highest deposition depth at the mizoguchi  
 285 reached 9.5 m, the riverbed was uplifted, and nearly 1/3 of the river was buried. The debris flow blocked the

286 Minjiang River temporarily during the flood peak, causing the river to return and flood the Taipingyi hydropower  
 287 station 200 m upstream, leaving two plant workers missing.
