Severe Hemolytic Anemia and Acute Renal Failure After Mitral Valve Repair Associated With Non-endothelialization of Artificial Chordae Tendinae: Case Report

Case report

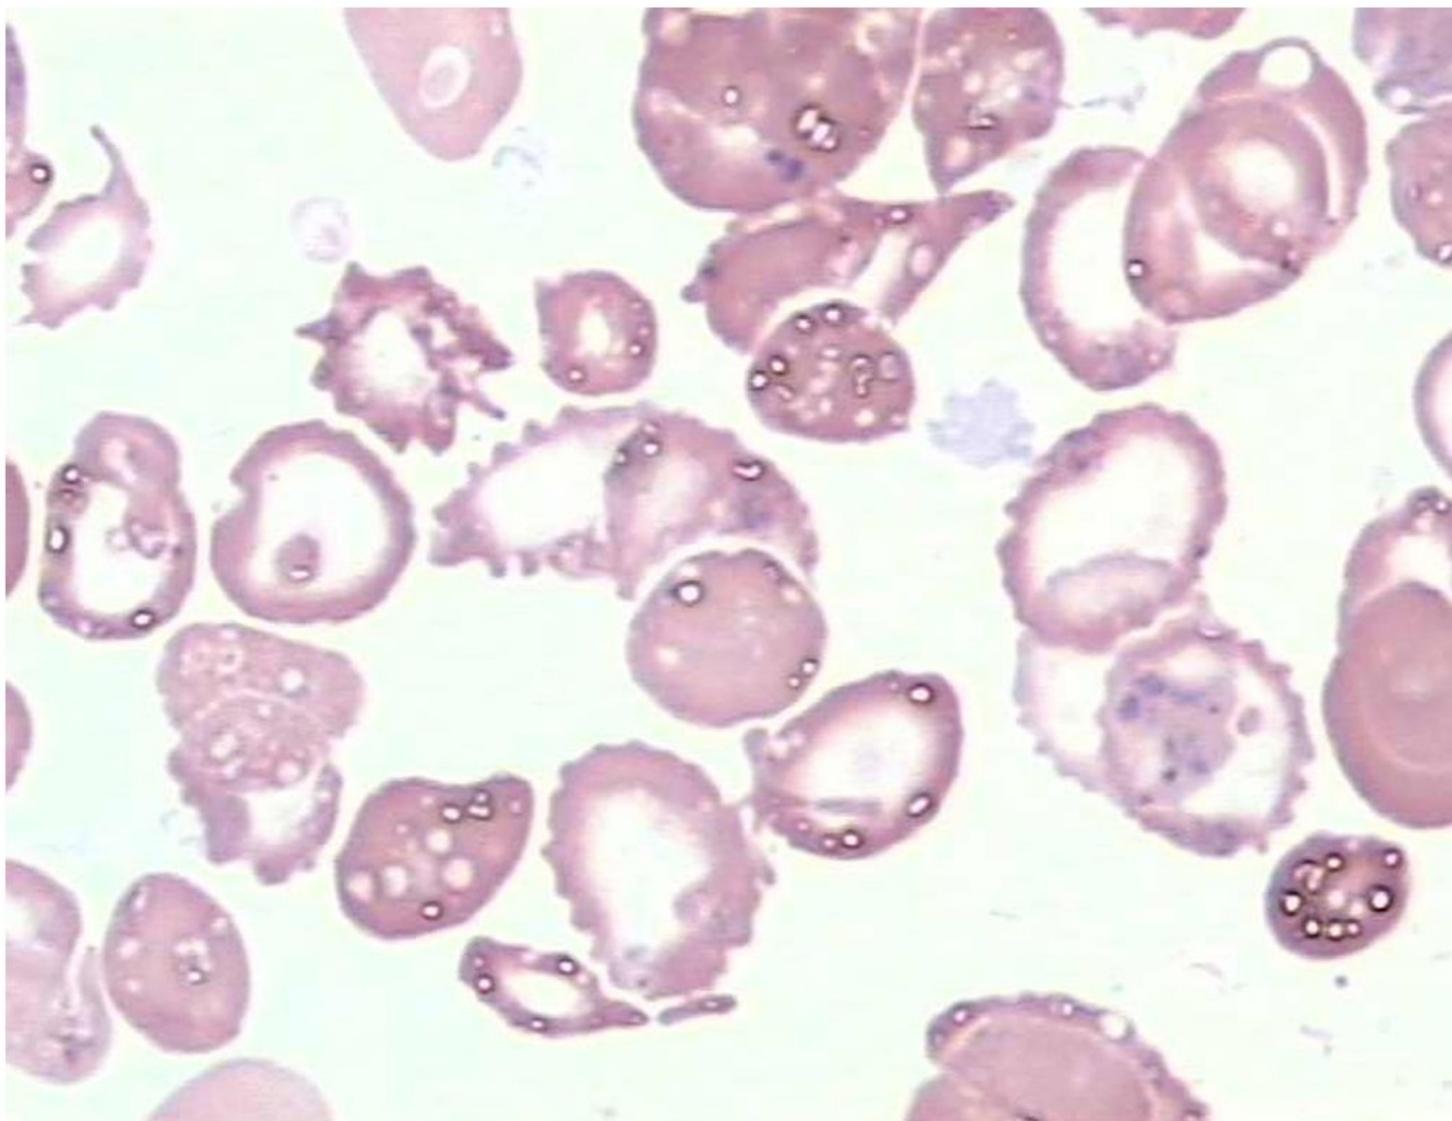
Figure 1

Peripheral blood smear demonstrated schistocytosis and red cell fragmentation.

bilirubin of 69.86 μ mol/L (indirect of 57.1 μ mol/L). Peripheral blood smear demonstrated mechanical hemolysis with schistocytosis and red cell fragmentation (Fig. 1). Creatinine levels ranged from 256 μ mol/L to 362 μ mol/L. Coomb's test, Ham test and sugar water test were negative. Expression of CD55 and CD59 for paroxysmal nocturnal hemoglobinuria was normal. Drug-induced hemolytic anemia was not apparent, because there was no reduction of hemolysis after stopping the administration of any drug. On transthoracic echocardiography, mitral valve jet was found and judged to be mild, originating from the centre of the valve and striking the annuloplasty ring (Fig. 2). The velocity of the mitral regurgitation jet was 2.3 m/s. The investigation did not show any evidence of a structural defect of the valve or the annuloplasty ring. Predonisolone for the possible microangiopathy was used. Three times of plasmapheresis and blood transfusion of 15 units red blood cells were required. After these treatments, the anemia and dark urine did not improve, with a creatinine level at 256 μ mol/L. Based on previous experience with hemolytic patients following MVR and useless of aggressive conservative therapy, we decided to do reoperation for intracardiac inspection and mitral valve replacement after a detailed communication with the patient, despite RF. During the intraoperative inspection, there was no ring dehiscence or suture-related tear of the valve tissue. The annuloplasty ring was well endothelialized. Chordal attachments were intact. However, the new artificial chordae tendinae was completely non-endothelialized (Fig. 3). The plasty ring was excised and the mitral valve was replaced with a 27-mm bileaflet prosthesis (Edwards Lifesciences). The hemolytic anemia resolved gradually after the reoperation. But the RF persisted after surgery and the patient was transferred to the department of hematology for hemodialysis. Three months later, the LDH level gradually fell to 224 U/L. His hemoglobin level was stable at 95 g/dL with 3% reticulocytes. Serum creatinine level was 80.4 μ mol/L.

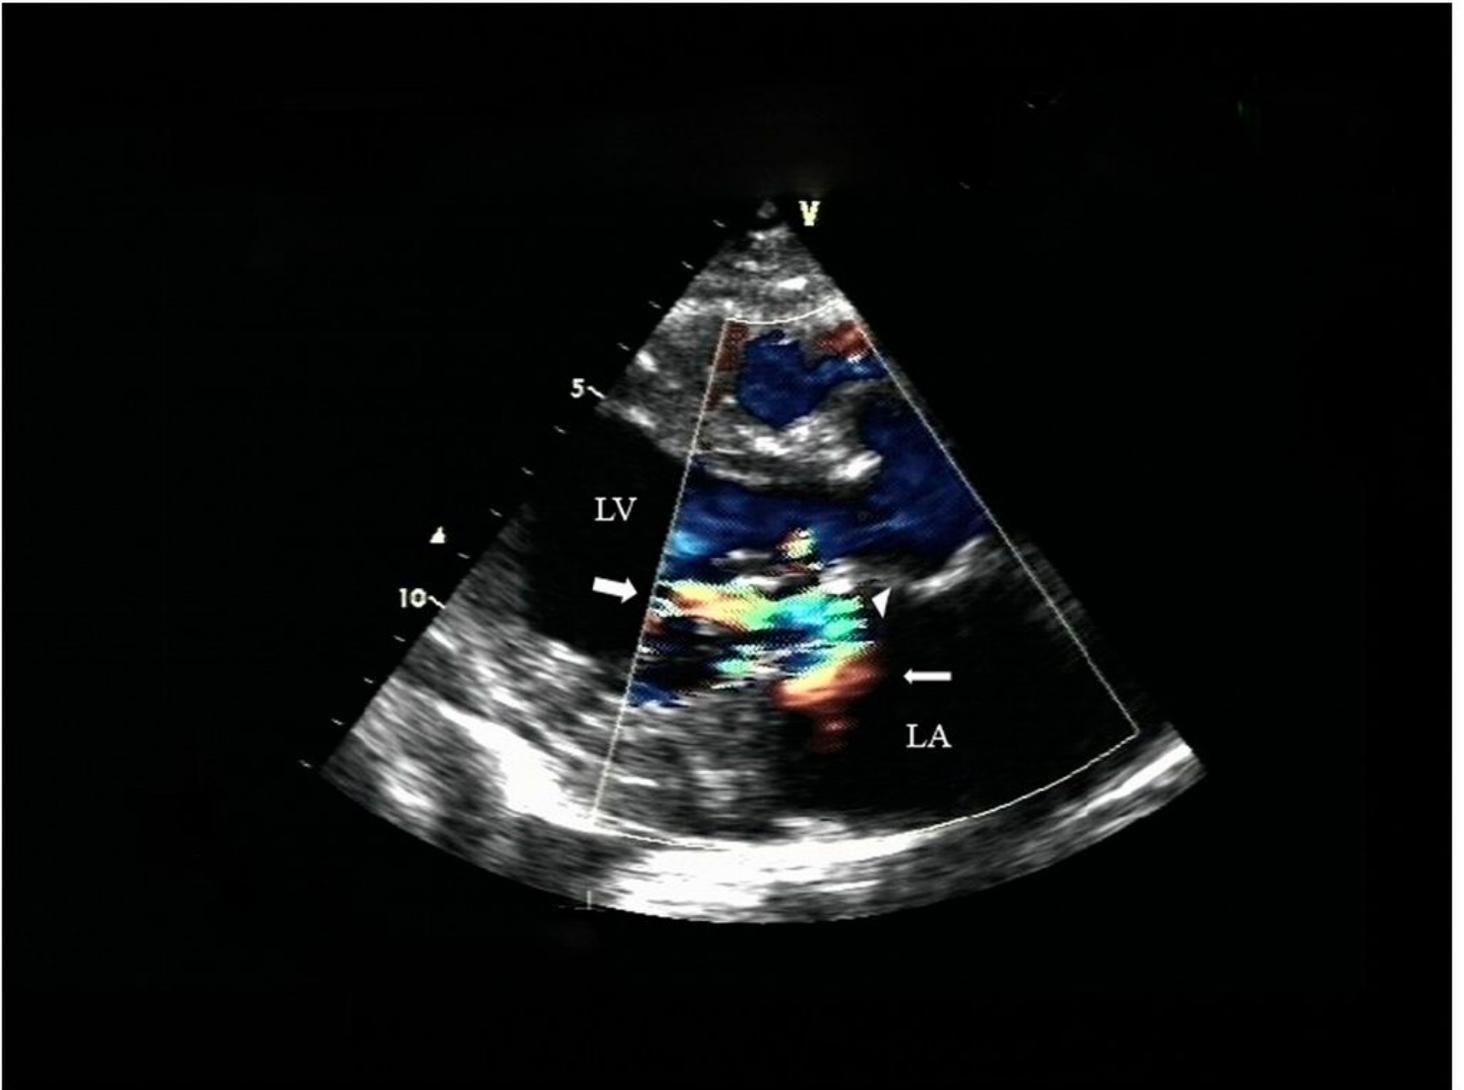
Figure 2

Transthoracic echocardiography showing a jet of mitral regurgitation (large arrow) which immediately collides with the annuloplasty ring (arrowhead), redirecting the jet at a right angle into the central LA (small arrows). LA, left atrium; LV, left ventricle.

Residual mitral regurgitation was the major cause to mechanical hemolysis. High velocity mitral regurgitant jet could denude the endothelium, expose the expanded polytetrafluoroethylene surface, prevent complete endothelialization of expanded polytetrafluoroethylene and increase the risk of hemolysis.² In the case presented here, the velocity of the regurgitant jet as assessed by Doppler analysis was 2.3 m/s. Such a high-speed jet could cause turbulence and increased trauma. Although many reported cases had high grade mitral regurgitation, echocardiography only showed mild mitral regurgitation and no other structural findings in this case.¹ Therefore, though rarely, the clinician should have an index of suspicion for mechanical hemolysis even if the mitral regurgitation is mild or trivial.

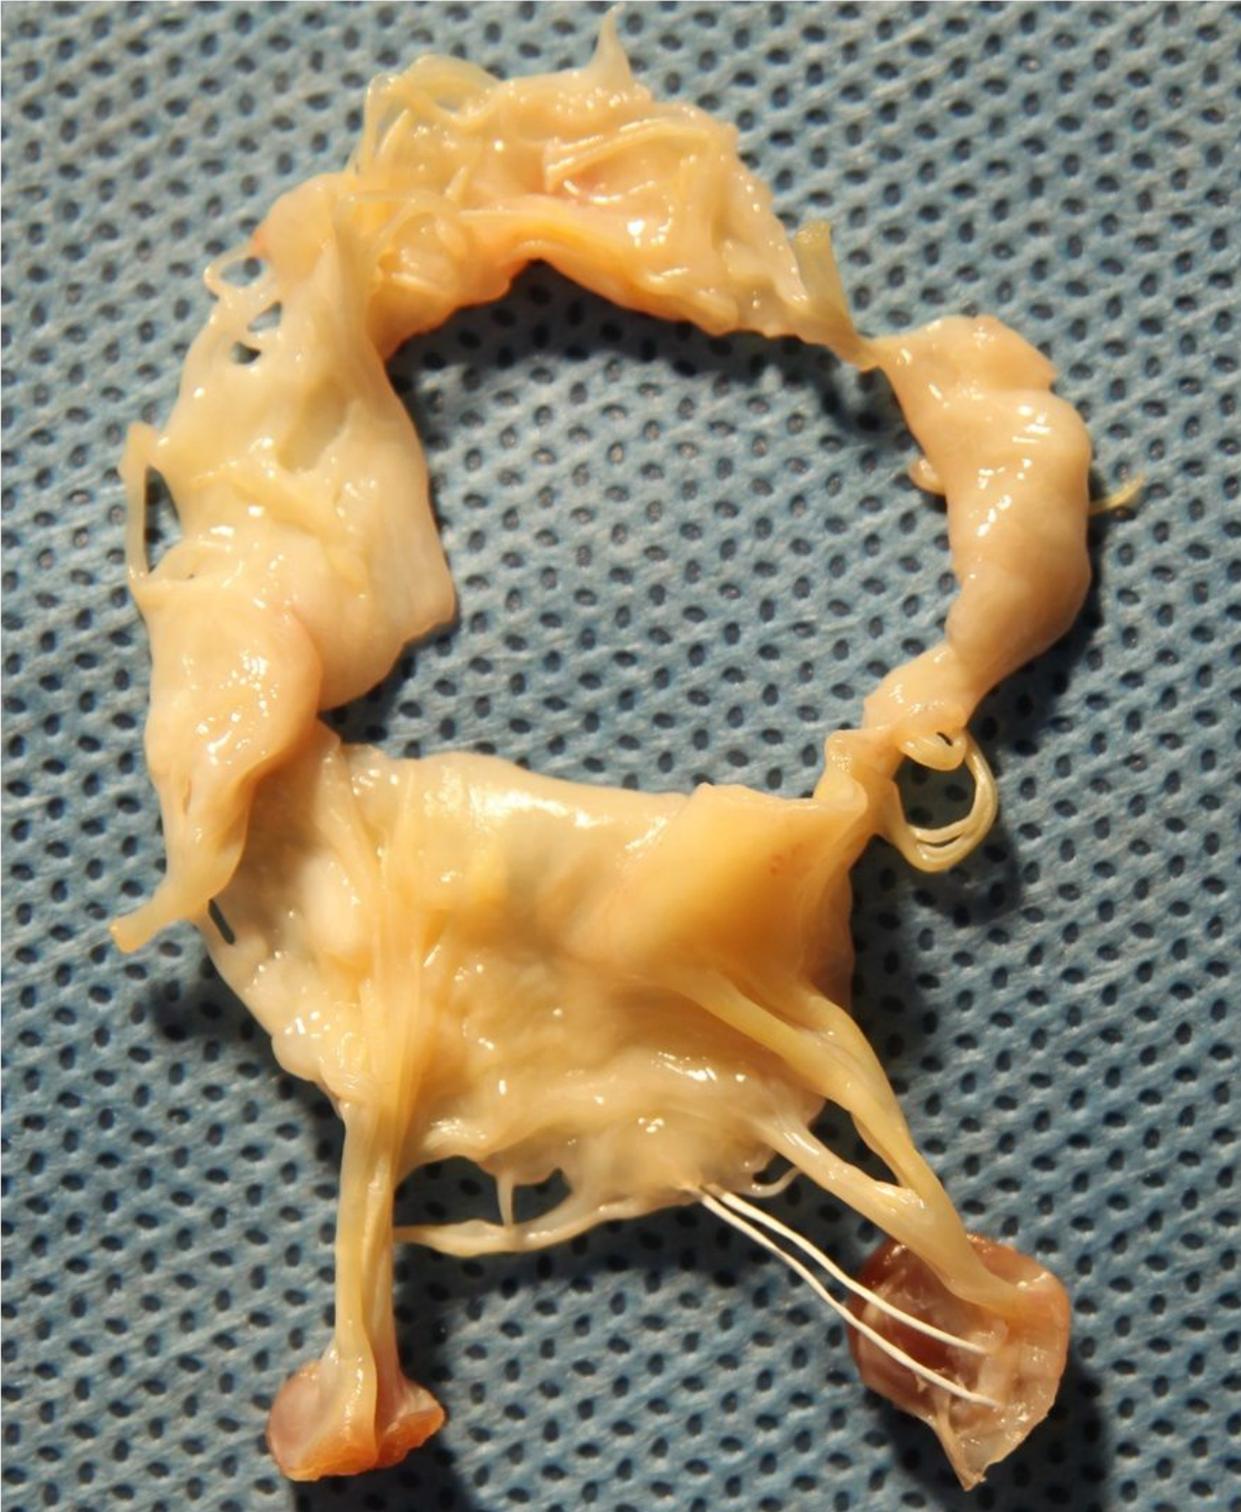
Figure 3

The artificial chordae tendinae is completely non-endothelialized.

Expanded polytetrafluoroethylene is a linear, nonabsorbent monofilament polymer that has been used in cardiovascular surgery patches and sutures for many years and has many documented advantages over other suture materials.^{10,11} MVR surgery with implantation of expanded polytetrafluoroethylene chordae tendinae has been offered as a safe and effective surgical alternative for mitral valve. However, it has been reported that expanded polytetrafluoroethylene suture was calcified and ruptured and that no connective tissue or calcium deposits was found in the suture material.¹⁰⁻¹² We report a unique case of completely non-endothelialized expanded polytetrafluoroethylene. We suspect that non-endothelialization of the expanded polytetrafluoroethylene might play a role in the genesis of mechanical hemolysis. But it is difficult to identify whether it is primary or secondary.
