Quantitative Weathering Assessment of Rock Slope using CIELAB Color Space and Image Analysis Technique

Research Article

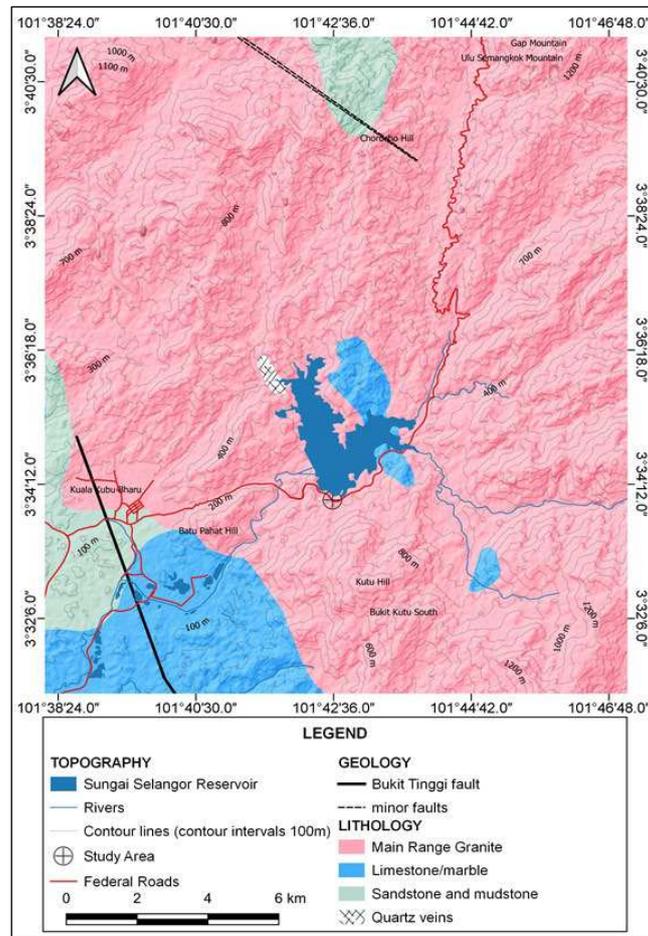
Fig. 1 General geology of the study area (Lebuhraya Kuala Kubu Bharu–Teranum–Raub route). Modified after the map provided by Jabatan Mineralogi dan Geosains 2014. Map Scale 1:10000

In this study, the weathered granitic rock slope was chosen on the basis of its predominant rock formation in the Malaysian Peninsula. The Lebuhraya Kuala Kubu Bharu–Teranum–Raub is composed of granite of the S variety (Fig. 1). The granites of the Main Range are typically coarsely porphyritic with perthitic to microcline alkali feldspar (Jasin, 2013; Jasin & Harun, 2011a; Spiller, 2002). The S-type Main Range Granite (granitoid belt) is found along the western margin of the Bentong–Raub suture zone, although it occasionally intrudes into the suture zone, forming a stitching pluton (Jasin, 2013; Jasin & Harun, 2011b; Metcalfe, 2000, 2013). The rock slope latitude is 3°33'57.23"N, and the longitude is 101°42'34.97"E. The rock slope's perimeters reach 102 m, and the crest's elevation is 327 m.

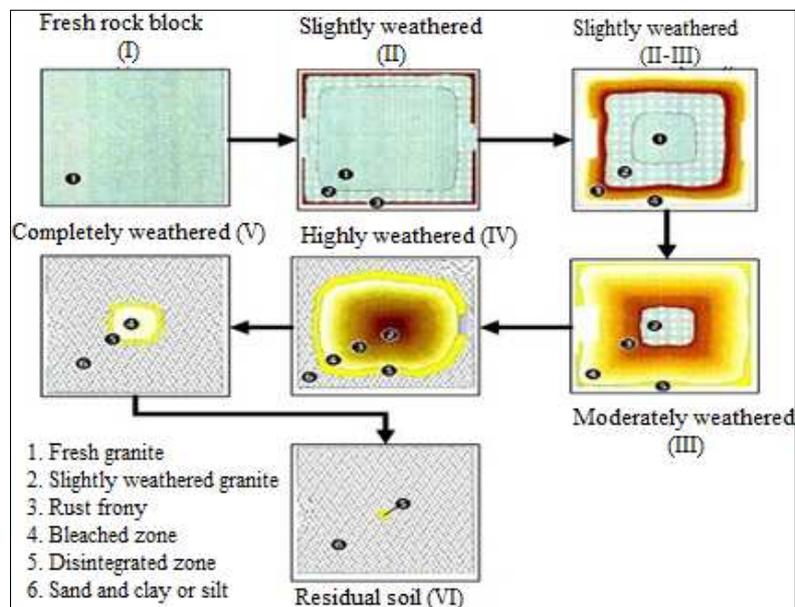
Fig. 2 Distribution of weathering grade of the rock mass (Thuro et al., 2002)

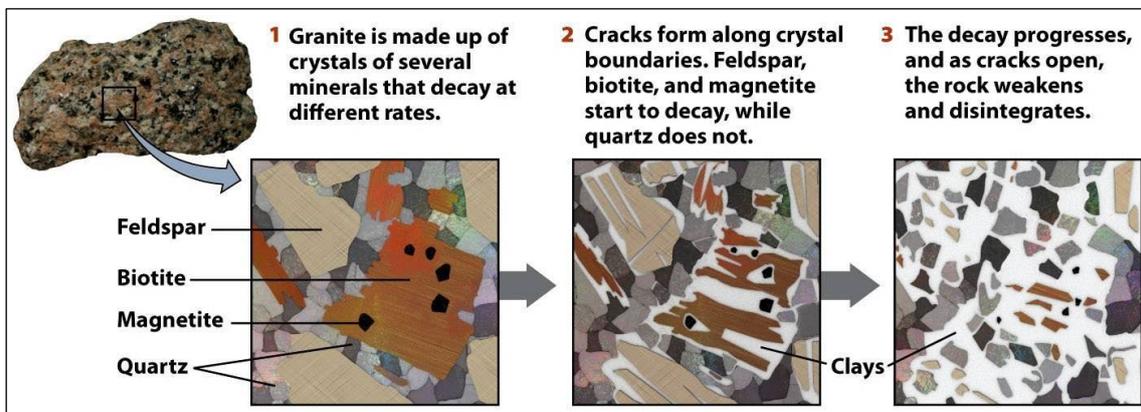
Fig. 3 Chemical weathering process of granite (Grotzinger et al., 2009)

minerals due to their high weathering resistance. Hydrolysis of biotite and/or amphibole yields clay, which is then oxidized to yield iron oxides. Furthermore, moderate-scaled oxidation and hydrolysis (Fig. 3) occurred in the decayed and discolored granite surface. A summary of granite oxidation is provided below:

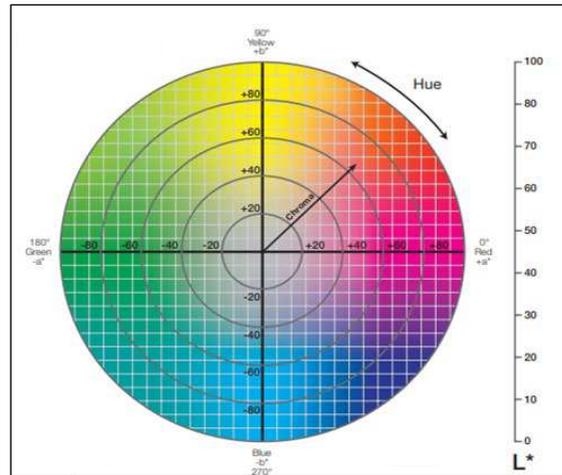
Fig. 4 Theoretical CIELAB color space (Hunter, 1958)

This study explores the CIELAB color space analysis in examining the effects of different color systems based on Richard Hunter's former L, a, and b systems (Cinko & Becerir, 2019; Goyena & Fallis, 2019; Shrivastava et al., 2021; Thwaites et al., 2018; Yeerken, 2017). This framework is the most widely used color management system because it implements the international color consortium's (ICC) device profile in a device-independent model. L*a*b* is an abbreviation for the three distinct color spaces (Cinko & Becerir, 2019). RGB images were transformed to CIELAB (Cinko & Becerir, 2019; ju et al., 2014; Shrivastava et al., 2021; Thwaites et al., 2018; Yeerken, 2017). CIELAB is a nonlinear transformation of RGB in which the Euclidean distance between two colors equals the perceived distance between them (for distances <10 units). Color image processing algorithms frequently provide excellent performance with CIELAB (Ju et al., 2014). When a color is stated in CIELAB (Fig. 4), the term L* refers to the image's luminance or brightness. The values are between [0, 100], where zero indicates black, and 100 indicates white. The colors get brighter with the increase in L* (Kim, 2015). The value of a* indicates the proportion of red or green tones in the picture. A massively positive a* value indicates the presence of red/magenta. Green is represented by a large negative a* value. Although there is no fixed range for a*, the values often lie between [-100, 100], whereas b* specifies the amount of yellow or blue tones in the picture. Yellow is represented by a large positive b* value. A significant negative b* value correlates to the color blue. Although there is no fixed range for b*, the values often lie between [-100, 100] according to CIE 1976 (Cinko & Becerir, 2019; Grad et al., 2013; Yeerken, 2017). The colors with "+" values (red and yellow) are considered "hot", while those with "-" values (green and blue) are regarded as "cold". Many weathered earth materials have "hot colors", making the L*a*b parameter suitable for quantitative evaluation. The center of each axis is zero. a* and b* with a value of zero, or very low, will describe a neutral or near neutral. The area around the center represents achromatic colors, and color saturation increases as move outside from the center (Fig. 4).

where ΔE_{ab}^* is a total color difference, L* is lightness, a* is red/green, and b* is yellow/blue (Fig. 4).

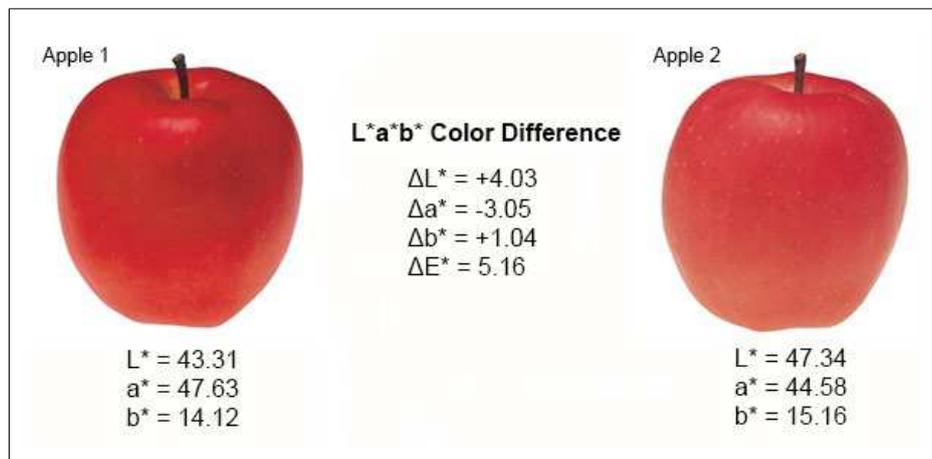
Fig. 5 L^* , a^* , and b^* color difference from the spectrophotometer

The plot of a^* and b^* on the color space shows the apple's chromaticity, while the L^* expresses the color's lightness (Fig.5). The $L^*a^*b^*$ color space enables precise color communication between a company and its supply chain, ensuring that products are manufactured to exact color specifications. Color difference ΔE_{ab} calculated from the $L^*a^*b^*$ values of a master and sample provides an easy quality check. The method used in this study for weathering assessment of rock slope with a colorimeter is similar to the mechanism utilized to measure the apple (Fig. 6). The color on the surface of the rock slope represents the degree of weathering. High a^* and b^* values indicate that the rock is more weathered and provides a good weathering assessment. The following values (Fig. 6) show that heavily weathered samples had higher a^* and b^* values than unweathered ones.

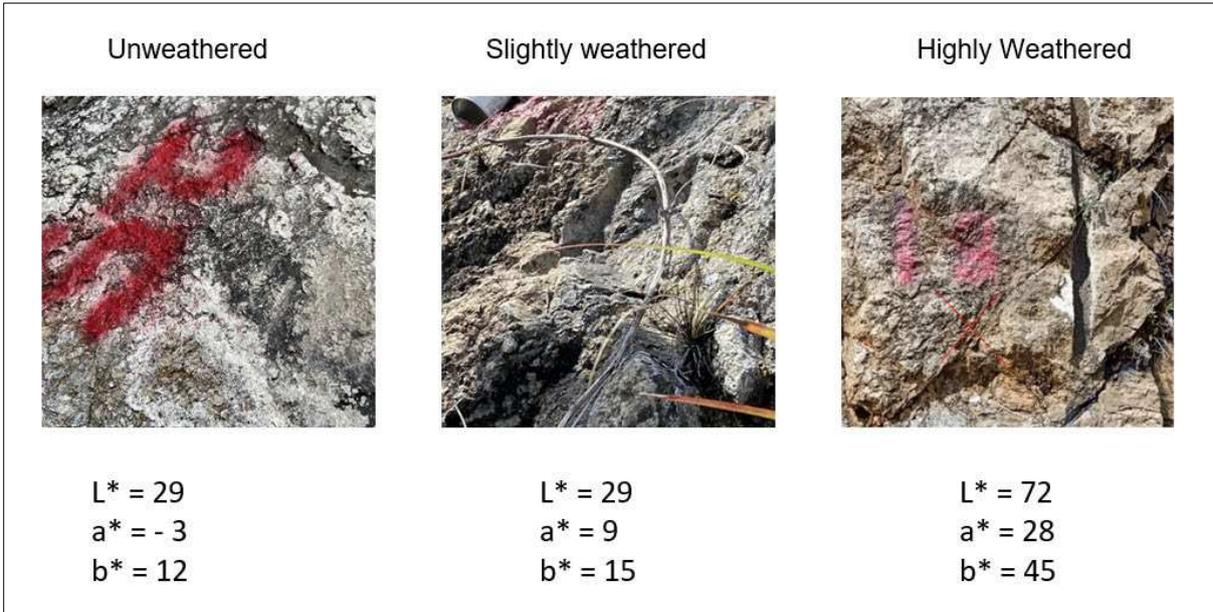
Fig. 6 Color analysis of the different weathering grades from the rock mass sample

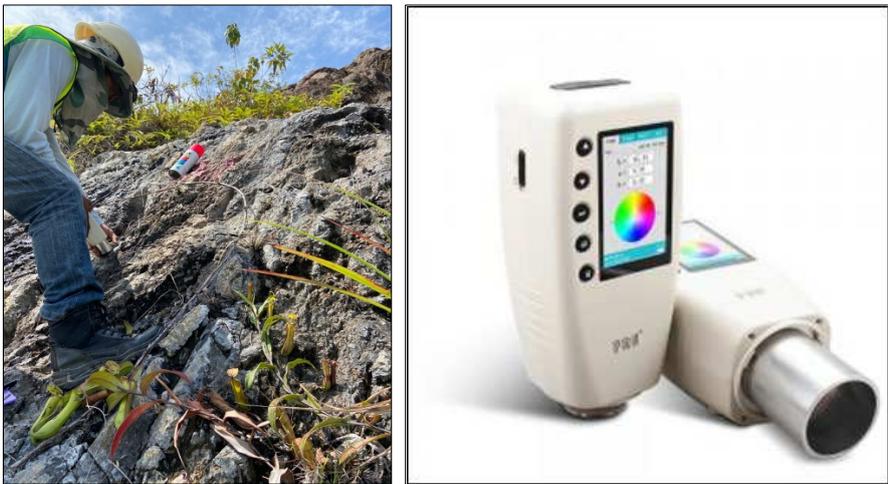
Fig. 7 In situ colorimeter testing using FRU colorimeter WR18 (40 mm aperture)

In this study, a colorimeter is a tool to assess the rock slope surface weathering color. In the in situ colorimeter test, red, green, and blue light sources were used to illuminate the rock slope surface. Tri-stimulus (RGB) values are distilled using these filters to match how our eyes perceive color (Amano et al., 2020; Ohta & Robertson, 2005; Planetary & Congress, 2014). When electromagnetic radiation is transmitted or reflected through an object or solution, the intensity of the electromagnetic radiation varies. The FRU Colorimeter WR18 with a 40 mm aperture was used for this study because it can measure big textured, uneven, and rough surfaces (Fig. 7) (Tobe et al., 2018). Kemp (2014) conducted a similar method by using a colorimetric analysis to measure the L^* , a^* , and b^* values of the rock slope. In this study, the different surface colors were tested for the value of a^* and b^* at 50 points of measurement, as shown in the orthophoto image (Fig. 9). Colorimeters must be calibrated with computer monitors to ensure accurate screen colors. Color software is used to import colorimeter data, which are then used as input data for image analysis.

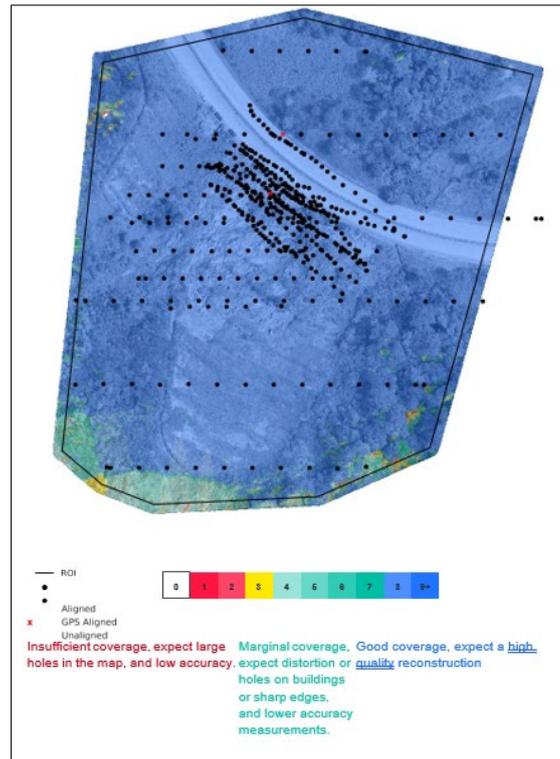
Fig. 8 Camera positions and the aligned images for rock slope at Lebuhraya Kuala Kubu Bharu–Teranum–Raub

Agisoft Metashape Professional (version 1.7.0) software is utilized in processing the georeferenced photos collected by the UAV (Agisoft & St Petersburg, 2016). The approach begins with the import and the alignment of UAV images with a high precision setting (Fig. 8). During the alignment of the image, it matches the scale-invariant using the transform (SIFT) technique and undergoes bundle block adjustments. The SIFT algorithm distinguishes and characterizes local features in the imagery (de Matias et al., 2009). It locates important spots and furnishes them with quantitative methods that the descriptors will utilize for object recognition. Then, the image information is transformed into local feature coordinates that are invariant to translation, rotation, scale, and other imaging parameters. Dense geometry is reconstructed with a high degree of accuracy, and 59 million points are generated as a 3D dense point cloud. Further processing of the dense cloud results in the creation of a digital surface model and orthoimages (Fig. 9).

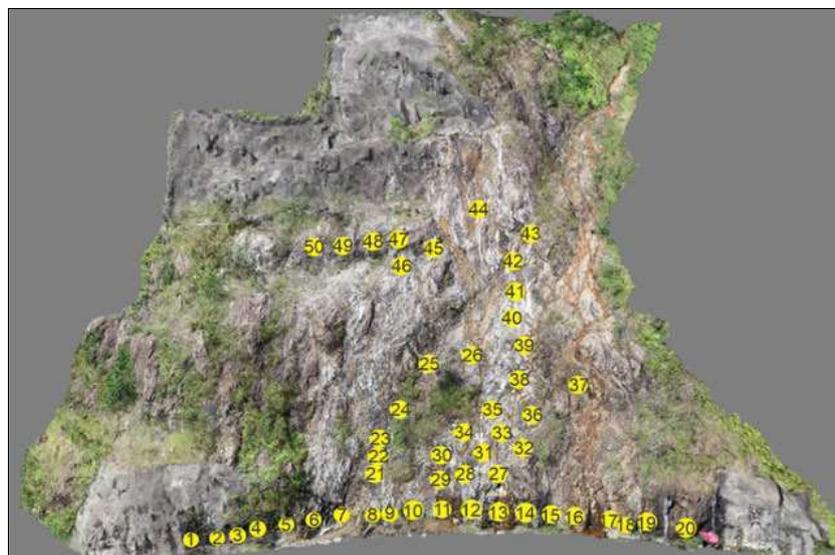
Fig. 9 Orthophoto of Lebuhraya Kubu Bharu–Teranum–Raub with 50 points of measurement marking

The reliability of the digital image analysis was increased in this study by filtering or converting the 2D orthophoto images (Fig. 9) of the rock slope color surface to different weathering grade regions utilizing the CIELAB equal color space (Fig. 11) (Gokay, 2018; Outal et al., 2008; Sun et al., 2019). The filtered or classified region of the weathering grades was utilized in verification with other geomechanical inputs and geological structure to determine the potential failure. However, precautions should be taken in evaluating the image analysis results considering the direction of the discontinuities and another index/mechanical attribute of the rock mass (Roy Choudhury, 2015b). This method was found to be more unbiased compared with the conventional weathering grade zoning. Digital camera images must be converted to L*a*b* values to accurately evaluate color tones using this method. This goal can be easily accomplished by utilizing existing image processing software. However, this task requires complicated operations. This system is based on equations Eq. (2) to Eq. (6) and automates the process to reduce the number of operations required in the field (Tobe et al., 2020).

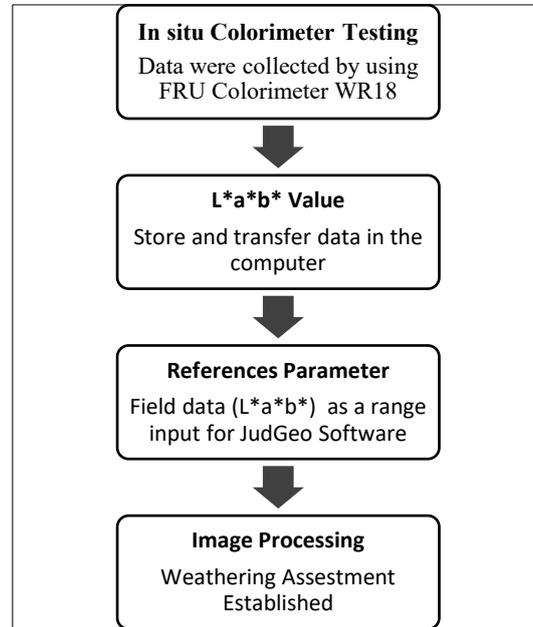
Fig. 10 Image processing framework in JudGeo software (Tobe et al., 2018)

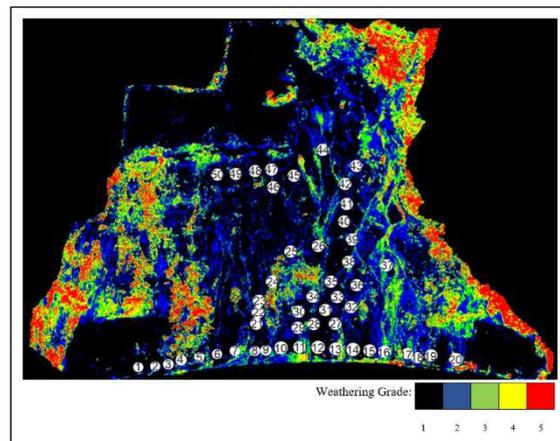
Fig. 11 Weathering evaluation for the rock slope surface by using the image analysis technique

The system convert RGB values to $L^*a^*b^*$ ones in each pixel and assign pixels to weathering grades to the highly weathered (Fig. 11). The degree of weathering on the slope surface is contoured by setting the color of the heavily weathered sample to no. 5 and the unweathered sample to no. 1. The areas of the diagram corresponding to no. 3 and higher are referred to as the "weathering region" (green, yellow, and red areas in Fig. 11). The system automatically calculates the proportion of these regions to the entire slope surface, and the value of the proportion is displayed as the slope surface's degree of weathering, ranging five levels of weathering grades from unweathered.

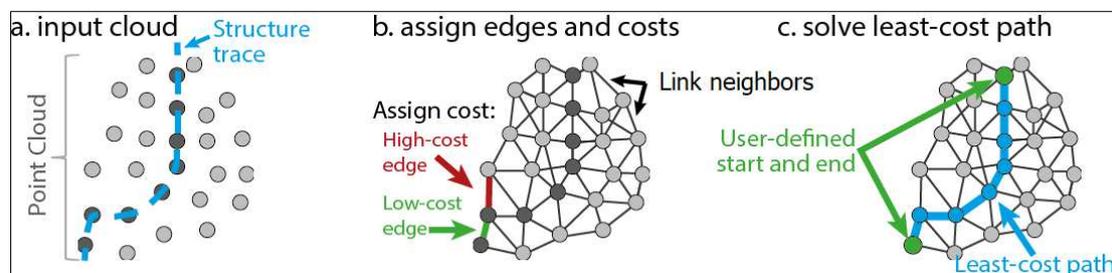
Fig. 12 Schematic showing the least-cost path approach to trace detection in a point cloud implemented in the compass plugin (*Compass (Plugin) - CloudCompareWiki*, n.d.)

The COMPASS plugin is a structural geological toolset for modeling and interpreting virtual outcrops. This tool combines a flexible data format for organizing geological interpretation with a set of simple and computer-assisted digitization and measuring capabilities. The instrument is divided into two modes: Map Mode, which is used to denote geological units, and Compass Mode, which is utilized to determine orientations and thicknesses. In this study, a plane is fitted to each trace (using least squares) when it is finalized (green tick or space key),

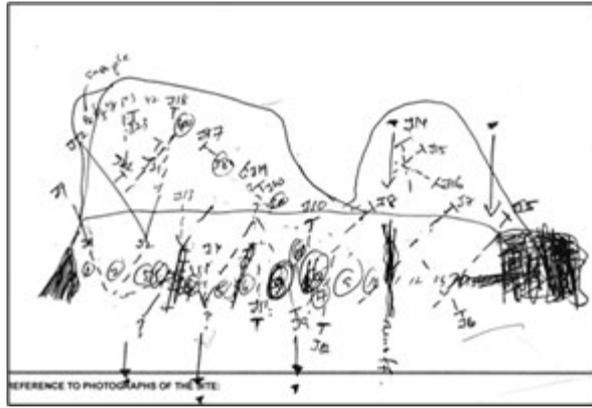
Fig. 13 Manual geological sketch of slope in Lebuhraya Kuala Kubu Bharu–Teranum–Raub showing a variation of dip and dip directions and 23 critical planes

The Compass plugin orientation is verified using manual field mapping (Fig. 13) to replace the facet method. Approximately 23 discontinuity orientations were collected for manual mapping and 58 discontinuity orientations for this study. The example data collection from COMPASS plugin for study area is illustrated in Fig. 14 and Table 2.

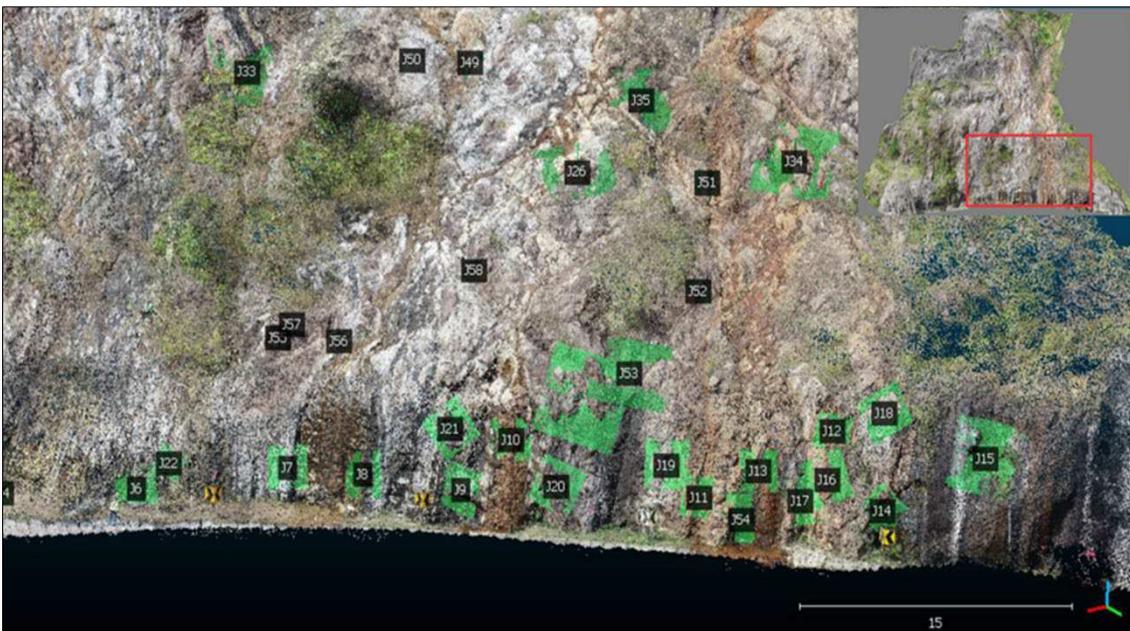
Fig. 14 Example of Compass plugin's discontinuity reading for Lebuhraya Kubu Bharu–Teranum–Raub

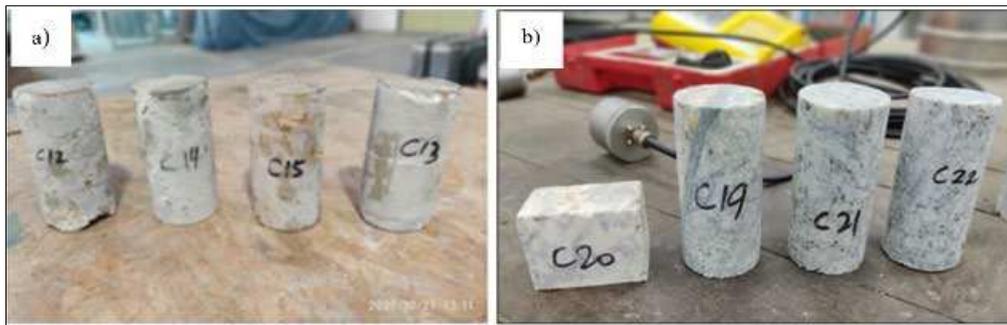
Fig. 15 Samples prepare for a) UCS Test and b) UPV

In this study, the image analysis technique will be compared with geomechanical testing to verify the outcomes. This study focused on 50 points of measurements of the rock slope of Lebuhraya Kubu Bharu–Teranum–Raub. The geomechanical testing included in this study is uniaxial compressive strength (UCS) from N-type Schmidt rebound hammer, laboratory UCS, point load test, and ultrasonic pulse velocity (UPV). The number of samples is summarized in Table 3. The methodology for the index properties is as follows: ASTM D5731-08, 2008; Franklin, 1985, and the samples tested are cylindrical cores with a width (D) to height (H) ratio of 0.3 DHD. The point load strength is converted to UCS using the correlation $UCS = C \times I_{s50}$ (Franklin, 1985). This study tested four (4) granitic samples from the study area for the corrected point load strength index, I_{s50} , using the D550 machine model. A UCS was correlated to the color index (a^* and b^* values) and image analysis zoning to validate the results. The test is carried out on an intact rock at the laboratory with no discontinuities and yield data on the rock material properties. The height to diameter ratio of 2:1 is a minimum for cylinders,

according to the International Society for Rock Mechanics (Fig. 15) (ASTM, 2014; ISRM, 1977). The velocity of the P-waves (V_p) in the UPV test was determined using the time-of-flight technique at 1 MHz (ISRM, 1978).

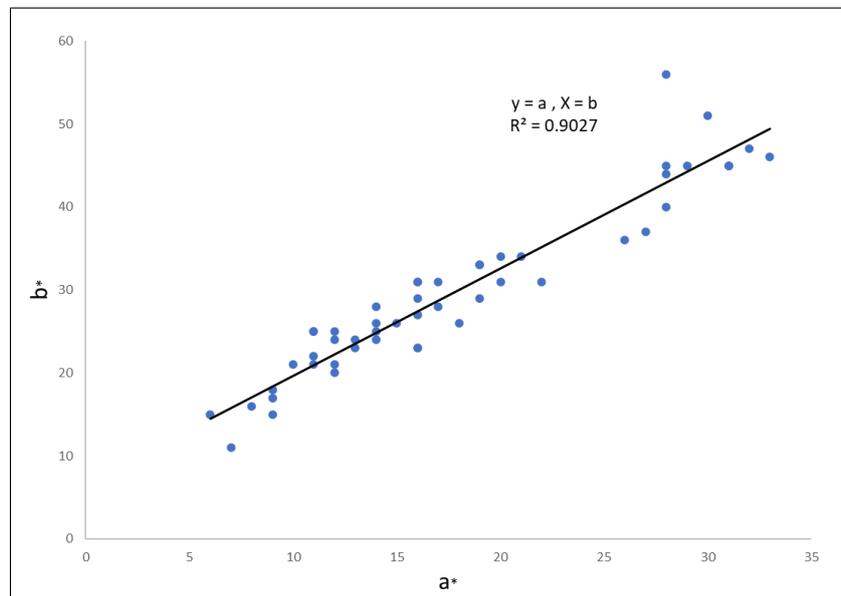
Fig. 16 Correlation of a* to b* of the study area

The L^* , a^* , and b^* values from the CIELAB color space demonstrate a positive correlation with weathering grades. The findings (Fig. 14) show that the rock is more weathered when the a^* and b^* values are higher than those with lower values. Similar results prove the hypothesis stated in predicting the tunnel face weathering grades (Tobe et al., 2020). The CIELAB values were tabulated for each of the 50 points of measurement on this rock slope (Fig. 16). Table 4 summarizes the data on an average basis. The results show that the a^* value ranged from 5 to 35 with an average of 18, while the b^* value ranged from 10 to 50 with an average of 30. The correlation of the a^* and b^* values show significant results with $R^2=0.9027$, which was nearest to one. The positive a^* value in the CIELAB color space represents an object's redness (Fig. 16). The results quantify the change in color of the rock slope from unweathered to highly weathered rock. These findings are consistent with those of Tobe et al. (2020) who found that heavily weathered rock samples had higher a^* and b^* values than unweathered rock. The study's findings were compared with a digital photo taken on site (Table 5), and a correlation with weathering description shows a significant value. The selected samples from 50 points of measurements in the study area demonstrate a reliable assessment, increasing the level of weathering from slightly weathered (strong rock) to highly weathered (weak rock) with the increase in the a^* and b^* values. This result suggests that it is a feasible and reliable method for quantifying weathering using the CIELAB color space. Given that color is a primary indicator of weathering rock, digital photographs can be an effective tool for comparing the value obtained with a colorimeter.

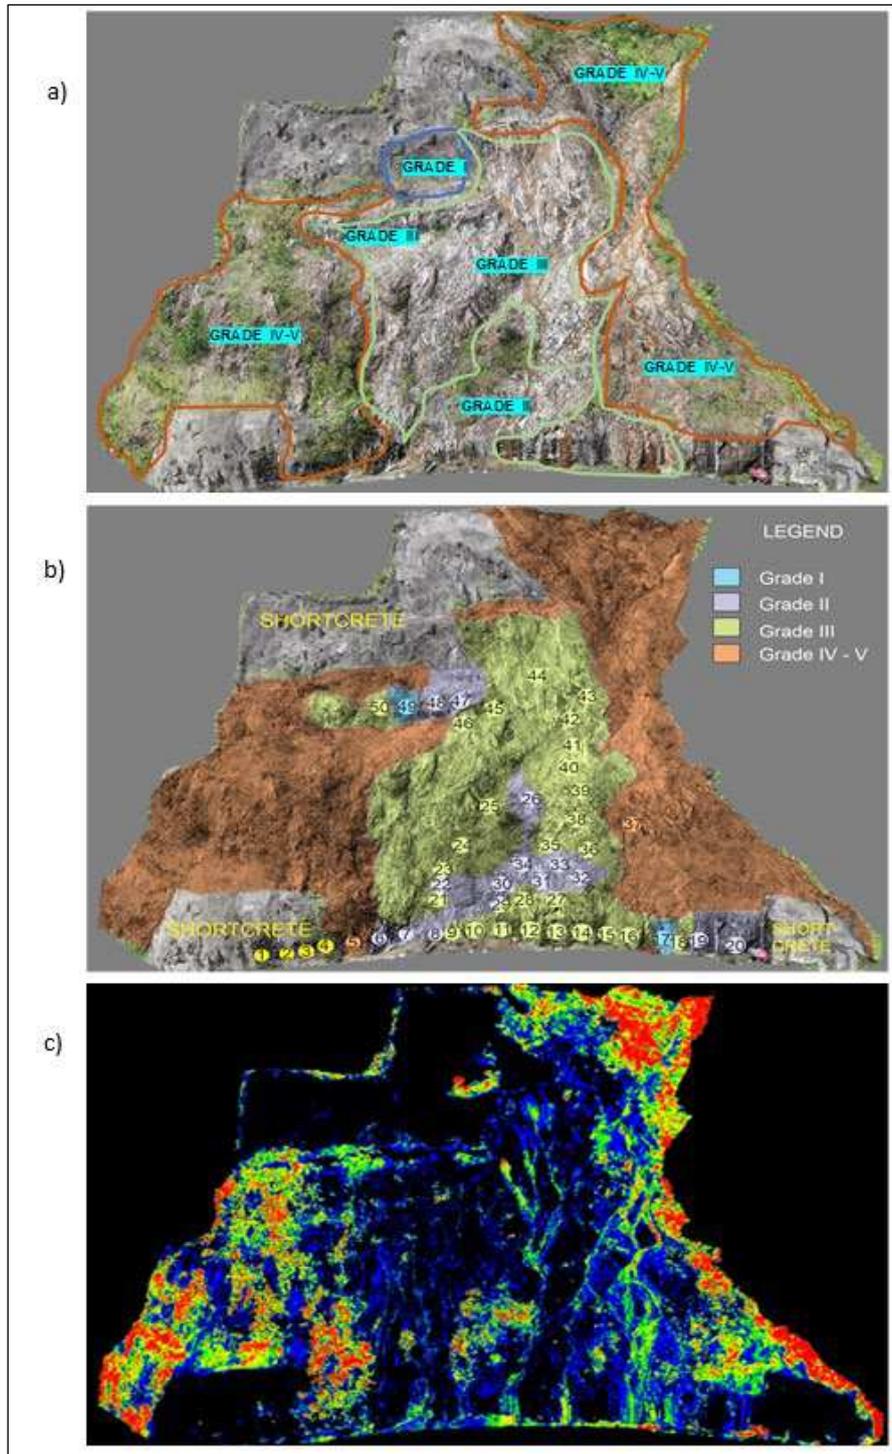
Fig. 17 Weathering grade zoning and image analysis of Lebuhraya Kuala Kubu Bharu - Teranum – Raub route; a) and b) manual observation, c) image analysis observation

The finding illustrates some results of the image analysis method in quantitatively assessing the weathering grade. In Table 6 and Fig. 17, the color of the rock changes with the increase in the weathering grade. The orange and red colors indicate vegetation and are particularly noticeable near the crest area. At this zone, the rock is weathered, and the rock mass is loose. Granites are highly variable in thickness even at the outcrop scale (hence the differences in weathering extent between heavily jointed and massive granites); thus, the saprolite thickness may be highly variable. Rotational slides are common in the color zone red-orange, with debris slides in the yellowish zone. Green zoning with reddish-yellowish brown discoloration indicates that this zone has the possibility of rock rolling. Blue zoning has a similar possibility of failure as the green zone, which is influenced by rolling rocks because some rocks decomposed and/or disintegrates into the soil and have discontinuity on the slope surface. Blue zone is the second most prevalent colour, accounting for 23% of the total rock slope, indicating extensive discoloration on the granite masses. The texture of rock from medium to coarse grain when its moderately weathered also influenced rock to rolling. The black zoning represents the major area with 51% of the total rock slope. This percentage excludes shotcrete on the slope.. Green is the next color, containing 12% discoloration and rock that degrades into the soil. Yellow represents the residual soils found near certain types of vegetation. Accordingly, a combination of orange and red represents 8% of the total rock slope and is used to analyze the vegetation on the slope. This zone is composed of heavily weathered granite because of the exposure and water flow from the top of the slope. Fig. 17 shows that the left and right sides of the slope are severely weathered, ranging from grade IV to V. Meanwhile, the slope's center is slightly to moderately weathered, with grades II and III as observed in Figs. 17a and 17b. The most intriguing discovery we made was the correlation between weathering grade zoning and slope image analysis. The finding from image analysis (Fig. 17c) shows a more significant value compared with the manual observation.

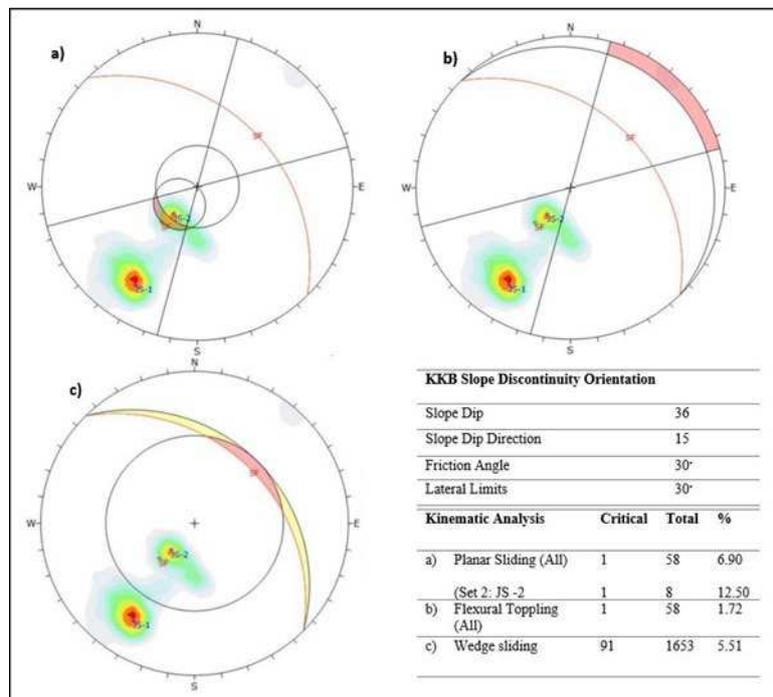
Fig. 18 Stereographic plots defining a) planar, b) toppling failure, and c) wedge failure mode

Based on the results (Fig. 18), the risk of planar sliding is 6.90% in the study region, with a critical joint set (JS) two risks of 12.5% and a flexural toppling failure risk of 1.72%. In the study locations, the chance of wedge sliding is 5.51%. The COMPASS tool from CloudCompare provides a good result for determining the rock discontinuity. The field mapping produced 23 visible discontinuity orientations. In Fig. 18, the granite slope in the

study area is susceptible to flexural toppling failure, wedge sliding, and risk of planar sliding. Planar sliding at these study locations has a common trend whereby the failure planes are sub-parallel to the slope face, and the rock mass slides down along a relatively planar failure surface. The observed failure surfaces are overlain by slightly to completely weathered rock. The limitation of this study is that the extracted values from CloudCompare has a certain offset of 10° or 10% from the actual reading on-site (Nagendran et al., 2019a; Tung et al., 2018). For instance, the extracted slope face orientations from COMPASS tool CloudCompare for the study area provides $36^\circ/45^\circ$, while the manual mapping on-site produces $35^\circ/40^\circ$ (Table 2). A slight difference of 1° for the dip and 5° dip directions was observed. The apparent difference is acceptable, and the offset of dip direction is caused by the misconception of the slope plan profile's point of view. The combination of UAV photogrammetry and field discontinuity data measurement overcomes the limitation in assessing the big scale slope face. Based on the results (Table 6), the rock slope can still fail due to geological structural failure; rolling, rockfalls, rockslides, block glides, and slide over sheeting surfaces, although the rock is considered strong (R4–R5). According to the image analysis, 51% (black zone) and 23% (blue zone) shows the critical zone intent to slope failure because only this zone is a structurally controlled failure. The results from stereonet (Fig. 16) verify this statement. The blue and black color zoning can still slide with the stated type of failure. The findings demonstrate the potential of improving the technology for quantitative weathering assessment using CIELAB and image analysis. In the zoning image, the Schmidt hammer value is used to determine the weathering grade. With this correlation, the weathering results obtained through image analysis are more detailed than those manually obtained using the Schmidt hammer value. It is much easier to determine and verify which portion or area has been moderately or significantly weathered.

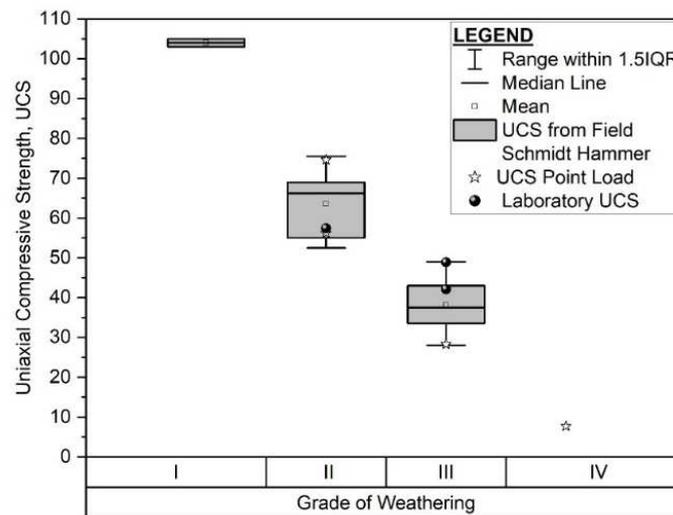
Fig. 19 Relationships between surface weathering, UCS Schmidt hammer rebound values, laboratory UCS, and UCS point load test from the study area

Table 7 illustrates that the rebound values of the UCS Schmidt hammer range from 100 MPa to 105 MPa. The weathering of grade (II) shows positive trends, with values ranging from 54 MPa to 75.5 MPa for the study areas. The weathering grade (III) indicates a strength range of

28.5–49 MPa (Fig. 19). Given that grades (IV) and (V) are considerably low for Schmidt hammer, no UCS Schmidt hammer rebound values are tabulated for these weathering classifications. The finding is important to validate the results from the image analysis. According to the UCS Schmidt (Fig. 19), the laboratory results showed a positive trend. The grade classification for the study area is classified as medium-strong (R3–R4); hence, it is a strongly validated the image analysis technique results (Fig. 17). These relationships minimize the uncertainties of the UCS Schmidt hammer rebound values.
