Wear Performance of The Zirconia Toughened Alumina Added With TiO_2 and Cr_2O_3 Ceramic Cutting Tool

Research Article

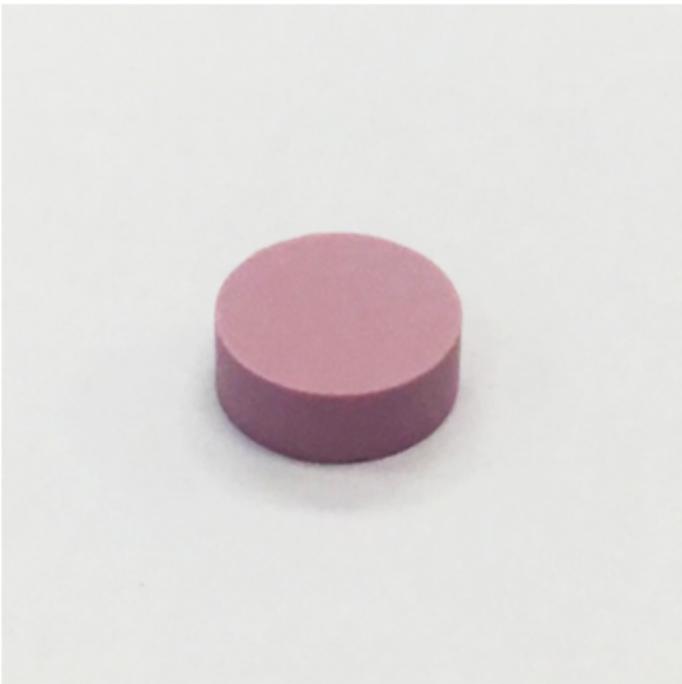
Figure 1

ZTA-TiO₂-Cr₂O₃ cutting tool

The properties of the ZTA- TiO_2 - Cr_2O_3 ceramic cutting tools were measured and shown in Table 1. The fabricated cutting tool is shown in Fig. 1. The turning process was performed using a CNC lathe machine (Bridge Port-Romi Powerpath) with a ZTA- TiO_2 - Cr_2O_3 cutting tool mounted on a Sandvik Coromant (CRDNN 2525M 09-ID) tool holder. The machining was performed on stainless steel 316L at the parameters shown in Table 2.

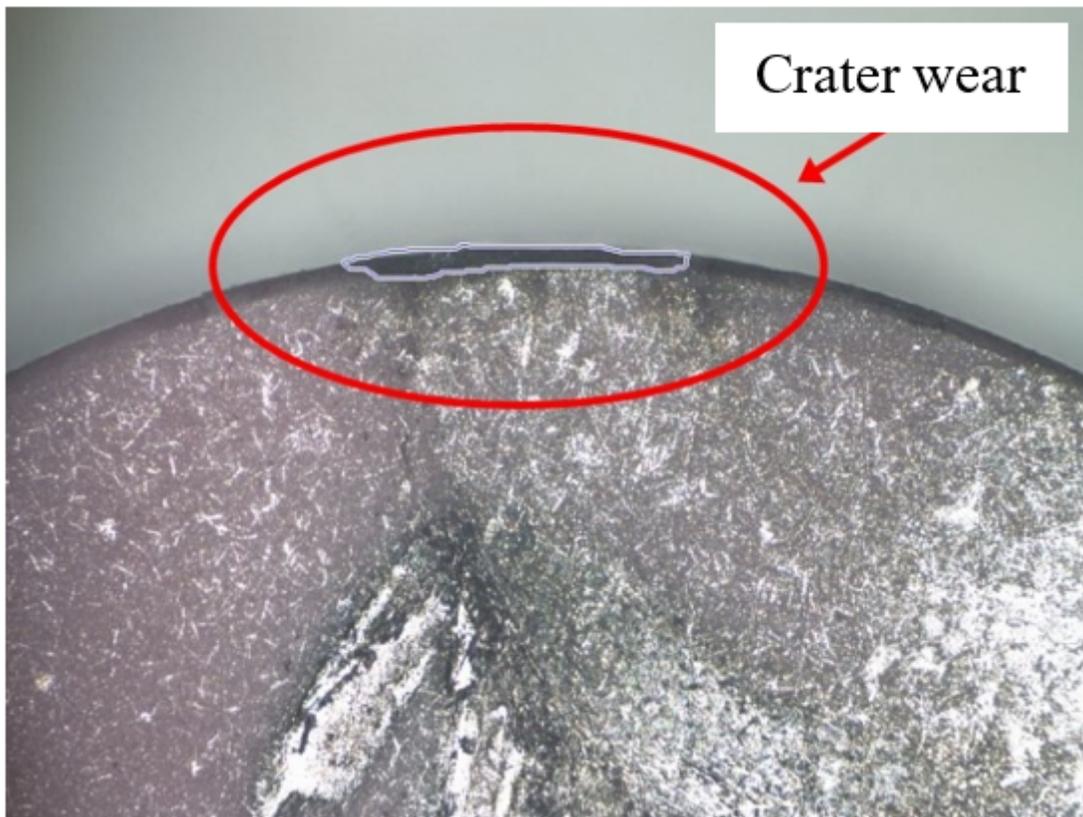
Figure 3

The crater wear observed in the experiment

Crater wear area on the other hand analyzed by using MATLAB programming software. The software measured the highlighted area to determine the crater wear area as shown in Fig. 3. Scanning electron microscopy (SEM) (JEOL JSM-IT100) was utilised to observe the chipping area on the ZTA-TiO₂-Cr₂O₃ cutting tool. The surface roughness of the machined surface, stainless steel 316L was measured by using the portable surface roughness (Mahr MarSurf M3000C). Three readings of surface roughness (Ra) were taken based on each machining parameter, and the average of the readings calculated.
