Strong Ground Motions From the 21 May 2021 M6.4 Yangbi Earthquake in Western China Obtained From a Dense Network of Accelerographs and Intensity Meters

Research Article

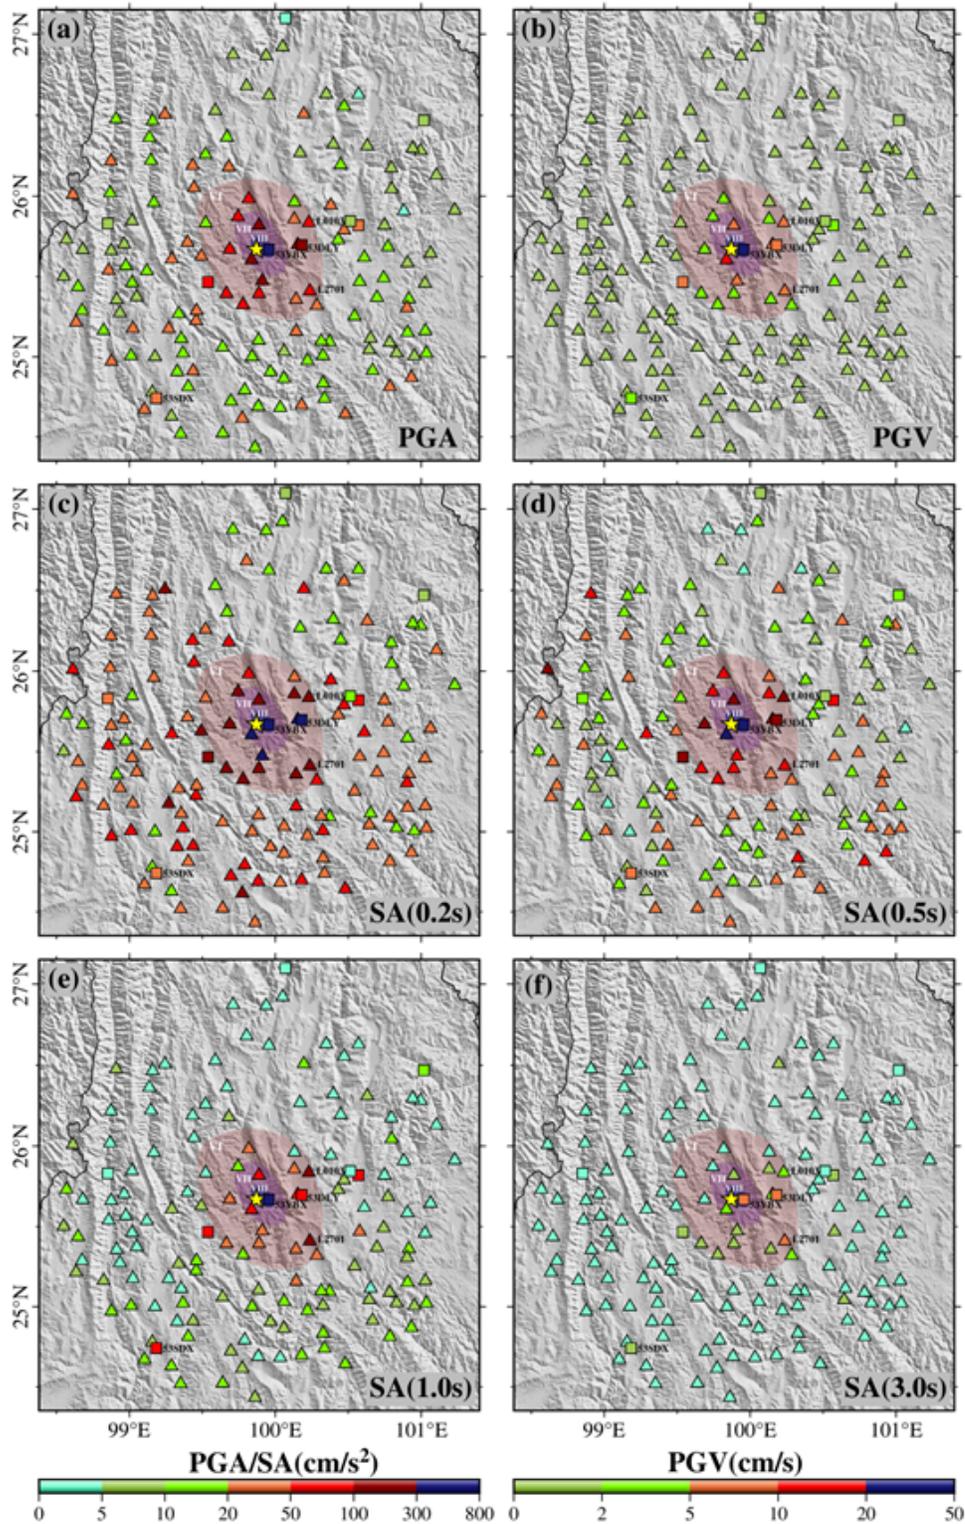
Figure 4

Spatial distribution of observed horizontal (a) PGA, (b) PGV, and SAs at period $T =$ (c) 0.2 s, (d) 0.5 s, (e) 1.0 s and (f) 3.0 s. Strong motion stations and intensity stations are shown in rectangles and triangles respectively. The color shaded elliptical areas indicate the intensity map given by CEA (2021). The elliptical areas from inside to outside are characterized by Chinese earthquake intensity VIII, VII and VI, respectively.

Figure 5 shows an overview of the spatial variability of observed horizontal PGA, PGV and SAs at periods $T=0.2 \text{ s}$, 0.5 s , 1.0 s , and 3.0 s . The horizontal ground motion parameter is presented as the geometric mean of the EW and NS components. The largest PGA and PGV are recorded at station 51YBX, which is close to the epicenter. All 6 recordings with PGA over 100 cm/s^2 and PGV over 10 cm/s are located within the isoseismic circle of intensity VI, less than 30 km from the source. We find a sharp decrease of observed spectral values with increasing periods. The largest SA value is 725.0 cm/s^2 at $T=0.2 \text{ s}$, while only 38.8 cm/s^2 at the period of $T=3.0 \text{ s}$. At period $T=1.0 \text{ s}$, only three records of 53YBX, L0103, and L2701 have SAs larger than 100 cm/s^2 . At period $T=3.0 \text{ s}$, there are only two records with SAs larger than 20 cm/s^2 , obtained by the 53YBX and 53DLY stations. In the distribution of PGA (Fig. 5a) and short-period SA at $T=0.5$ (Fig. 5d), we note many recordings with much larger IMs than the nearby stations, especially at far distance of 100-160 km. They are mainly caused by local topographic amplification effects. We will further investigate these anomalies in the latter section.

The seismic intensity distribution shows that the serious damage zone is relatively small and concentrated within the earthquake intensity VIII circle. Compared with PGA and short period SAs, the spatial variability of PGV and long period SAs at 1.0 s and 3.0 s correlates much better with the damage distribution. We note an outlier of station 53SDX located 125.8 km southwest from the epicenter, with recorded PGV and long-period SAs of 1.0 and 3.0 s much larger than nearby stations. The 53SDX station locates in the center of the small Shidian basin. The borehole log shows the site is covered with soft sediments of peats and clay over 40 m. Response spectra and HVSR curves of the 53SDX record in Fig. 6 show strong amplification in horizontal ground motions relative to the vertical component, especially at periods of 1.0 - 3.0 s . Meanwhile, the dominant period of horizontal response spectra of 53SDX reaches about 1.5 s , which is much longer than the nearby sites.

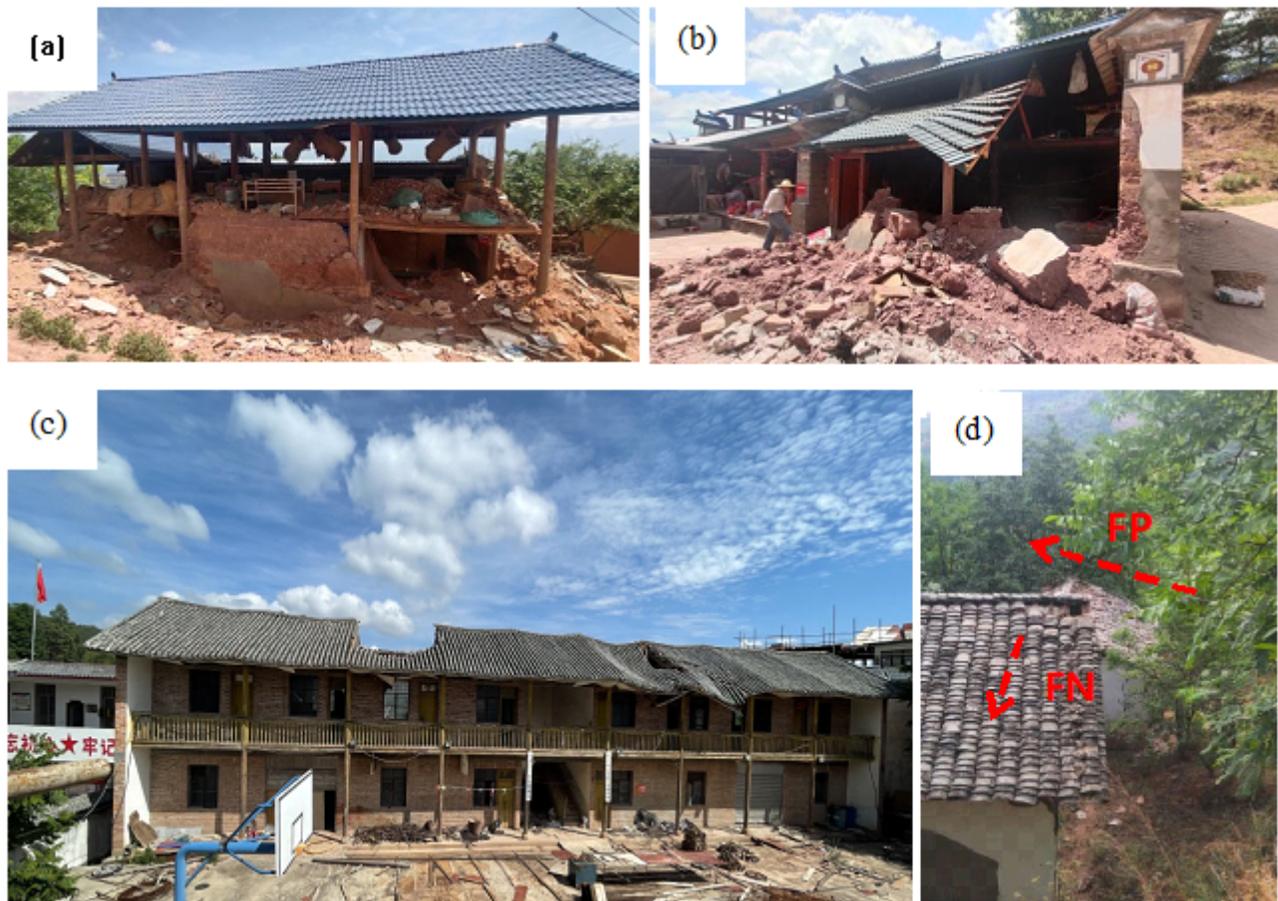
Examples of structural damage observed in Yangbi county town during the reconnaissance mission. (a) earth wall collapse of a earth-wooden house in Xiajie village (site #2); (b) shear failure of earth-rockfill wall of a mosque in Xiajie village (site #3); (c-e) overall offset and collision of brick concrete buildings (site #4); (f) collapse of old earth-wooden houses in Laojie (site #5); (g) failure of old wooden columns due to decline in bearing capacity (site #6); (h) shear failure of courtyard wall in Huaian village (site #7); (i) collapse of gables in earth-wooden structures (site #8).

Figure 12 shows the typical earthquake damage phenomena in (a-e) Xiajie village and (f-g) Laojie of Yangbi county town and (h-i) Huaian village, such as collapse and shear failure of filled wall of earth-wooden structures (Fig. 12a-b), overall deviation of the brick-concrete house caused by foundation failure (Fig. 12e-f), shear failure of brick concrete courtyard wall (Fig. 12h). Among them, Fig. 12c-e shows the overall offset of a brick concrete house (left side) in Xiajie village, colliding with adjacent houses due to foundation failure. A distance of 50 cm was reserved between the two buildings, but they touched each other after the earthquake. The earthquake also caused the building on the left to rotate. This damage may result from the shallow foundation and slope in the foundation of building, and the asynchronous displacement occurred in the earthquake.

We find that most of the gables of local earth-wooden houses are rammed walls, which are seriously damaged in this earthquake. The damage includes peeling and cracking of gables, cracking at the

junction of vertical and horizontal walls, flash collapse of some gables (Fig. 12a-b, i). The wooden structures of civil buildings are basically intact, but some wooden columns are damaged due to the decline of bearing capacity (Fig. 12g). The seismic damage of frame and brick concrete buildings is relatively light, and the main damage is tile falling, wall peeling and infilled wall cracks. The brick concrete structure with ring beam and structural column structure generally has good seismic performance with less damage and fewer cracks on the wall.
