Assessments of Geotechnical Condition of Landslide Sites and Slope Stability Analysis Using Limit Equilibrium Method in Goncha Siso Eneses Area, Northwestern Ethiopia

Abstract

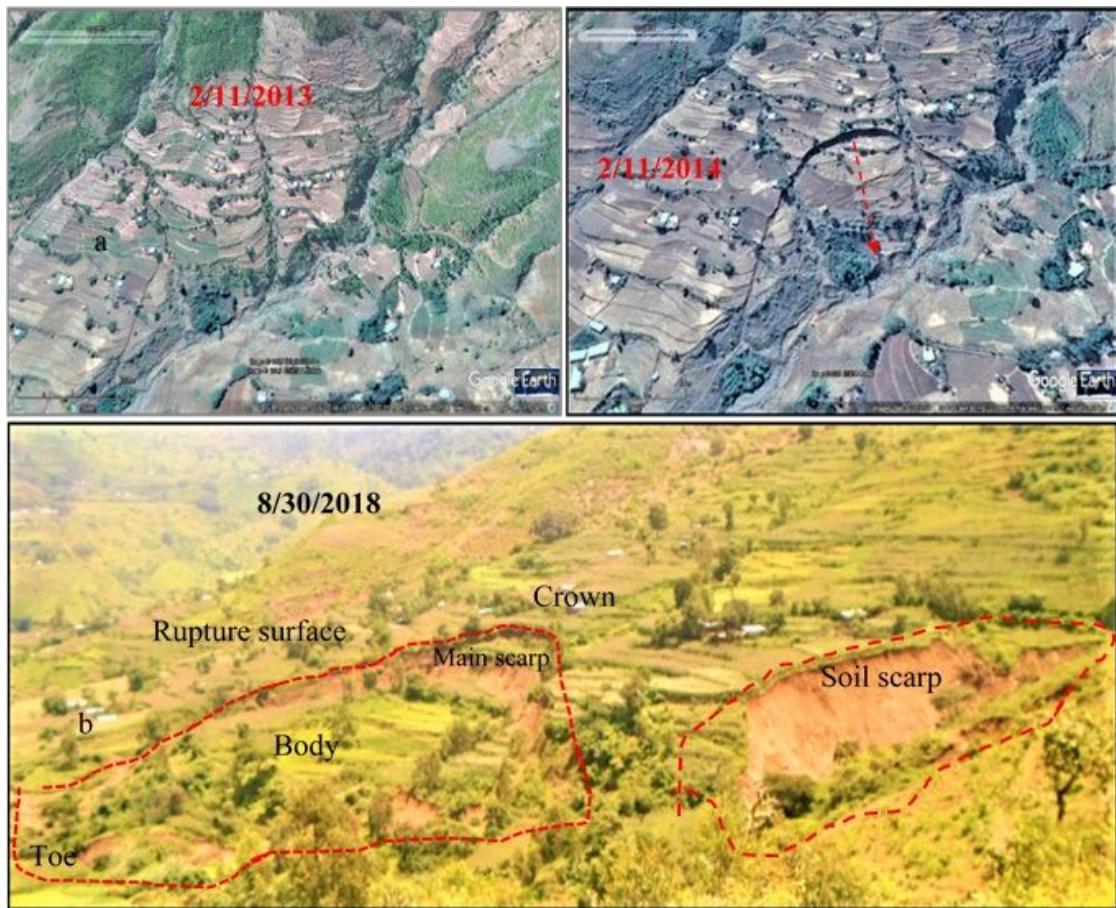
Figure 4

Soil Slide in Gete Semane

According to local people, the first small landslide with crack development was occurred in 2014, which forced to relocate one family from their village (Fig. 4a). According to local people, a small landslide in this village continuously occurred in the rainy season, and curved cracks developed from year to year. This village has been affected again by a reactivated landslide in 2018 (Fig. 4b) and caused damages in a house and 48 hectares of cultivated land that has been covered by various crops like maize, teff and bean and different fruits like coffee, almond, lemon, buckthorn, orange, and papaya. This slide has occurred due to stream erosion, gully erosion, man-made activities, and due to the presence of spring, heavy rainfall, and unconsolidated deposit.

The type of slope failure in this village is soil slide with a width of 10–800 m, depth of 1–15 m, depletion zone of 1–25 m, runout distance of 18–950 m, and accumulation zone of 0–800 m. Landslide in this village will pose risks in the future because various tension cracks have been developed continuously from the toe to the top parts of the slope with an average length of 1–241 m and depth of 0.1–0.3 m. These cracks caused a change in the streamflow directly into the cracks. The flow of water into the crack has caused the slope material to saturate by raising the groundwater level. The saturation of soil material can weaken the strength of the soil and result in slope failure. Various technical remedial and preventive measures like plantation of the eucalyptus tree, fruits, rock riprap, and terracing were applied but it is not possible to stop land sliding because of imbalance in the driving force with the constructed support and the plantation was above the failure zone. This further adds weight to unstable slopes.

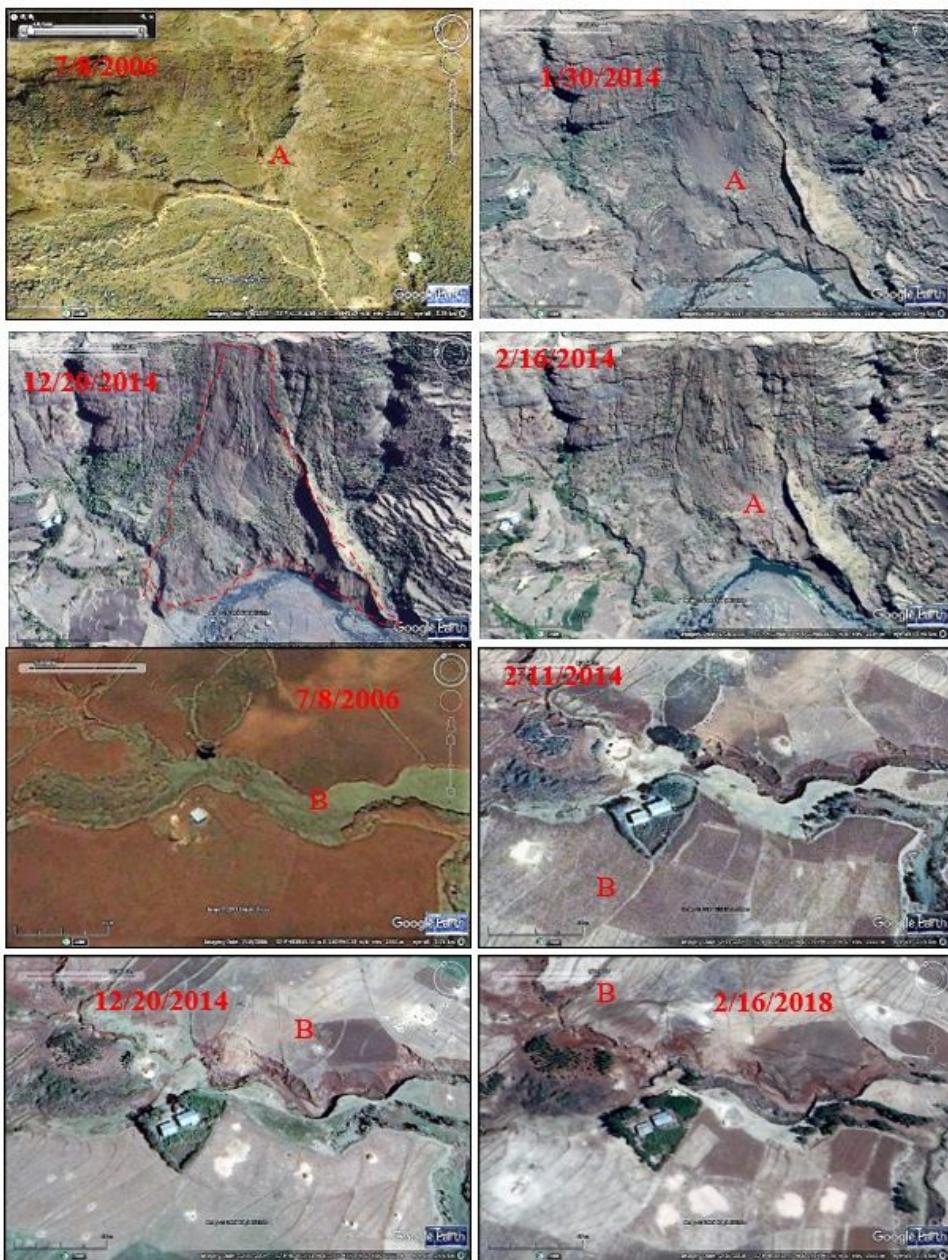
Figure 6

Time series landslide data from Google Earth image of Sekela Village B) in site 1 and A) in site 3

Landslide in this village has occurred due to stream initiated gully erosion, removal of slope toe by the river since 6/8/2006 (Fig. 6B) as observed in Google Earth image interpretation. Starting from this year, the study area, stream formation, and gully erosion increased from year to year as can be observed from Google Earth image interpretation (Fig. 6B). A few years ago, a permanent and large gully has been formed. The stream has been removing the slope toe support during the rainy season. This caused curved crack development, and then the slope falls as a curved surface and slides down towards the stream. The moving material moved away by the flowing stream. In 2018, a large soil slide is occurred because of springs, gully and stream erosion, improper ditch design, overgrazing, intensive agricultural activities, weathering, and heavy rainfall. Landslide in this area includes transitional, rotational, weathered rockslide and ground subsidence related landslide with average landslide depth of 0.5–6 m, the width of 15–300 m, depletion zone of 0.1–15 m, an accumulation zone of 0–360 m, and runout distance of 0–370 m. These caused damages in seven-hectare farmland with crops and five houses are under risk. Various measures like plantation of the eucalyptus tree, terracing, rock riprap, and gabion wall were applied, but it is not effective because the measures are not applied in their-appropriated location. Landslide in this area has been occurred since 2006 and active until 2018 due to the removal of the slope toe by the river undercutting during the rainy season.

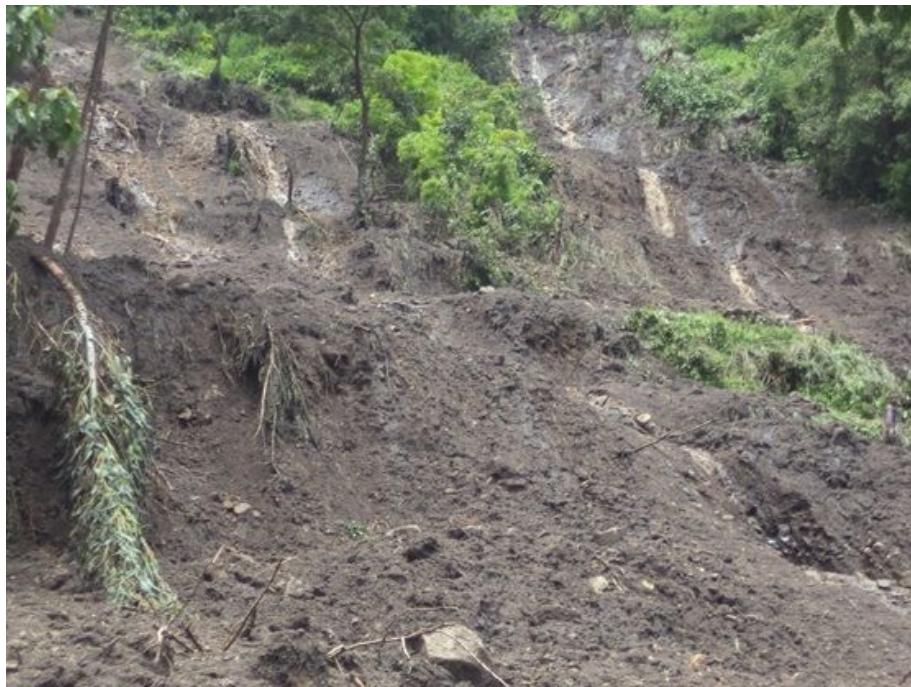
Figure 7

Earth flow in Ineget area

According to local people, the earth flow type of landslide occurred in 2018 in this village, which caused damages to two houses, the death of eight people, and destroyed the 2.5-hectare crop and permanent fruit covered farmland. In this area, slope failure has occurred at the soil-rock interface when the slope soils are fully saturated due to heavy and prolonged rainfall. This slope failure has initiated by agricultural activities, steep slope gradient, shallow colluvial soil deposit overlaid on fractured, and highly weathered basalt unit and triggered by heavy and prolonged rainfall. It has a runout distance of 900–910 m with an average width of 15–20 m.

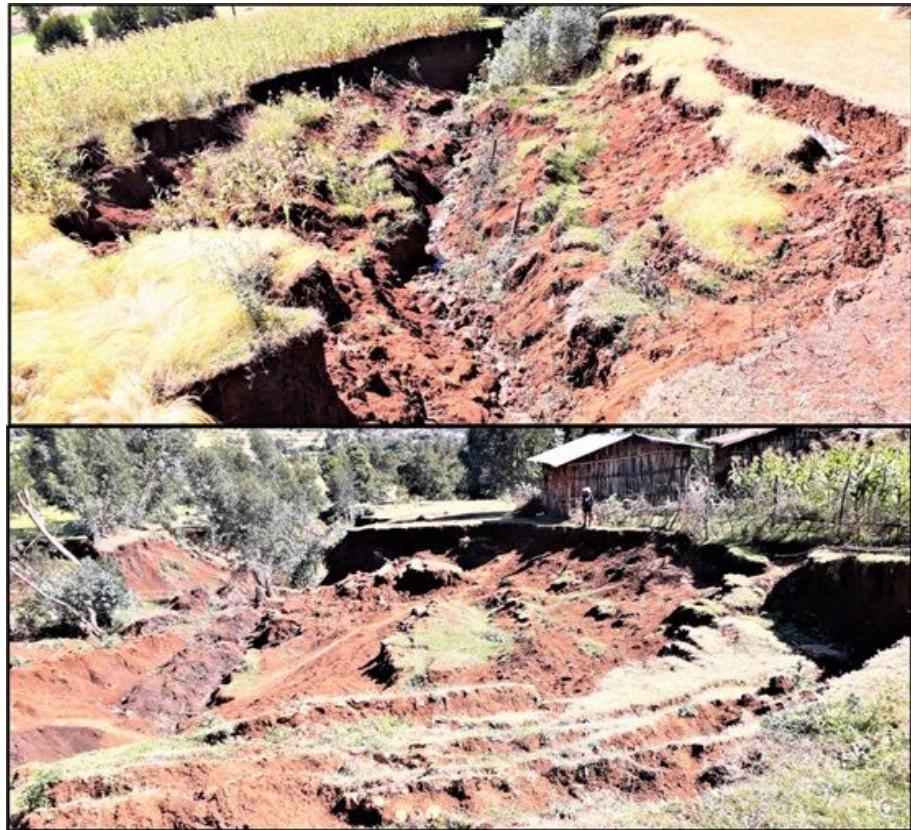
Figure 8

Soil slide in Tora Meda area

In this village, soil slide is predominantly found and caused the destruction of farmland that has covered by various crop types, eucalyptus trees, and fruit. In addition to this, more than five houses are at risk. The rotational slide occurred on thick unconsolidated soil because of the removal of slope toe by stream erosion and gully erosion. In Tora Meda area, landslide incidence is a common problem in Gofer and Yigagira area and has landslide dimensions with depletion zone of 1.5–12 m, accumulation zone of 0–20 m, runout a distance of 11–300 m, the width of 7–60 m and a depth of 1–12 m.

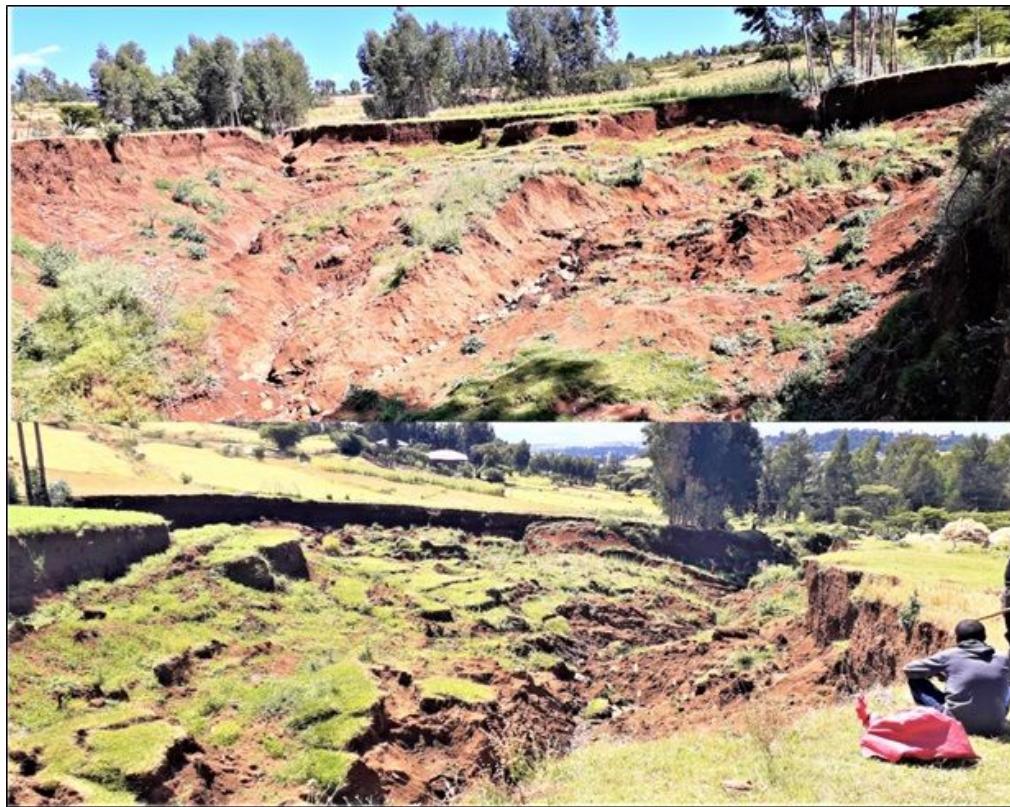
Figure 9

Soil slide in Debre Yakob area

In this village, the landslide has occurred as soil slip with a curved failure surface because of stream erosion of the slope toe and spring emanation at the soil-rock interface. According to local people, a landslide in this village has been occurred since 2012 and is reactivated in 2018 that caused damages on two hectares of cultivated land, which was covered by “teff”, wheat, chickpea, and eucalyptus tree. Since the soil is unconsolidated, less permeable, and has high water absorption, it has failed when the soil is fully saturated. Earth fall has occurred at the interface of soil and rock units. Hence, the soil at the top of the slope is unconsolidated and the interface rock is highly weathered, the slope materials have failed at any season as earth fall.

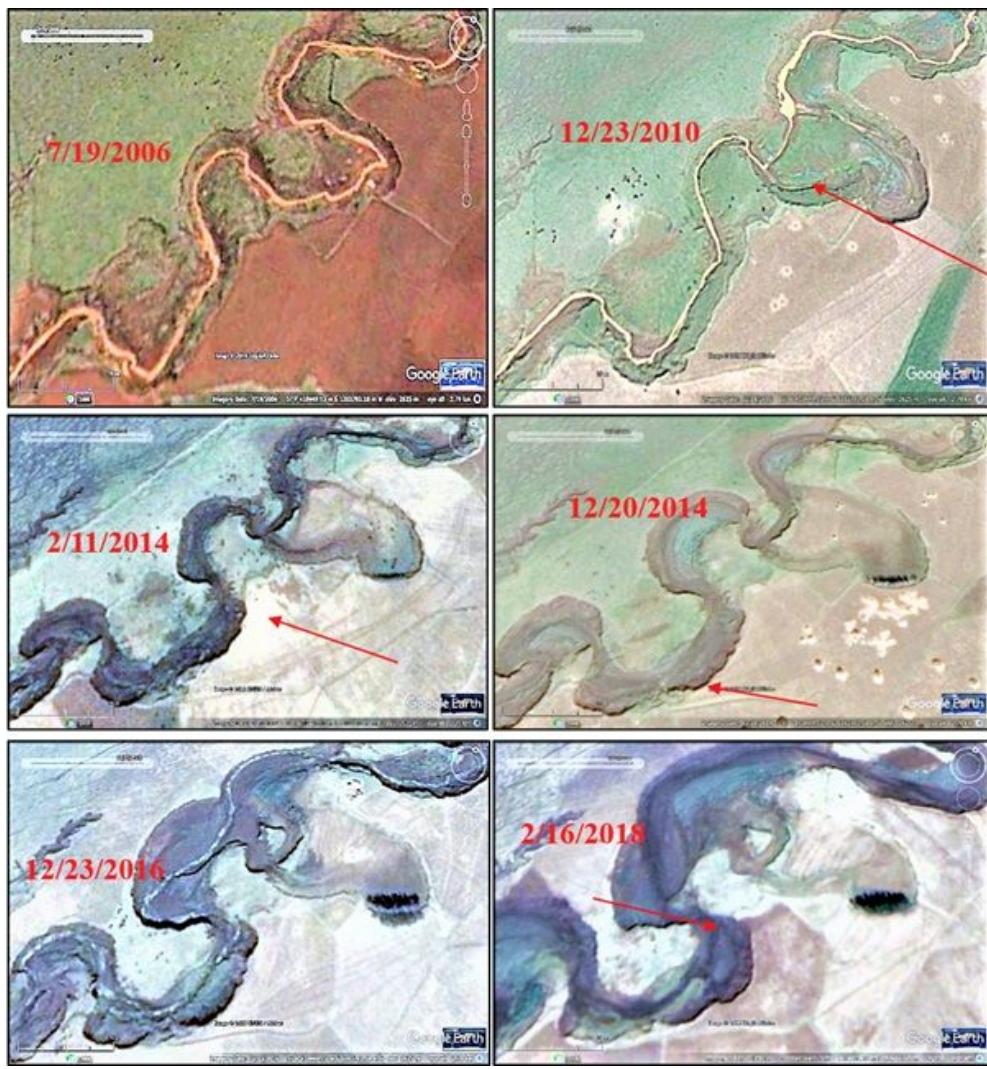
Figure 10

Time series landslide Google Earth image in Debire Birhan area

Debre Birhan is one of the areas that have been severely affected by landslide incidence before 2006 (Fig. 10) and active still now as observed in Google Earth image interpretation. Landslide in this area is damaged three-hectare farmland with crops because of Bina river erosion of the thick unconsolidated soil deposit, agricultural activities, and the presence of erodible soil, springs, heavy and prolonged rainfall.

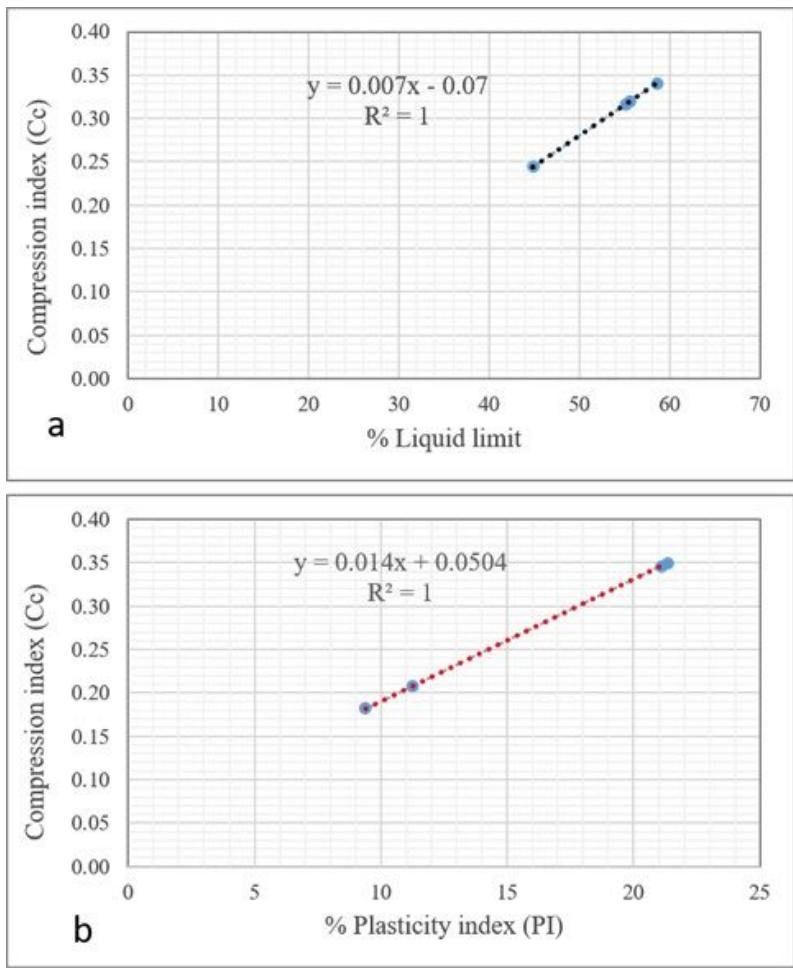
Figure 12

a) linear regression between Cc and LL and b) linear regression between Cc and PI

The compressibility of soil is one of the engineering properties of soils that can be determined using the odometer test but it is time-consuming, expensive, and requires undisturbed soil samples. The compression index has a good relationship with a liquid limit, plasticity index, and shrinkage index (Skempton 1944; Sridharan and Magaraji 2000). In this study, the compressibility condition of the soil was estimated using atterberg limit test. The compression index of the selected slope section of the study area was calculated using both the value of liquid limit and plasticity index values using the formula that has been used by (Skempton 1944; Sridharan and Magaraji 2000) i.e., $Cc = 0.007(LL-10)$ and $Cc = 0.014(PI+3.6)$.

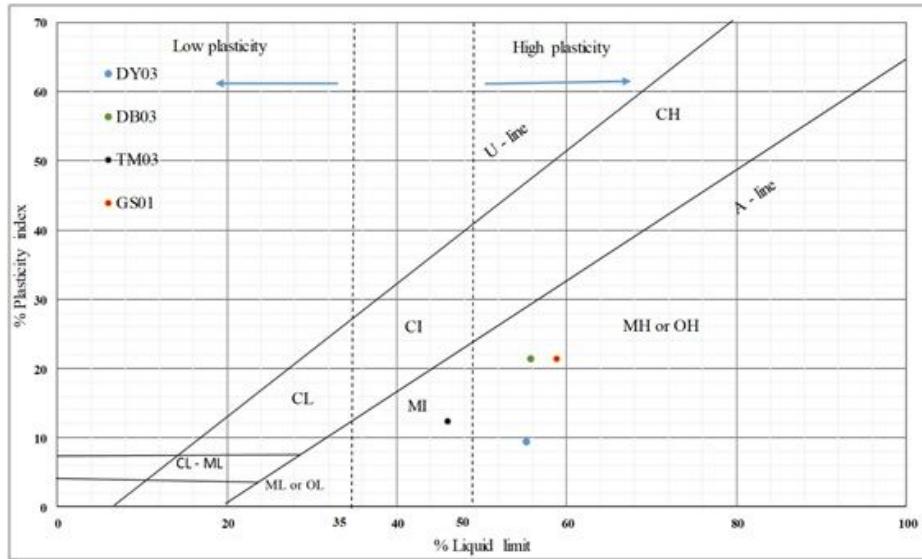
Figure 13

Fig. 13 Plasticity chart

Plasticity chart

Characterization of the physical properties of the soil is important to deduce the engineering properties of soil at various conditions. For this purpose, atterberg limit test was performed. The liquid limit and plasticity index value of the selected slope sections are more than 35%, 9% and the plasticity index of soil falls under intermediate, high compressibility, and plasticity zones in the plasticity chart of Fig. 15.

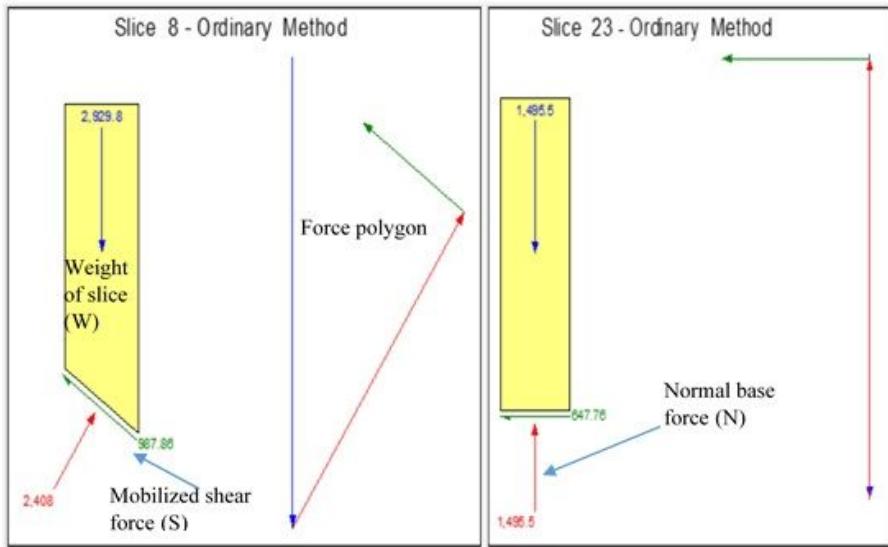
Figure 17

Fig. 17 Free body diagram and Force polygon closure in Ordinary method

Free body diagram and Force polygon closure in Ordinary method

As indicated in Table 10, this method was applied to calculate the factor of safety for selected failed slope sections under various groundwater conditions but it does not consider both normal and shear inter slice forces (Fig. 17), and not satisfy force in equilibrium (Fig. 22). Thus, it has not provided a factor of safety vs lambda graph because lambda is undefined (Fig. 22). The ordinary method satisfies only the equation of moment in equilibrium (Fig. 22). The force polygon closure is not possible as can be seen in the free body diagram in Fig. 17 and it has worsened force polygon closure from the crest of the potential slid mass to the toe of the sliding mass. As shown in the force polygon on slice numbers 8 and 23, the force polygon closure is so poor. This can help to conclude that an ordinary method will not satisfy the overall force equilibrium. The factors of safety, calculated in this method, are unrealistic because the force polygon closure is so poor which means each slice is not in force equilibrium (Fig. 17).

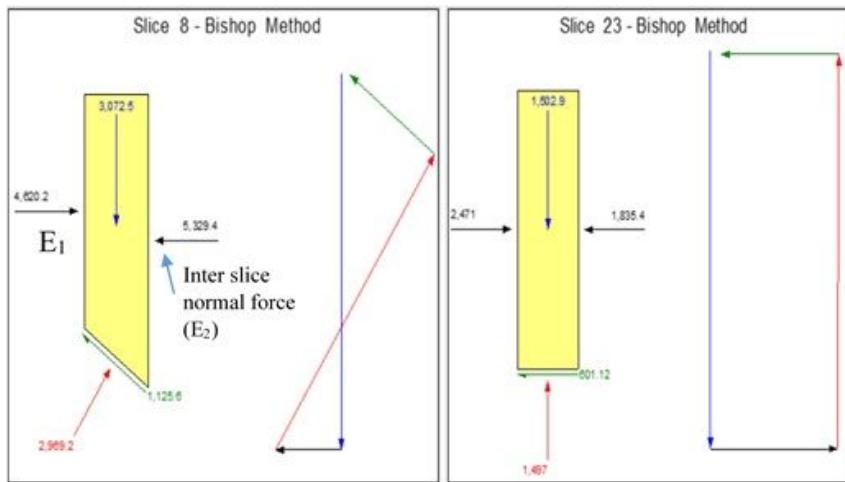
Figure 18

Fig. 18 Free body diagram and Force polygon closure in Bishop's method

Free body diagram and Force polygon closure in Bishop's method

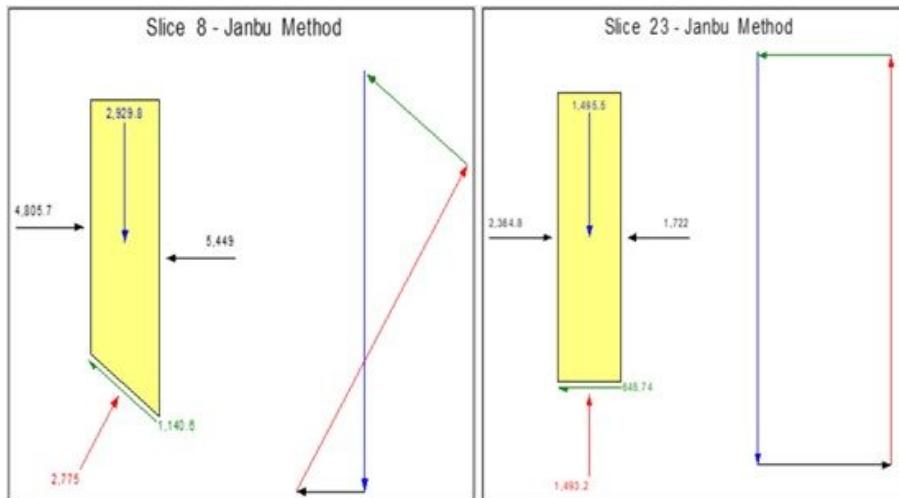
Figure 19

Free body diagram and force polygon closure in Janbu Method

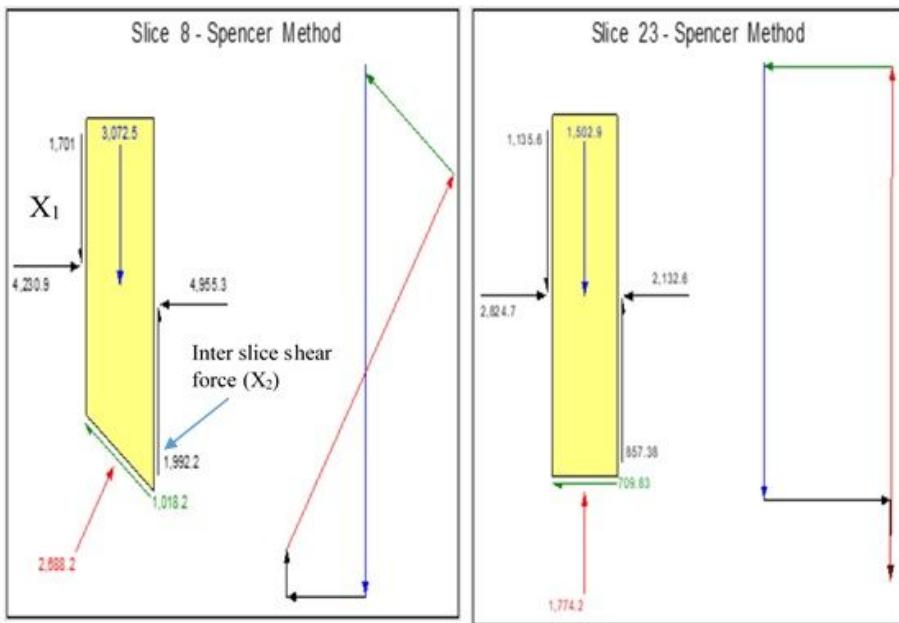
Figure 20

Fig. 20 Free body diagram and force polygon closure in Spencer method

Free body diagram and force polygon closure in Spencer method

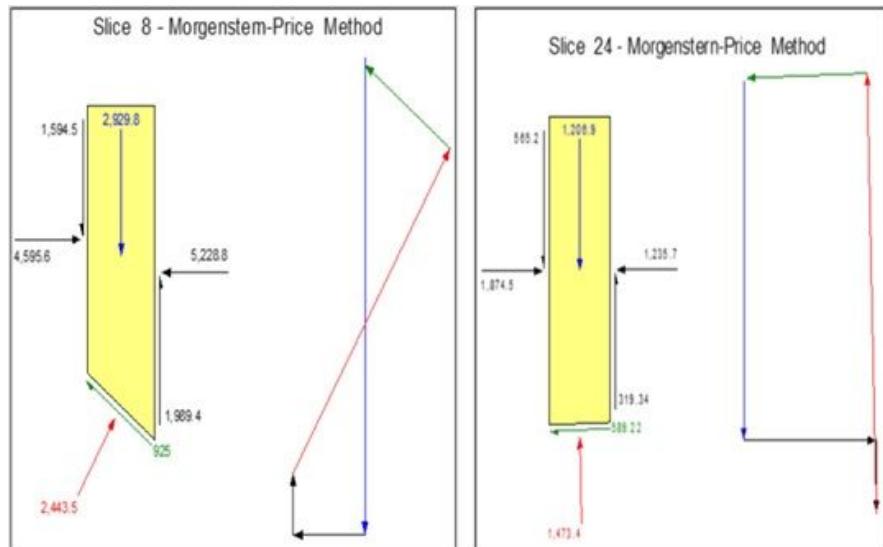
Figure 21

Free body diagram and force polygon closure in Morgenstern price method

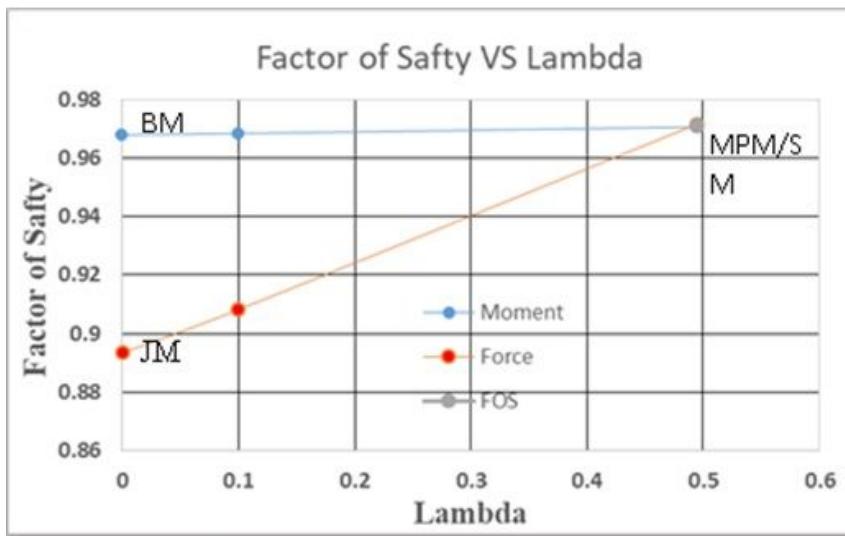
Figure 22

Factor of safety Vs Lambda graph

The factor of safety for all failed selected slope sections was calculated using slope/w software. As we know the factor of safety is the ratio of resistance force to driving force and it depends on the slope condition, material properties, and slope angle. As the result indicated in Table 10 and Fig. 22, a factor of safety for all failed selected slope sections is less than one

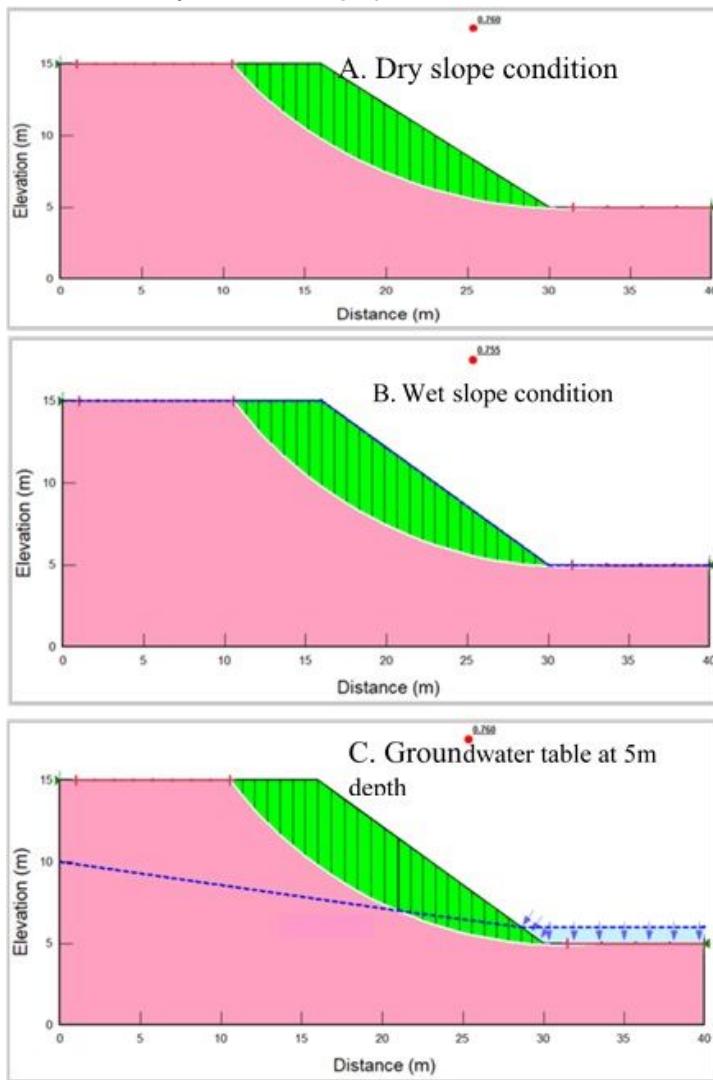
Figure 23

Critical slip failure surface of a slope section at different groundwater conditions

The slope stability analysis in the selected slope section is performed based on the input data (cohesion, internal friction angle, unit weight of soil, and groundwater condition using slope/w methods as can be seen in Fig. 23.

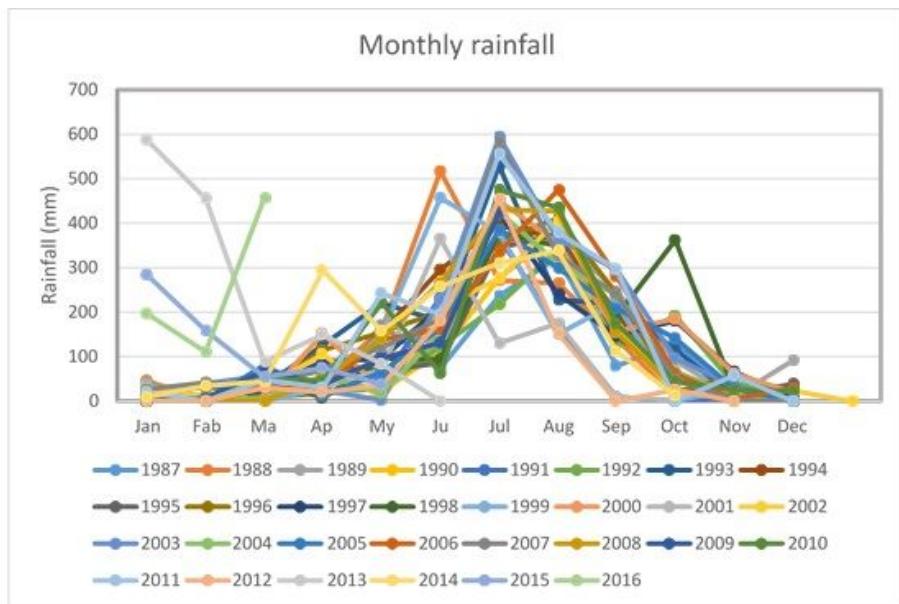
Figure 24 Annual based rainfall

Annual based rainfall

Slope failure has occurred in the middle, end of July, August, and September with intense and prolonged rainfall in the study area. As indicated in the bar graph of Fig. 24, the rainfall intensity varies from month to month. For instance, the rainfall intensity in July, August, and September are so high. The information that has gathered from local people interview, Natural soil moisture test result, liquidity index, and Google Earth image interpretation indicates, landslides in the study area have occurred related to heavy and prolonged rainfall. This shows that rainfall is one of the most important triggering factors for slope failure in the study area. As designated in Table 3, the natural soil moisture content of soil increase with depth for the selected failed slope section. This implies the fluctuation of soil moisture due to the effects of rainfall. This result shows, during the rainy season the moisture of soil increase and cause reduction unsaturated zone of the soil profile. This also causes a reduction of shear strength but the increasing weight on the slope and driving force. These all trigger the slope instability in the area. However, the presence of heavy and prolonged rainfall in a given region may not cause landslide unless other conditioning factors are available. In the study area, in particular, cool zones that have high rainfall but have not subjected to landslide incidence due to flat topography and the absence of slope modification. Therefore, rainfall by itself does not trigger landslide without the contribution of other factors like geology, soil depth, slope gradient, slope modification, vegetation cover, and vegetation type.

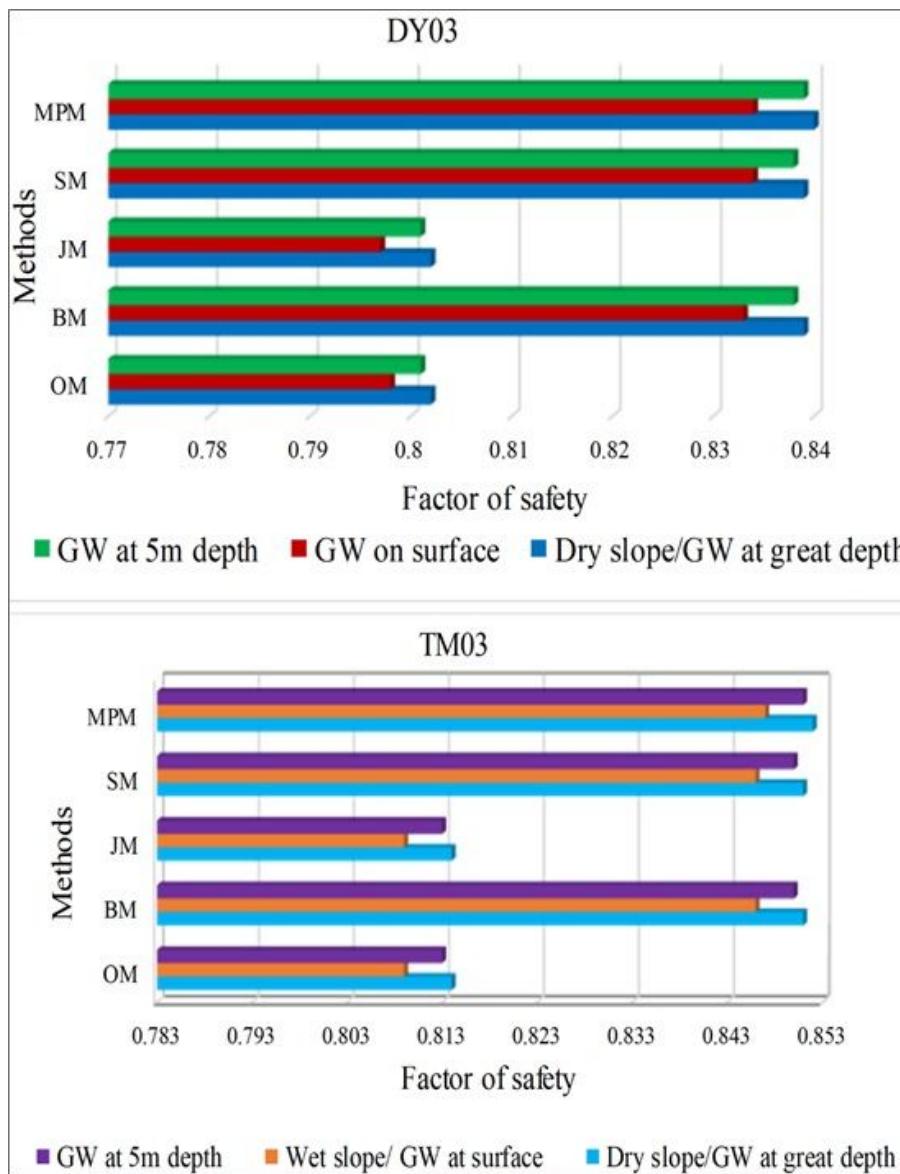
Figure 25

factors of safety comparison with different groundwater conditions

The minimum factor of safety and critical slip surface of three selected slope sections are calculated and searched for different limit equilibrium methods by considering various groundwater conditions as indicated in Fig. 25. All potential safety factors that are calculated at different groundwater conditions using various methods have been summarized in Table 10.

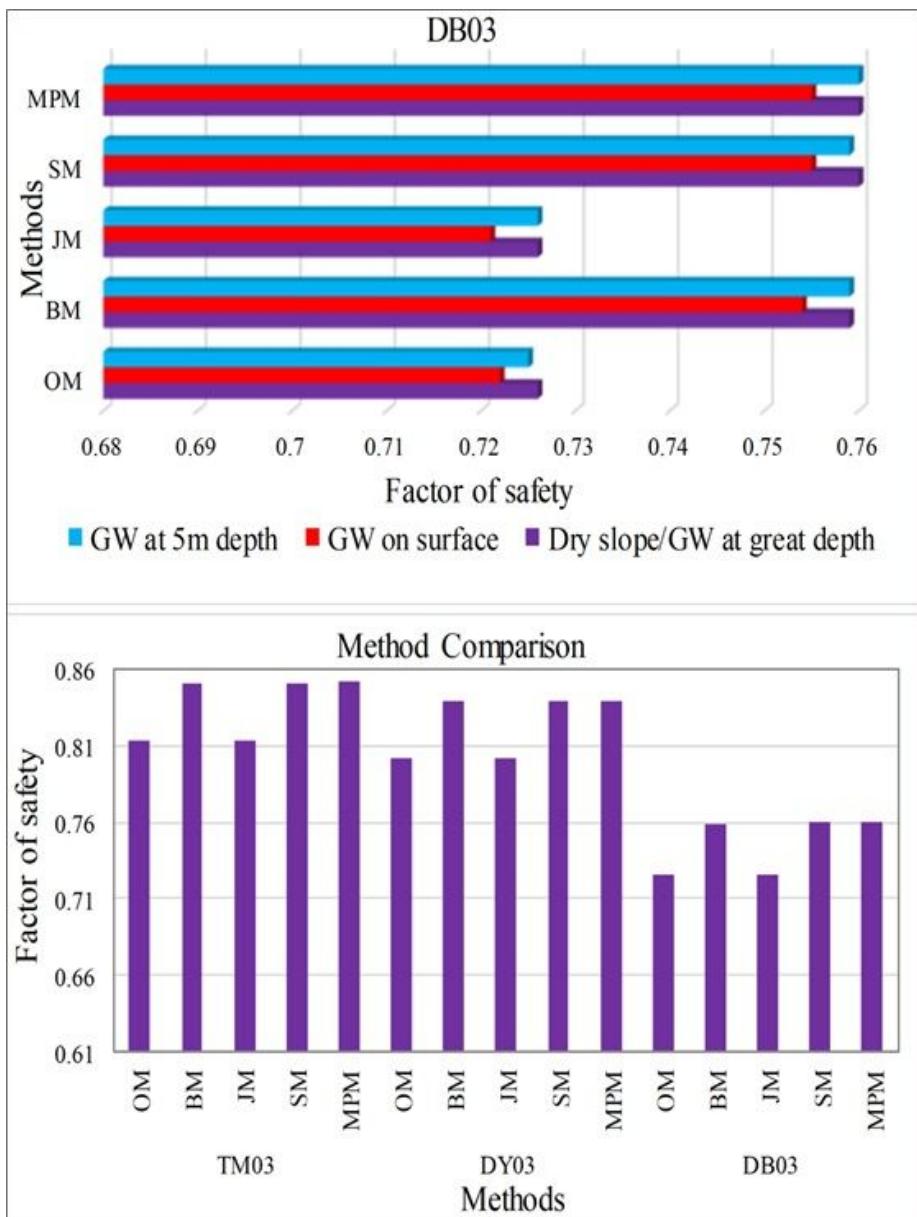
Figure 26

factors of safety comparison among different methods
