Performance of RC Cast-in-Place Buildings During The November 26, 2019 Albania Earthquake

Abstract

5. Structural Damage Of Cast-in-place Rc Buildings In The 2019 Albania Earthquakes

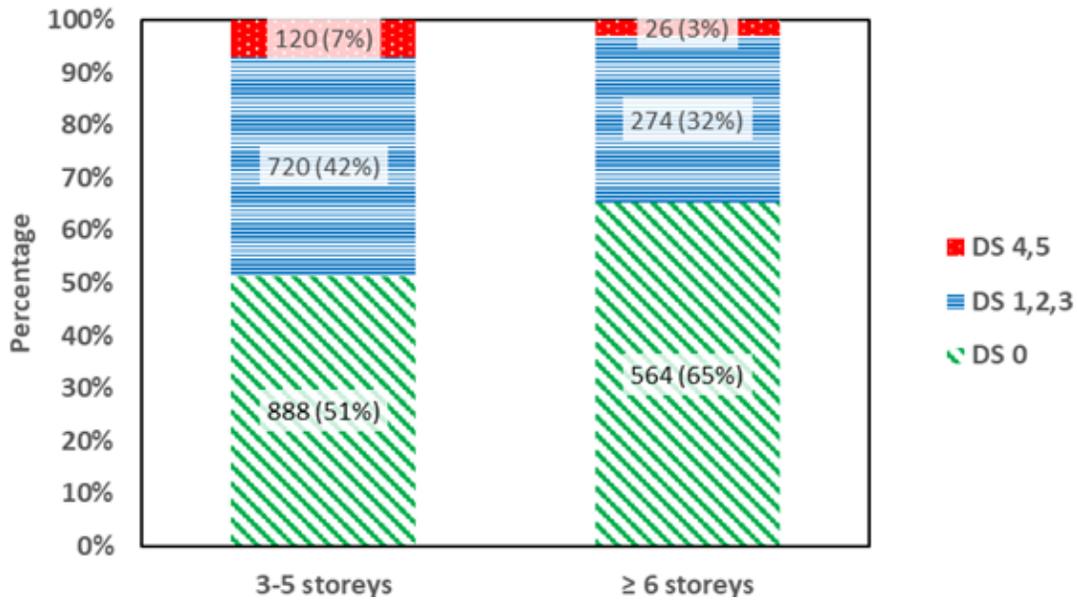
Figure 5 presents the estimated number of RC buildings categorized in different damage states following the 26 November 2019 earthquake. Out of 1,728 buildings with 3-5 storeys in Durrës municipality, 120 buildings (i.e. 7%) suffered severe damage or collapse (DS4/5), 720 buildings (i.e., 42%) experienced minor to moderate damage (DS1,2,3), while the remaining 888 buildings (i.e., 51%) remained undamaged. The results showed that taller buildings (6 storeys and higher) experienced less damage than 3-5 storey buildings. However, during field observations it was observed that the taller RC buildings (with 6 storeys or more) experienced significant non-structural damage. According to the results of the presented analysis for the buildings with 6 or more storeys, 26 buildings (i.e., 3%) were severely damaged or collapsed (DS4/5), 274 buildings (i.e., 32%) suffered

Estimated damage distribution for RC buildings in Durrës municipality

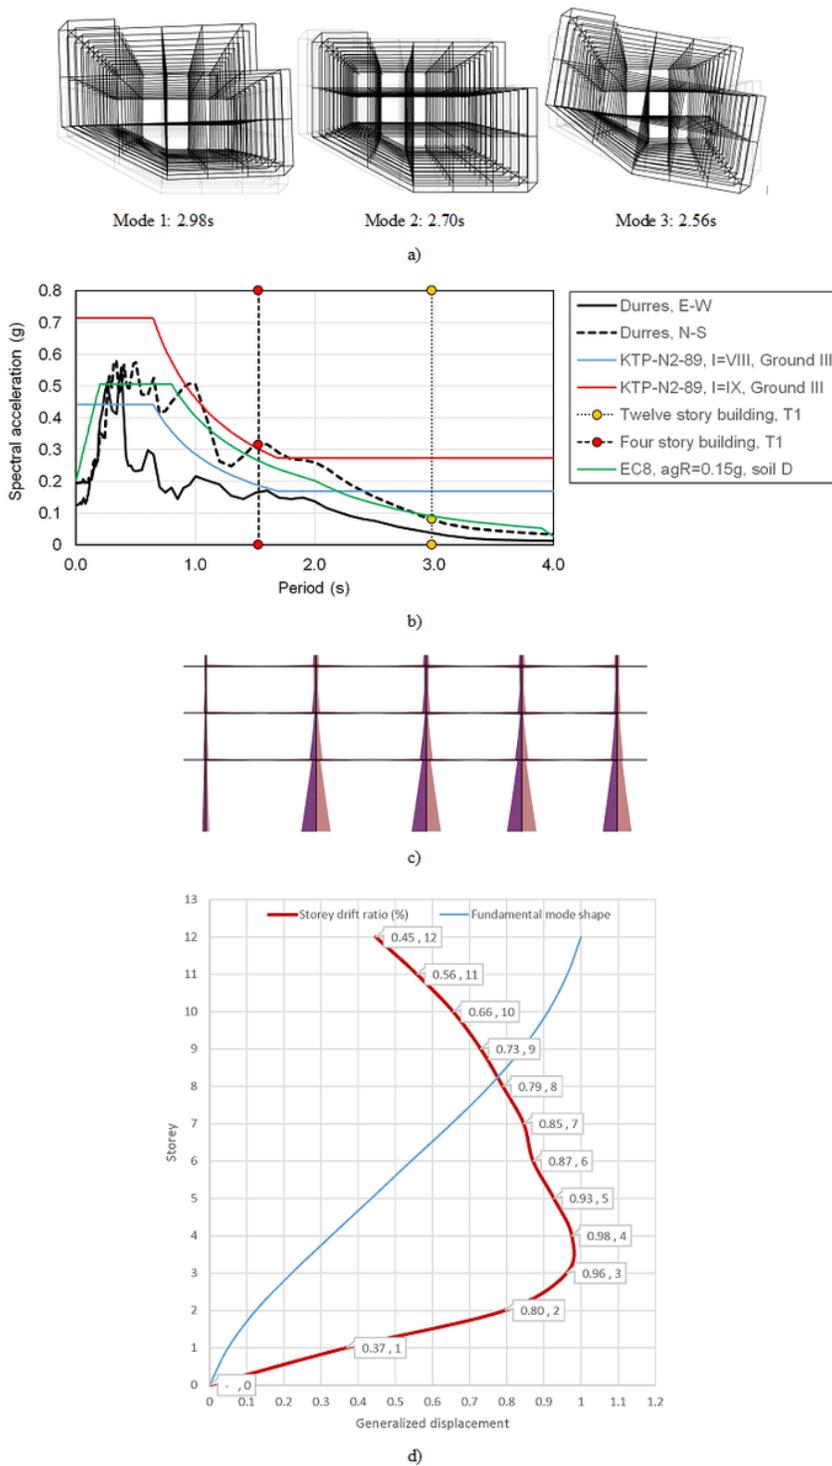
Figure 28

A 3-D linear elastic model of the building block was developed to study dynamic characteristics of the building. The first three mode shapes are shown in Fig. 28a). As expected, the structure is very flexible, with the fundamental period on the order of 3.0 sec. It is expected that the dynamic properties would be different - fundamental period would have been smaller if the numerical model had taken into account the effect of masonry infills. In addition, the model did not include the effect of soil – structure interaction, which could result in an increase in the fundamental period. The mode shapes are fairly regular - the first two modes are translational while the third one is torsional.

Eurocode 8 Type-1 elastic response spectrum with 5% damping and $a_{gR}=0.15g$ for soil type D (Fig. 28b) is used for response spectrum analysis. The same spectrum is used for both orthogonal directions ($\pm E_{Edx} \pm 0.3E_{Edy}$ and $\pm E_{Edy} \pm 0.3E_{Edx}$). CQC is used for modal combinations, taking into account 12 mode shapes, producing modal mass contribution of 95%. The mass of the structure is calculated based on the combination (100% permanent load + 30% variable load) and no stiffness reduction is used for the structural elements (although 50% of reduction is suggested in Eurocode 8). Note that the seismic parameters were not considered according to the codes, for example behaviour factor of 1.0 was assumed for analysis purposes. The results show that the distribution of bending moments in the columns (Fig. 28c) is not typical for moment frames, since the contraflexure point is not located near mid-storey height; instead, the distribution resembles the response of shear wall systems. This result can be explained by the effect of flexible beams. As a result, the system behaved like a flat slab structure without adequate lateral bracing in the form of shear walls. This trend can be also observed in Fig. 28d), since the shape for fundamental mode is similar to cantilevered members (such as shear walls). The roof displacements obtained from the analysis were in the range from 25 to 30 cm (corresponding to 0.7% total drift ratio), which are very close to the size of actual seismic gap. The inhabitants reported strong noise during the earthquake, which could be explained by pounding of building

Analysis of the linear elastic model for the 12-storey building: a) characteristic shapes for translational and torsional vibration modes, b) Eurocode 8 spectrum used for response spectrum analysis, c) bending moment diagram for the bottom 3 stories obtained from the response spectrum analysis, d) fundamental mode shape and interstorey drift ratios

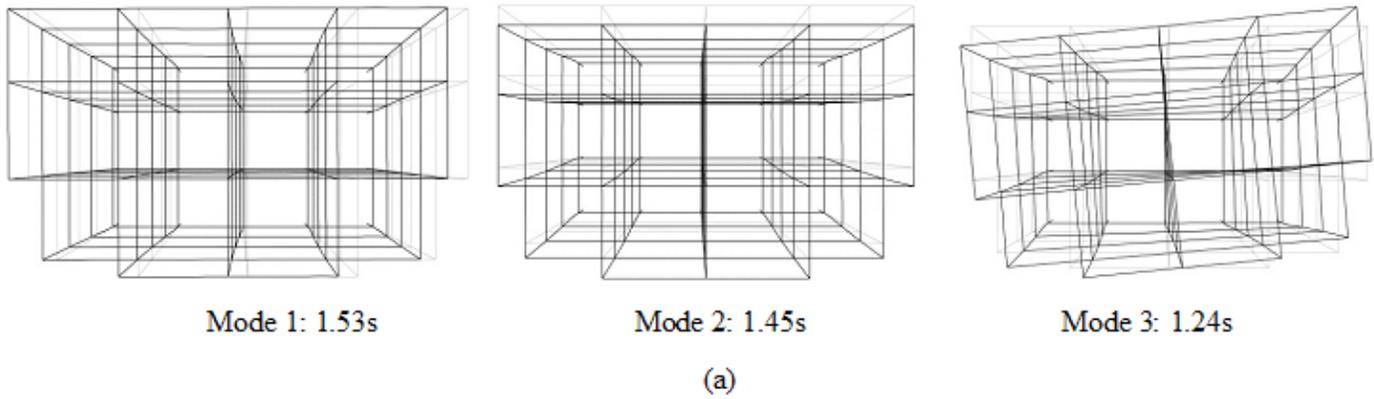
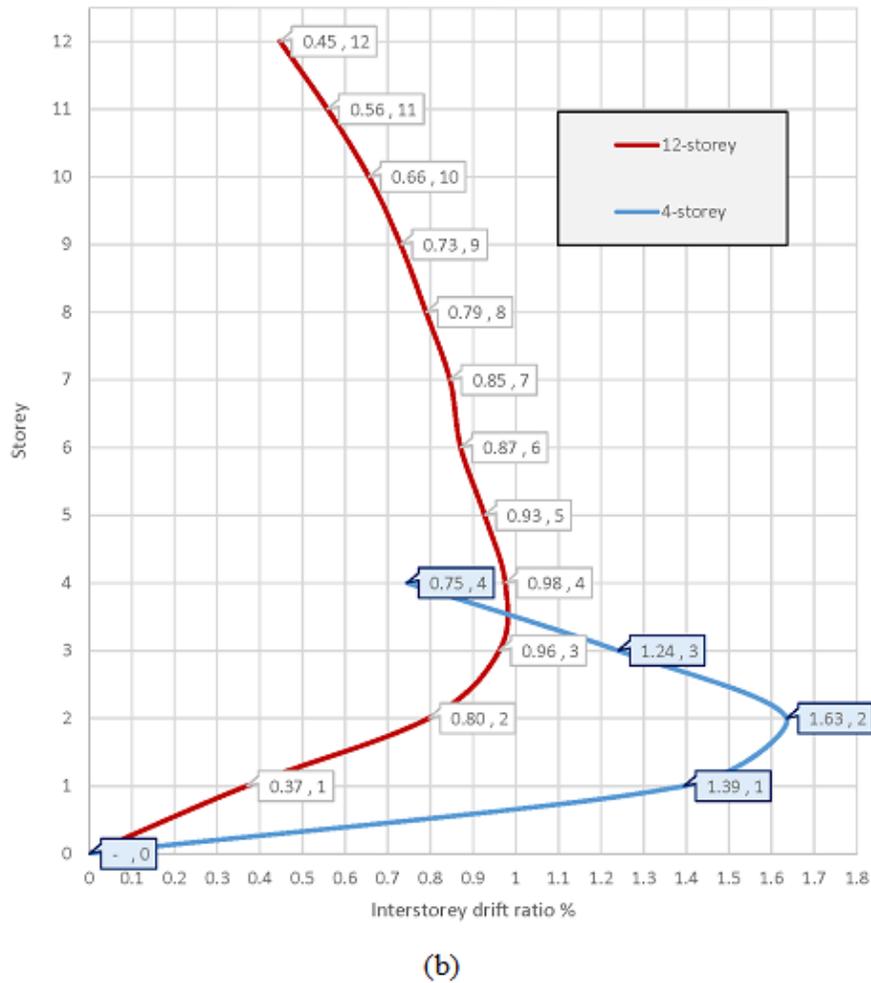
Figure 32

A linear elastic model was developed for this building based on the available data, neglecting the contribution of masonry infill walls and soil-structure interaction. Like in the case of 12-storey building, the response spectrum analysis was performed using the same input parameters (Fig. 28b). The results of modal analysis are shown in Fig. 32a. Even though the building has only four storeys, its fundamental period is quite high (approximately 1.5 seconds), which points out to a significant flexibility of this building. Maximum interstorey drift ratios obtained from the analysis are in excess of 1.5%, which is higher than the maximum drift of the 12-storey building (Fig. 32b). Besides very shallow RC floor beams, the columns were also characterized by a cross section which was smaller than or equal to 0.3 m × 0.3 m (see Table 2), which contributed to excessive flexibility of the structure. Based on the response spectrum for the Durrës station shown in Fig. 28b, fundamental period for this 4-storey structure ($T_1=1.53s$) is within the range of high spectral accelerations, which contributed to a higher seismic demand in comparison to the 12-storey building ($T_1=2.98s$).

Results of the response spectrum seismic analysis for the 4-storey case study building: a) characteristic shapes for translational and torsional vibration modes, and b) fundamental mode shape and interstorey drift ratios
