A Case Study of Two Failures of a High Cut-slope in the Northeastern Area of Sichuan, China

Abstract

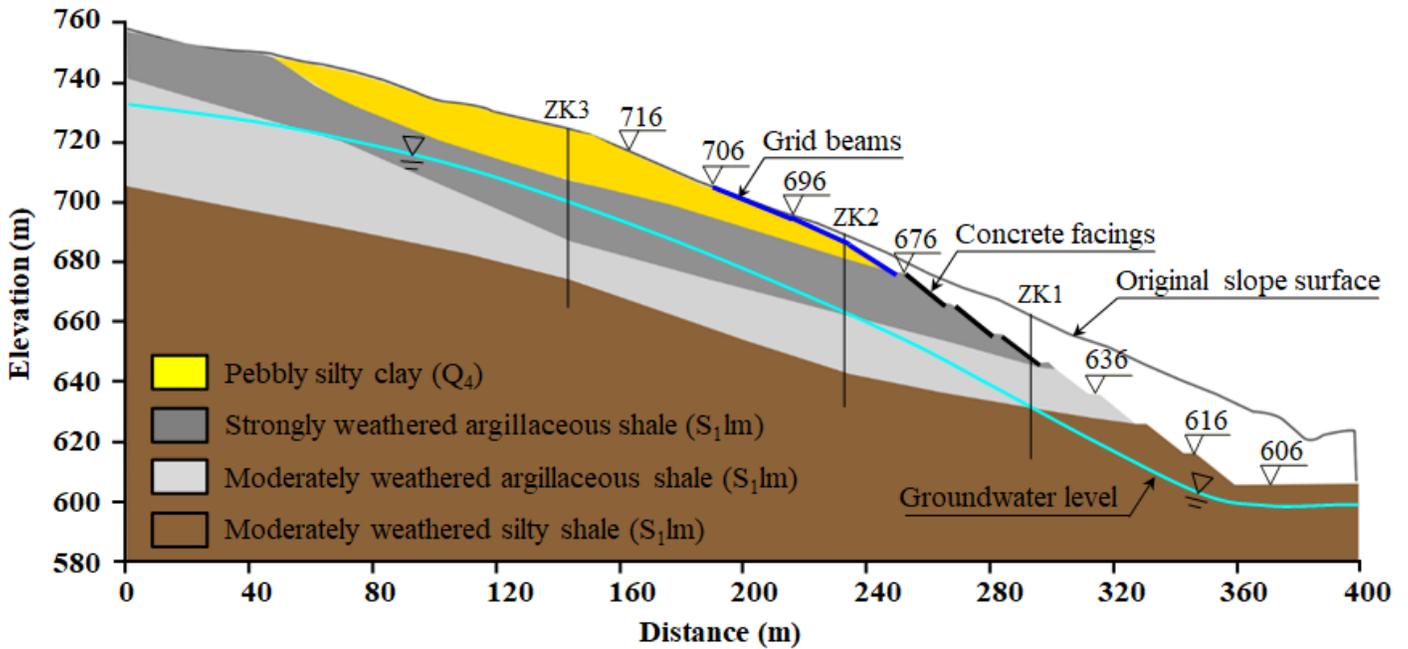
Figure 4

Typical ground profile of the excavated slope

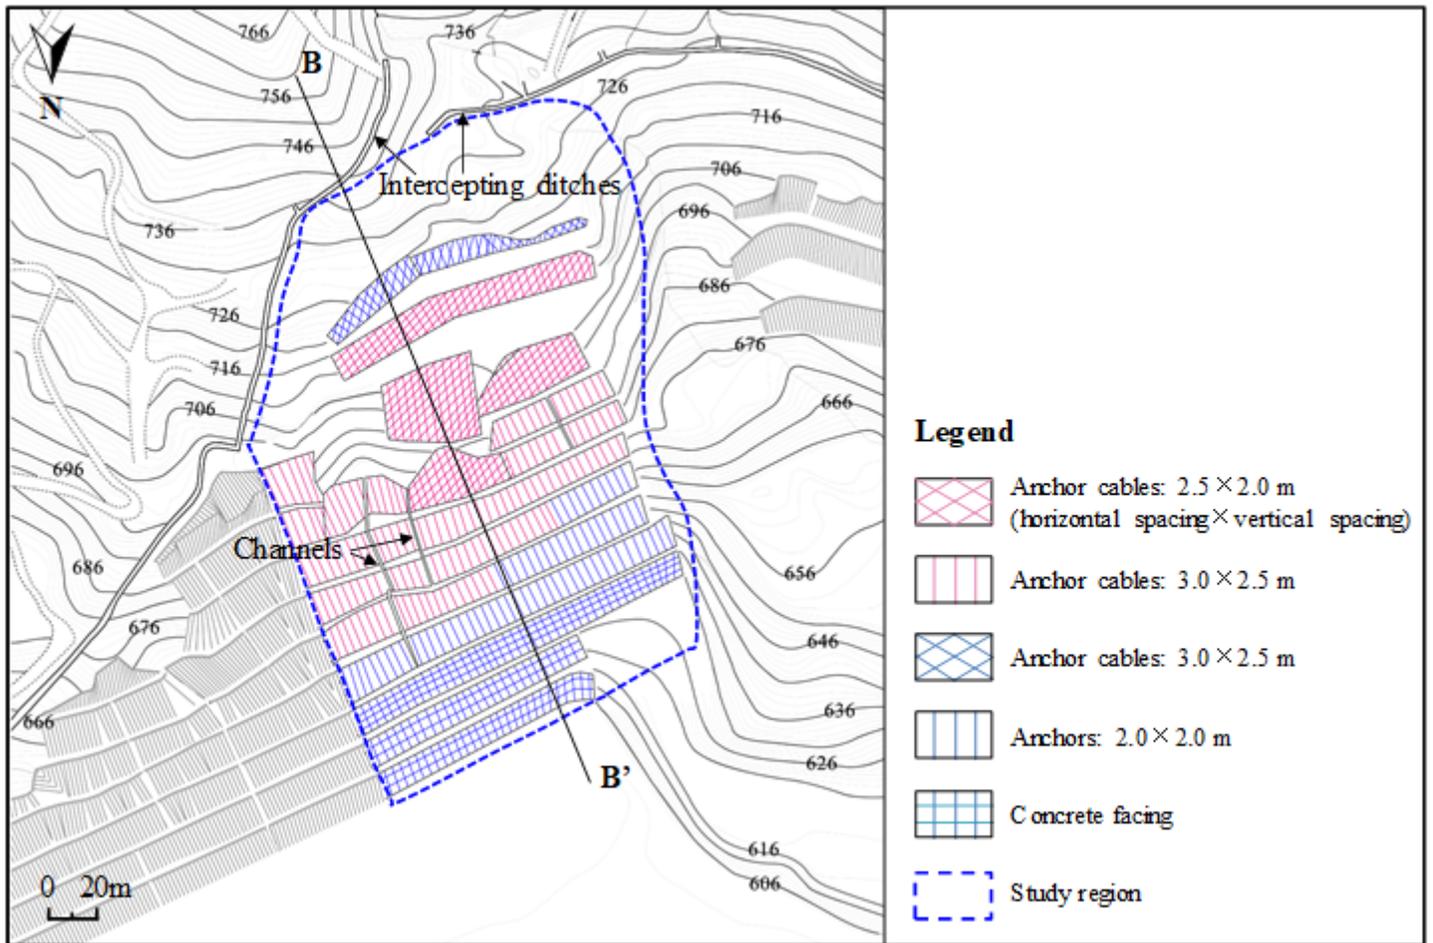
Figure 7

To avoid further sliding in the next rainy season, the slope at elevations between 636 m and 726 m was reinforced with fully-grouted anchors, anchor cables and grid beams. The material parameters listed in Table 1 were used in the original reinforcement design. The detailed plan view of reinforcement scheme of the failed slope is shown in Fig. 7. Firstly, excavations were performed at elevations of 706 m and 716 m to reduce the loading. Then anchor cables and grid beams were installed in the upper and middle sections of the slope and anchors were installed in the lower part of the slope. A detailed cross section of the reinforced slope can be seen in Fig. 10.

Plan view of the reinforced slope

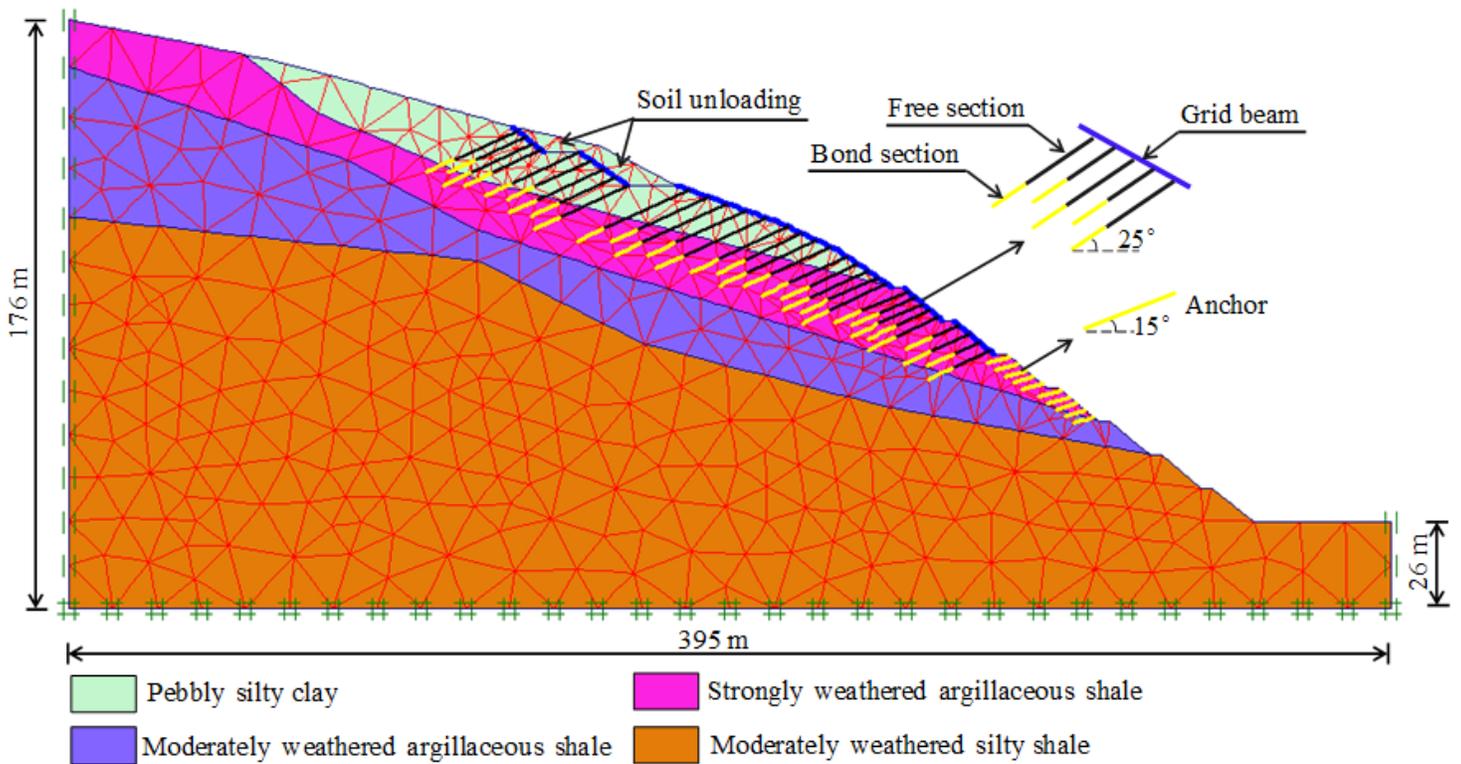
Figure 11

To investigate the failure mechanism and causes, the slope was analyzed using the two-dimensional finite element program, PLAXIS, Version 8.2. The cross section BB' shown in Fig. 10 was used to analyze the slope stability. The size of numerical model was 395 m in length and 176 m in height. The bottom boundary was fixed in both horizontal and vertical directions, and the side boundaries were fixed horizontally but free to move vertically. Fig. 11 presents the numerical model of the slope with the fully-grouted anchors, anchor cables and grid beams. The 15-node triangular element was used in the numerical model, which includes 860 elements and 7113 nodes, with very fine meshes. The initial stress field of the slope was obtained using the gravity loading procedure. Hydrostatic water condition was considered in the analyses.

Numerical model of the slope in PLAXIS

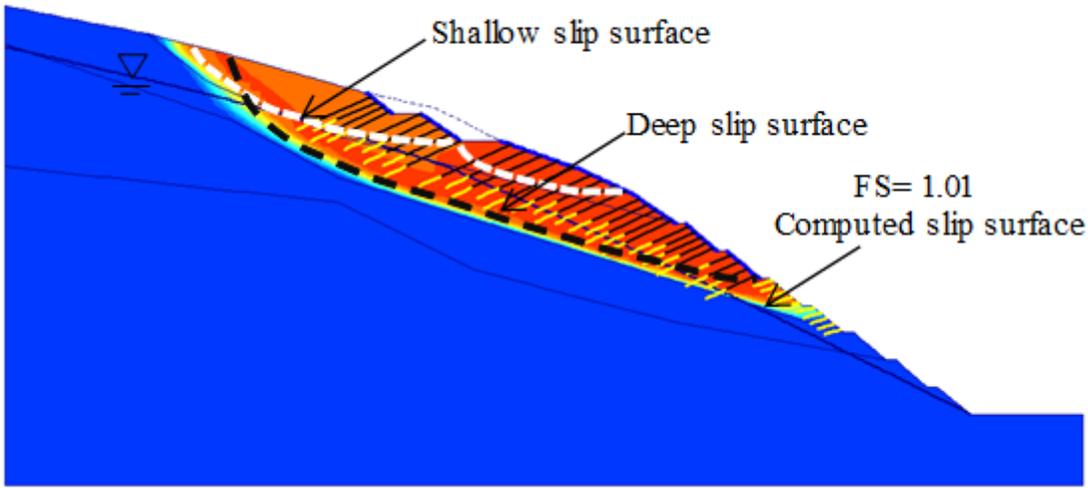
Figure 15

After the first failure, the remedial works were performed without proper understanding of the soil properties. The reduction of soil strength, especially strongly weathered argillaceous shale layer, and the two weak interlayers might not be appropriately recognized. The adoption of the soil shear strengths overestimated the stability of the reinforced slope. In fact, the natural drainage of ground water was blocked, possibly due to the first landslide and the application of shotcrete on the slope surface. Moreover, the drain holes were insufficient to completely dissipate the raised ground water during heavy rainfall. These could have caused the rapid rise of groundwater level within the slope, increased the weight of the sliding mass, and reduced the shear strength of materials along the potential sliding surface (Song and Cui, 2016). Therefore, the stability of the reinforced slope decreased significantly. In addition, the anchor cables were installed in the weak rock layer, and did not provide enough resisting forces to the slope under rainfall. These factors could have caused the second failure only few days after the remediation. The global failure of the slope, i.e. the deeper slip surface, resulted in the great loss of reinforcement effect of the anchor cables. The instability of the lower sliding mass could trigger the movement of upper section of the slope (Song and Cui, 2016), i.e., another two shallow sliding bodies shown in Fig. 10. Since once loosened, unlike the fully grouted anchors, the anchor cables can not provide any resistance for overall stability of the slope.

Total displacement increment contour of the reinforced slope at critical state considering the softening of soils in the top two layers
