# Mechanical wear analysis helps understand a mechanism of failure in retrieved magnetically controlled growing rods: a retrieval study

## Research article

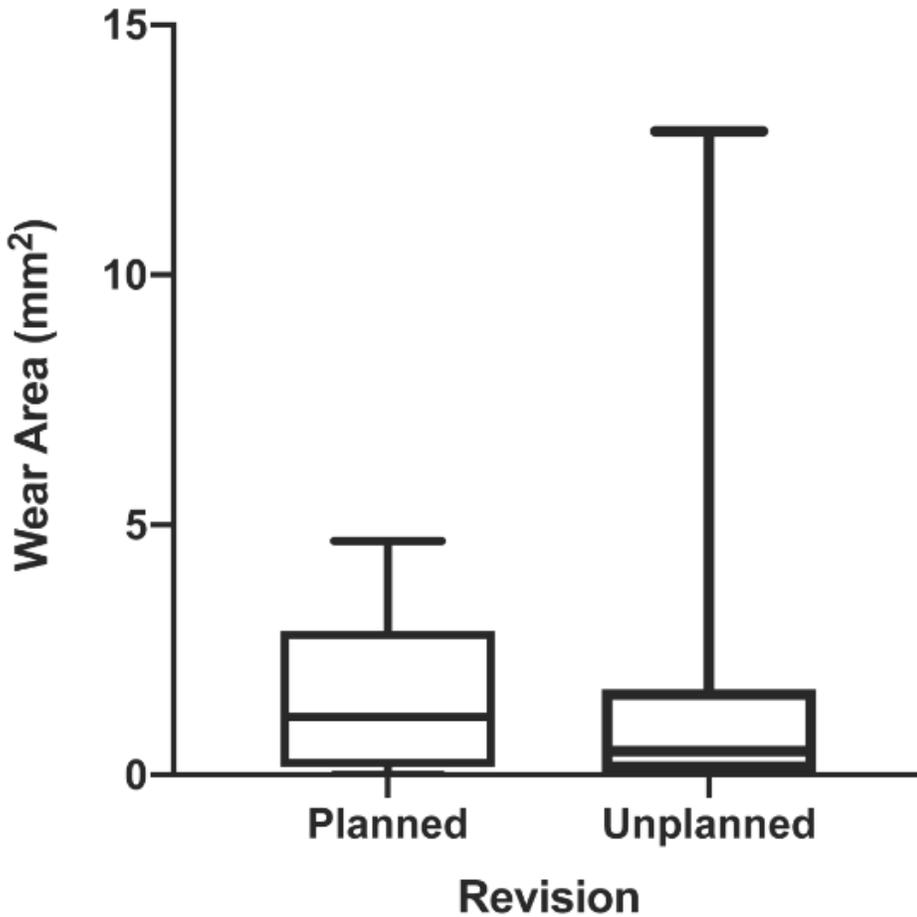
Figure 2

The rods of planned revisions were found with increased wear area ( $\text{mm}^2$ ), i.e. 1.158 (0.162-2.878), compared with 0.473 (0.056-1.711) for the rods of unplanned revisions (Fig. 10), although the difference was not significant ( $p > 0.05$ ). No significant difference was found in the material loss between different reasons for unplanned revision ( $p > 0.05$ ). No significant relationship was found between the three material loss values and the gender and age at implantation of patients ( $p > 0.05$ ).

Box and Whiskers plot presenting the difference in wear area between retrieved MAGEC rods from planned and unplanned revisions ( $p > 0.05$ )

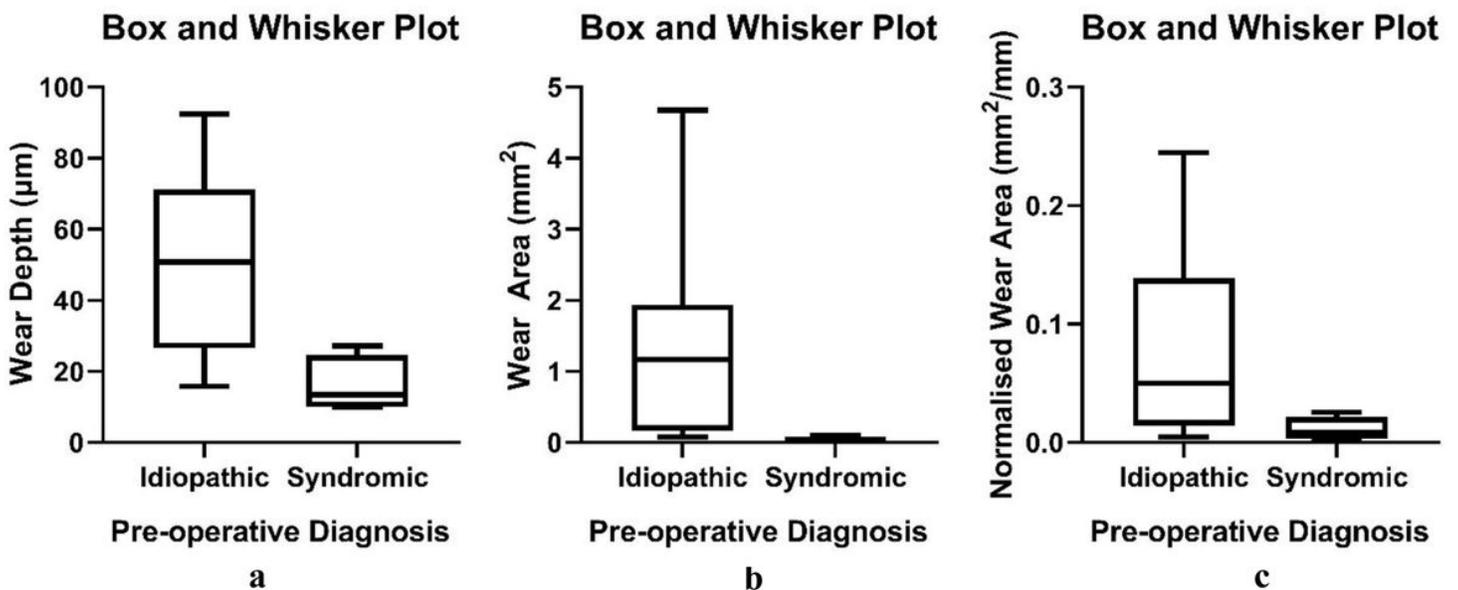
Figure 3

Kruskal-Wallis test showed a significant difference in the wear area between different pre-operative diagnosis groups ( $p < 0.05$ ), although no significant difference was found in wear depth and normalised wear area between these groups ( $p > 0.05$ ). By comparing material loss between any two diagnosis groups, the idiopathic scoliosis group was found to have significantly higher medians (INQ) of the three material loss values ( $p < 0.05$ ) (Fig. 9), i.e. 50.8 (26.6-71.2), 1.167 (0.166-1.939) and 0.050 (0.014-0.139), compared with 13.5 (9.9-24.6), 0.043 (0.012-0.087) and 0.009 (0.004-0.021) for the syndromic scoliosis group.

Box and Whiskers plot presenting the significant difference in wear depth (a), wear area (b) and normalised wear area (c) between retrieved MAGEC rods from patients diagnosed with idiopathic and syndromic scoliosis before the surgeries ( $p < 0.05$ )

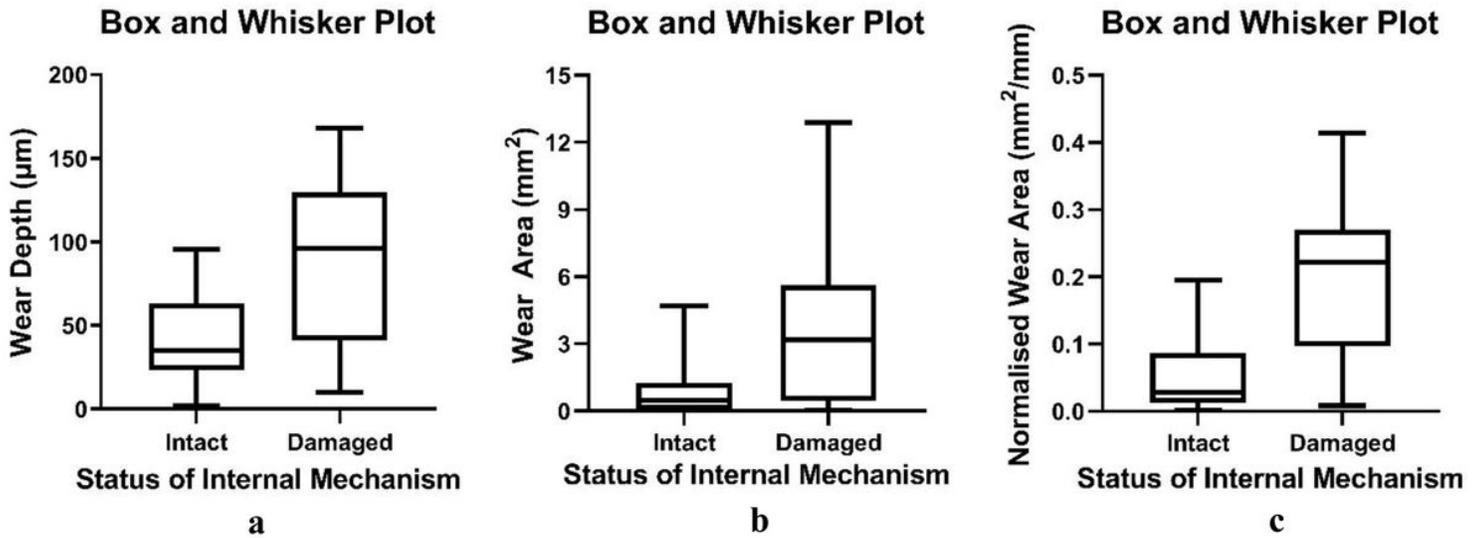
Figure 4

Mann-Whitney test found a significant difference in the three material loss values between rods with intact and damaged internal mechanism ( $p < 0.05$ ) (Fig. 8). For the damaged group, the medians (INQ) of these three values were 95.9 (40.9-129.5), 3.171 (0.450-5.621) and 0.222 (0.096-0.270), higher than that of the intact group, i.e. 34.8 (23.2-63.0), 0.473 (0.074-1.246) and 0.029 (0.013-0.087). No significant difference was found in these three values between rods with different types of damages in the internal mechanism ( $p > 0.05$ ).

Box and Whiskers plot presenting the significant difference in wear depth (a), wear area (b) and normalised wear area (c) between retrieved MAGEC rods with intact and damaged internal mechanism ( $p < 0.05$ )
