# The *Samuel F. B. Morse* Statue in Central Park: Toward a Sustainable Regime of Science-Based Monuments Conservation

## Research article

**Keywords:** outdoor sculpture, laser cleaning, conservation, 19th century, coating, gunmetal, corrosion

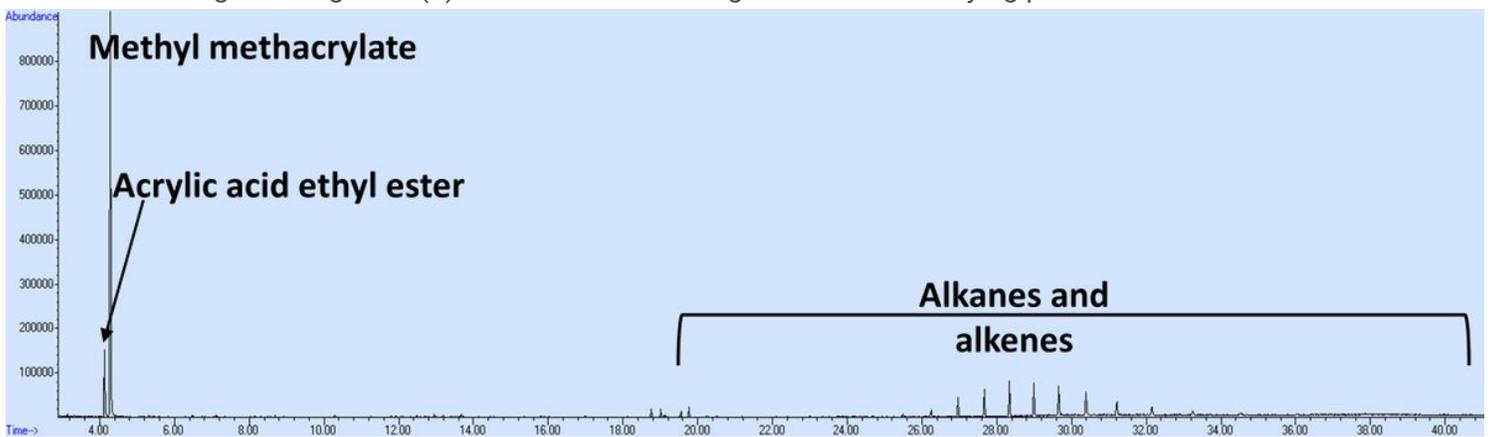
**Figure 4**

The organic coating was investigated to determine its constituent materials and the possible presence of pigments. In order to do so, a sample (S3) was removed from an area of the sculpture underneath the telegraph, below the figure's proper left thumb, and analyzed by Py-GC/MS. All chromatograms obtained with and without TMAH derivatization appeared to contain series of alkanes organized in a specific distribution that is characteristic of mineral waxes (Fig. 4). From a conservation perspective, mineral waxes are known for having a limited lifetime, ranging from 2 to 5 years, and for being reversible [16]. Besides, they are easily cleaned with water, which makes them suitable for a low cost and low maintenance application. However, the sample examined was found to contain also high relative amounts of acrylics, mostly methyl methacrylate and acrylic acid ethyl ester. The presence of these compounds is consistent with the use of Incralac® [17], which is, in fact, a product commonly used in the past and reported to have been applied to the Morse statue in the early 1990s according to the available conservation records. Acrylic coatings have a longer lifetime compared to mineral waxes, and they also show good reversibility properties [16]. Acrylic lacquers are coupled with a sacrificial wax topcoat that is renewed yearly in the case of Morse. Since 2003, two types of wax topcoats have been used by CPC's conservators: 1) Boston Polish™, also known as "butchers" paste wax, a carnauba-based wax, in use from 2003 to 2006; 2) Renaissance microcrystalline wax™, a mixture of Cosmoloid H80 and BASF A wax [18–19], used from 2007 to date for protecting outdoor bronze sculptures in Central Park.

Py-GC/MS chromatogram of sample S3 (organic coatings). Py-GC/MS chromatogram obtained upon derivatization with TMAH of sample S3, i.e. a scraping of the organic coatings. Compounds identified in the chromatogram indicate the presence of mineral wax and acrylics.
