Monitoring and Stability Evaluation of the Damaged Landslide Based on Multiple Monitoring Technologies

Research Article

Keywords: Damaged landslide, Emergency monitoring, Rainfall, Failure mechanism, Thermal infrared temperature

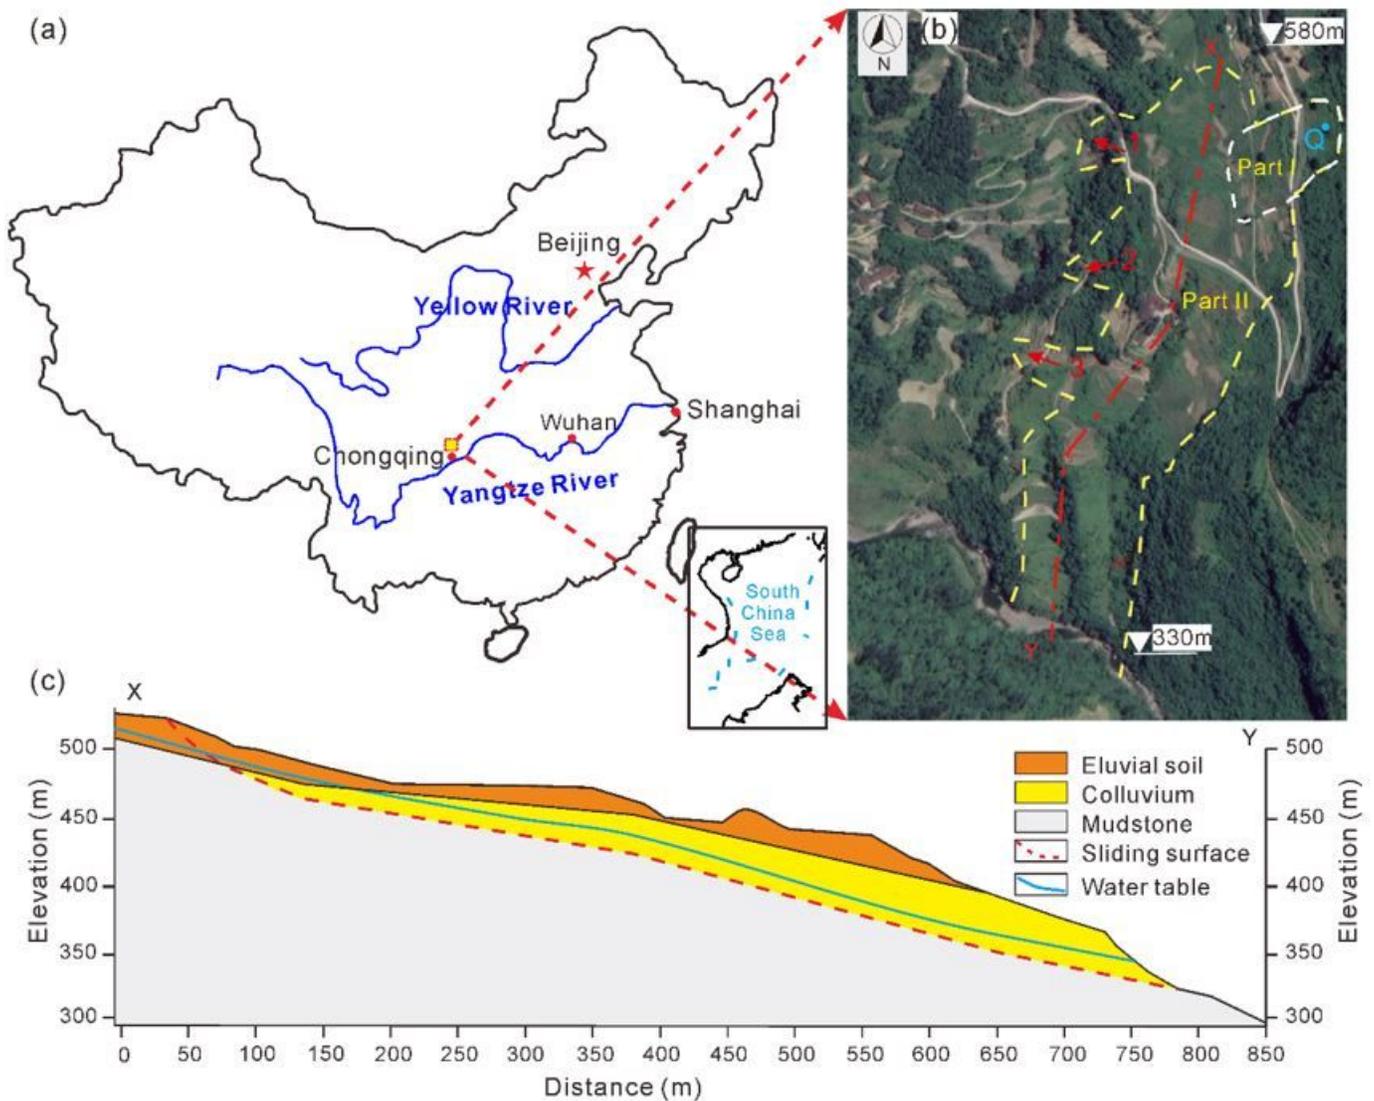
Figure 1

The Zhongbao landslide is located at the north side of the Yancang river, about 59 kilometers to the Wulong District, Chongqing, China (Fig.1 a). In plane view, the shape of the Zhongbao landslide approximately likes a tongue, with 850 m length and 200 m width (Fig.1 b). The thickness of the landslide is estimated 25m -47 m, and its' volume is approximately $4.6 \times 10^6 \text{ m}^3$ (Fig.1 c). The slope of the landslide surface is 25° - 45° . The main sliding direction is 210° , approximately perpendicular to Yancang River. The Zhongbao landslide began to slide at 16 p.m. July 23, 2020, and destroyed three buildings and main roads. Over $1.0 \times 10^4 \text{ m}^3$ soil and rock masses slipped into the river and formed a barrier lake.

Zhongbao landslide: a) location of the landslide, b) plane view and c) vertical profile after landslide failure Note: The designations employed and the presentation of the material on this map do not imply the expression of any opinion whatsoever on the part of Research Square concerning the legal status of

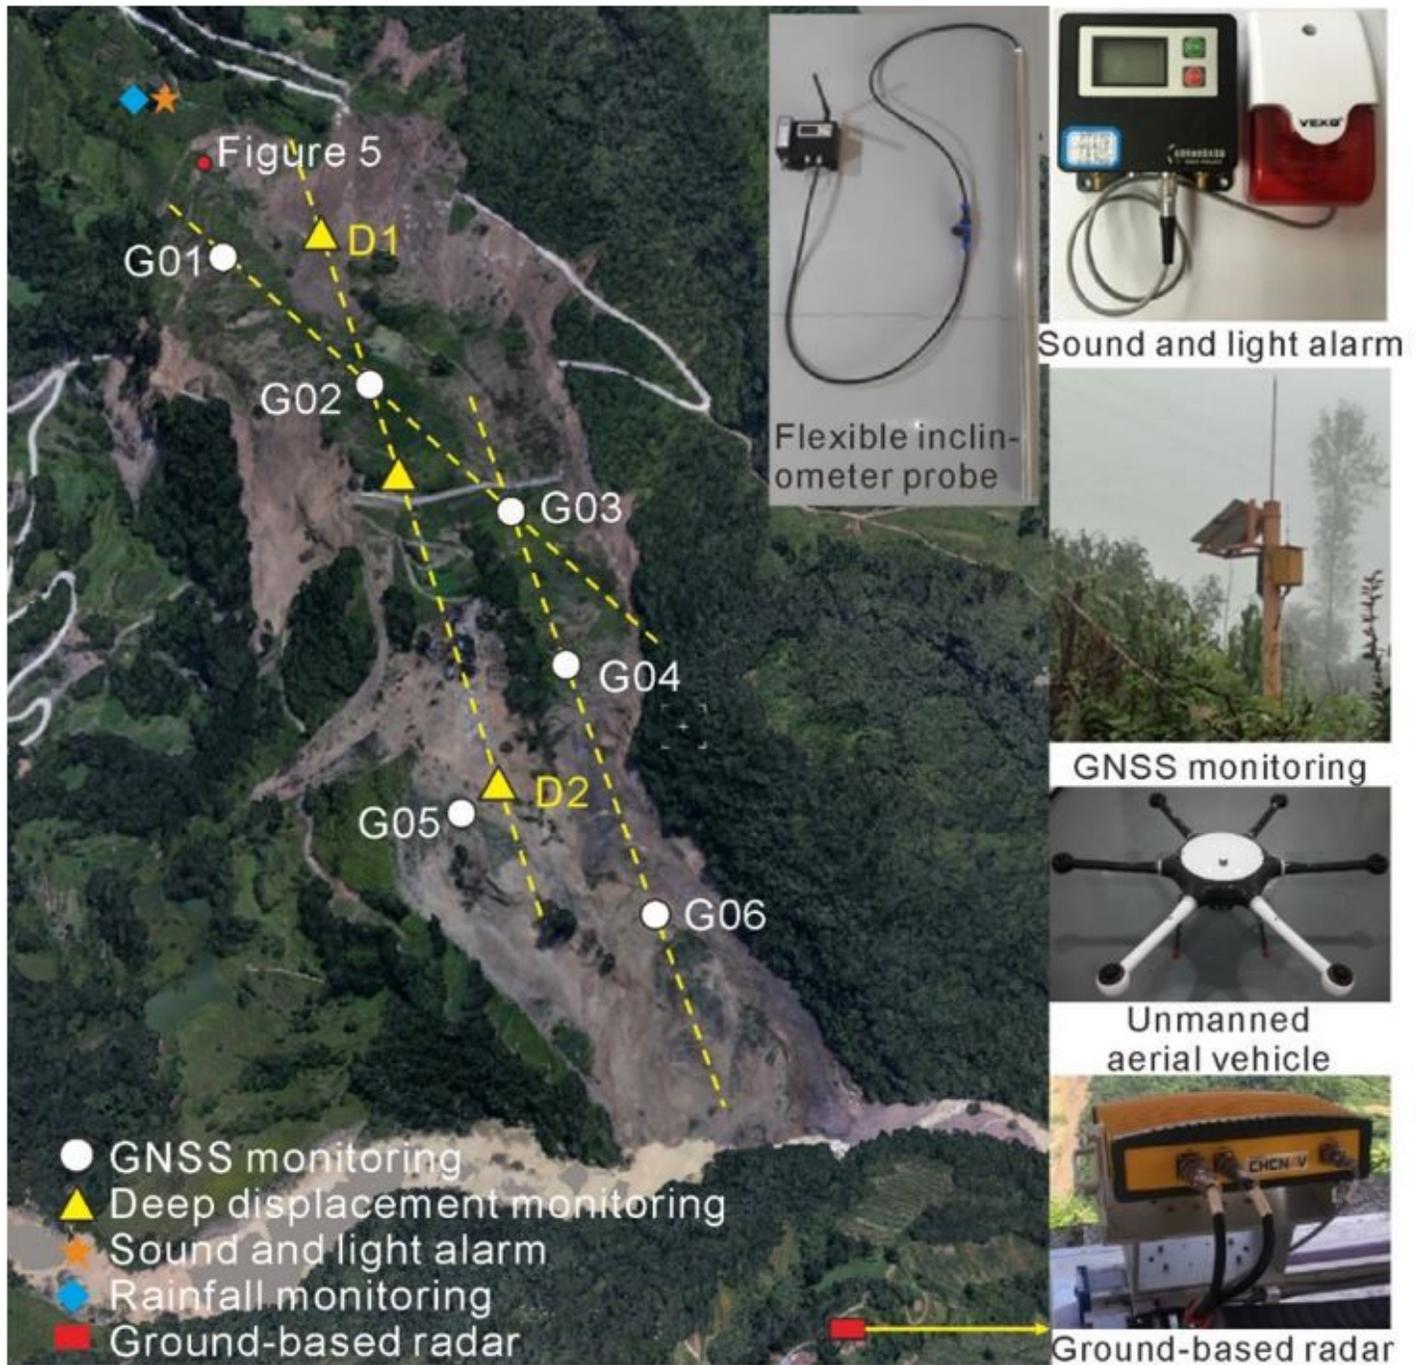
Figure 3

After landslide failure, emergency work and stability evaluation of the reactivated deposits are necessary, but conventional monitoring technologies are not equipped in monitoring the damaged landslide, because of the instability of the landslide. Therefore, some new methods are taken to monitor the deformation of the landslide(Figure 3):

An emergency monitoring was started from July 27 to Aug 2. Ground-based radar was 2.8 km away from the landslide (Fig. 3). The surface deformation of the landslide was scanned from July 27 to October 2. Unfortunately, the monitoring is un-continuous due to the power issues and the change of the device location. Therefore, two periods are selected to analysis the deformation characteristics of the failure landslide.

Monitoring system of the failure landslide and photographs of the devices Note: The designations employed and the presentation of the material on this map do not imply the expression of any opinion whatsoever on the part of Research Square concerning the legal status of any country, territory, city or area or of its authorities, or concerning the delimitation of its frontiers or boundaries. This map has been provided by the authors.
