Seismic Performance of Strengthened Masonry Structures: Actual Behaviour of Buildings in Norcia and Campi Alto During the 2016 Central Italy Seismic Sequence

Research Article

Keywords: post-earthquake damage, usability, strengthening interventions, masonry buildings.

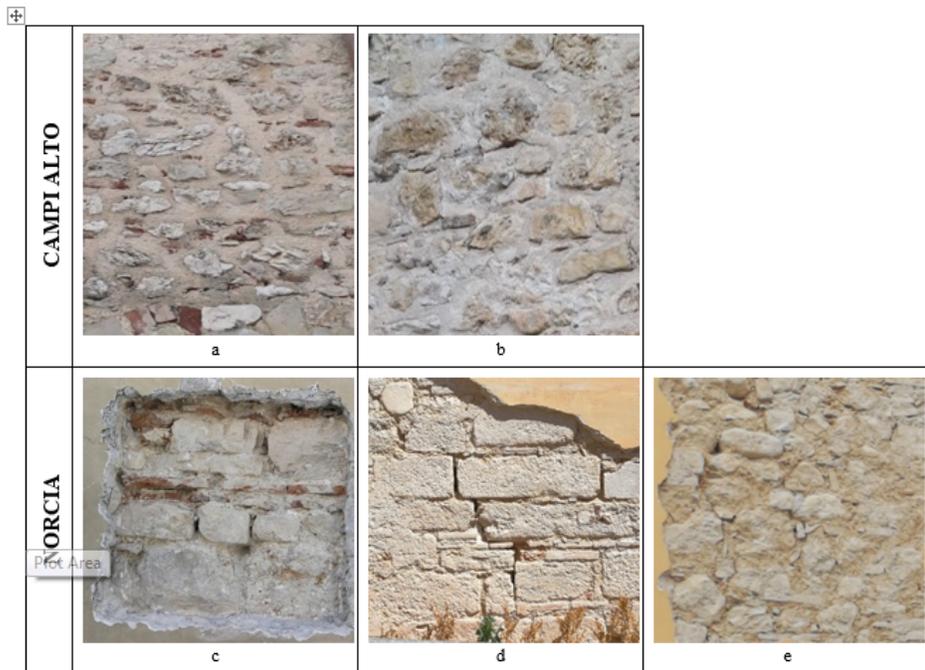
Figure 9
 Page 12/17

The majority of MSUs (65% and 60% for Campi Alto and Norcia, respectively) has been built before 1982 and strengthened after this date. However, there are no MSUs dated after 1982 in the sample related to Campi Alto. Thus, only few MSUs in Campi Alto (6%) have regular layout/good quality masonry, while 55% show irregular layout/bad quality masonry and 29% is characterised by both types of masonry (namely "mixed"). By contrast, the quality of masonry of MSUs in Norcia is evenly spread in the sample: regular layout/good quality masonry (27%), mixed (34%) and irregular layout/bad quality masonry (38%). Fig. 9 reports a comparison between Campi Alto and Norcia typical masonry types. The masonry of buildings in Campi Alto generally consists of rough stone elements (generally limestone, conglomerates, or travertine). It is commonly strongly irregular, and it is rarely possible to recognise the presence of horizontal bed joints (Fig. 9a,b). Furthermore, in several cases the masonry is made by disconnected layers, small elements and powdery mortar with lack of any cohesiveness. By contrast, the masonry of buildings in Norcia is mainly characterized by worked stone elements placed in a regular way (Fig. 9c,d). However, in some cases also in Norcia irregular masonry can be found as depicted in Fig. 9e. Furthermore, buildings of Norcia are commonly plastered.

Comparison between masonry types observed in Campi Alto (a, b) and in the historic center of Norcia (c, d, e).

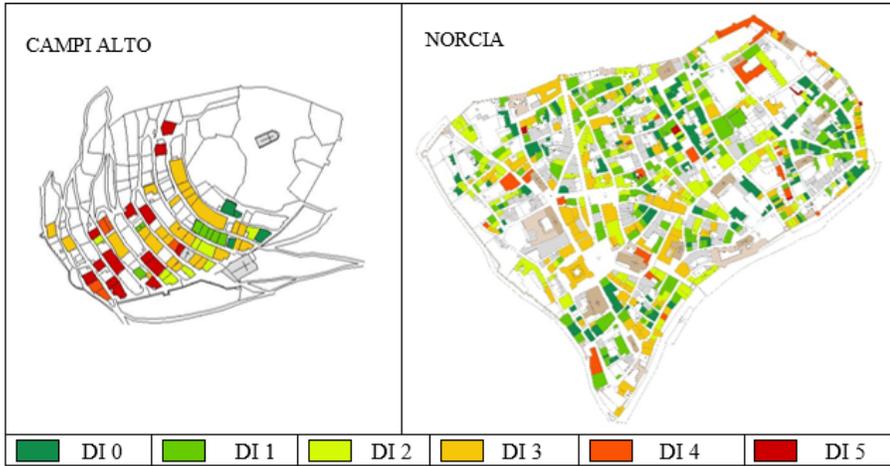
Figure 11

to Norcia: a DI lower or equal to 2 was detected on 78% of MSUs in Norcia against 26% in Campi Alto. Furthermore, in Campi Alto 29% of MSUs resulted affected by local or global collapse, DI 5. The plan distribution of DI in Campi Alto and Norcia is reported in Fig. 11 while Fig. 12 reports the cumulative percentages of MSUs with a DI lower than a fixed value. In particular, the trends are plotted with reference to MSUs built after 1982 ($C > 1982$) or before such year ($C < 1982$) but renovated before or after 1982 ($R < 1982$; $R > 1982$) or unreinforced (UR). It is noticeable that in Campi Alto 80% of the MSUs renovated after 1982 has a damage index lower than or equal to 3 (usually only local damage), while those renovated before 1982 reach the 50% mark. All the unreinforced MSUs had a damage index equal to 5.

Maps of Campi Alto and the historical centre of Norcia: identification of the damage index rating of residential buildings. Note: The designations employed and the presentation of the material on this map do not imply the expression of any opinion whatsoever on the part of Research Square concerning the legal status of any country, territory, city or area or of its authorities, or concerning the delimitation of its frontiers or boundaries. This map has been provided by the authors.

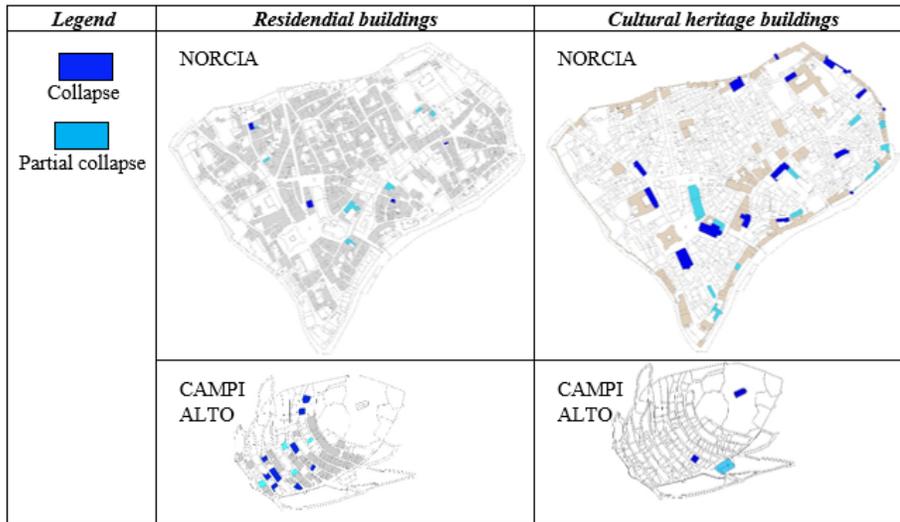
Figure 13

Furthermore, according to AeDES forms and *in situ* inspections specifically carried out by the authors resulted that in Campi Alto 13 MSUs collapsed (i.e. 9 full collapse and 4 partial collapse, see Fig. 13), corresponding to 26% of the entire built-up area. In particular, the full collapses affected 4 MSUs never consolidated, 4 renovated before 1982, and 1 renovated after 1982 while 4 partial collapses affected MSUs renovated after 1982. Fig. 13 also shows the three collapses that affected cultural heritage buildings inside the walls of Campi Alto: Santa Maria della Neve's church, Sant'Andrea's church and Madonna di Piazza's church; the latter two were examined in Penna et al. 2019. In Norcia, only 4 MSUs collapsed and 7 partially collapsed corresponding to about 2% of the dataset. However, the damage on cultural heritage buildings was diffused and severe also in Norcia as demonstrated by the collapse of several churches and heritage buildings inside the city walls.

Maps of Campi Alto and the historical centre of Norcia: identification of total and partial collapses in residential and cultural heritage buildings Note: The designations employed and the presentation of the material on this map do not imply the expression of any opinion whatsoever on the part of Research Square concerning the legal status of any country, territory, city or area or of its authorities, or concerning the delimitation of its frontiers or boundaries. This map has been provided by the authors.

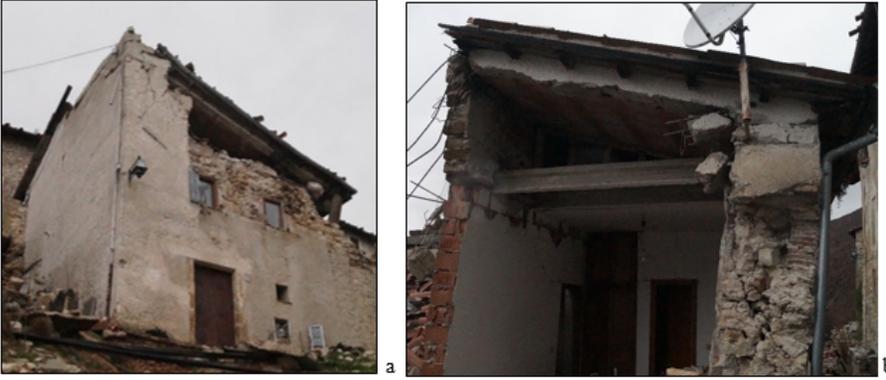
Figure 22

Severe damage after the 2016 sequence was also observed in case of MSUs strengthened by using a very heavy and rigid roof on a bad quality walls which were not adequately reinforced by extensive use of G.I. and R.P. as originally designed, (e.g. MSU of project 11, see Annex A and Fig. 22).

Project 11: collapse of poor quality masonry walls due to the presence of heavy roof: (a) downstream façade; (b) lateral section
