Architectural Ruins: A geoheritage of the anatomy of buildings as illustrated by Casa Ippolito, Malta

Lino Bianco (✉ lino.bianco@um.edu.mt)

Research article

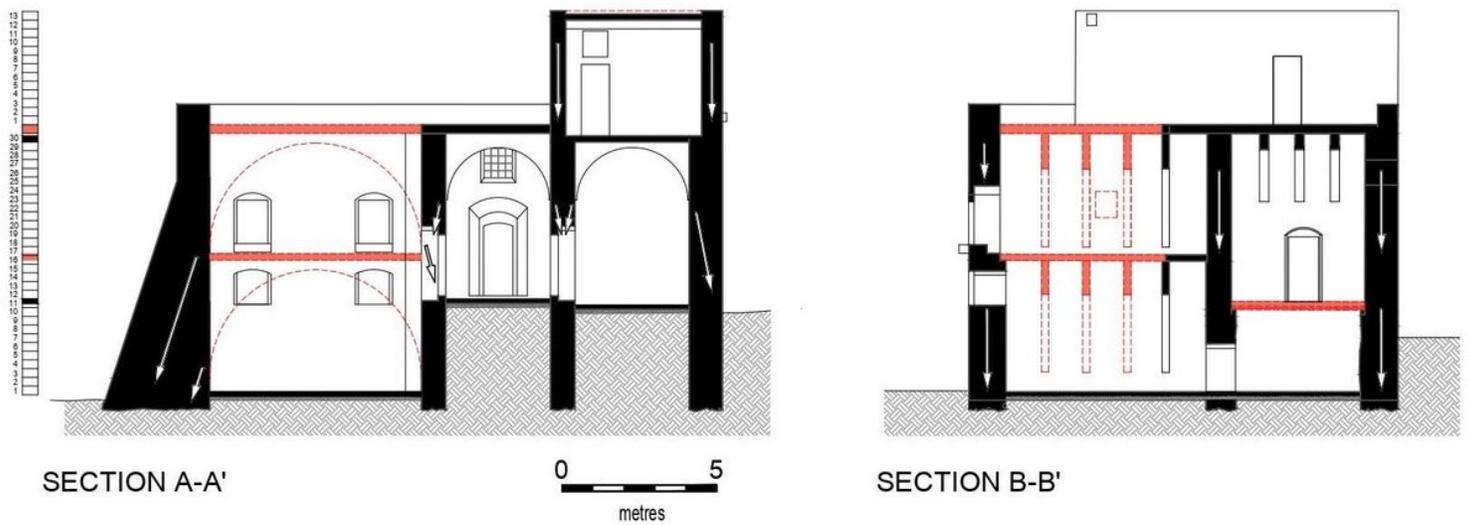
Figure 9

Characteristic of the geologic substratum, two soil types occur in the immediate vicinity of the Casa: Xaghra Series and L-Inglin Complex, overlying the MM and the LGL respectively [29]. Using the *Munsell Soil Colour Charts*, it was found that both types were utilized in the construction of double walls in Casa Ippolito, but the presence of the former – a semi-natural reddish brown clay soil which is distinct from the latter, which is anthropogenic [10] – is more frequent in the exposed sections. Unlike other heritage buildings, the internal walls were not single leaf. The external walls were designed to satisfy a significant structural engineering consideration: to accommodate the thrust of the masonry arches (Fig. 9). The thickness of the internal walls is 0.8m. Given that the second storey was roofed by horizontal timber beams which did not generate side thrust, the width of its external walls was less than those which form the room beneath. The construction of the buttress was not a military design. It was introduced to take the side thrust generated by the masonry ribs of the mill and the overlying room.

Section: The path of transfer of compressive stresses generated by the roofs are indicated by the direction of the arrows; for position of sections see Fig.5

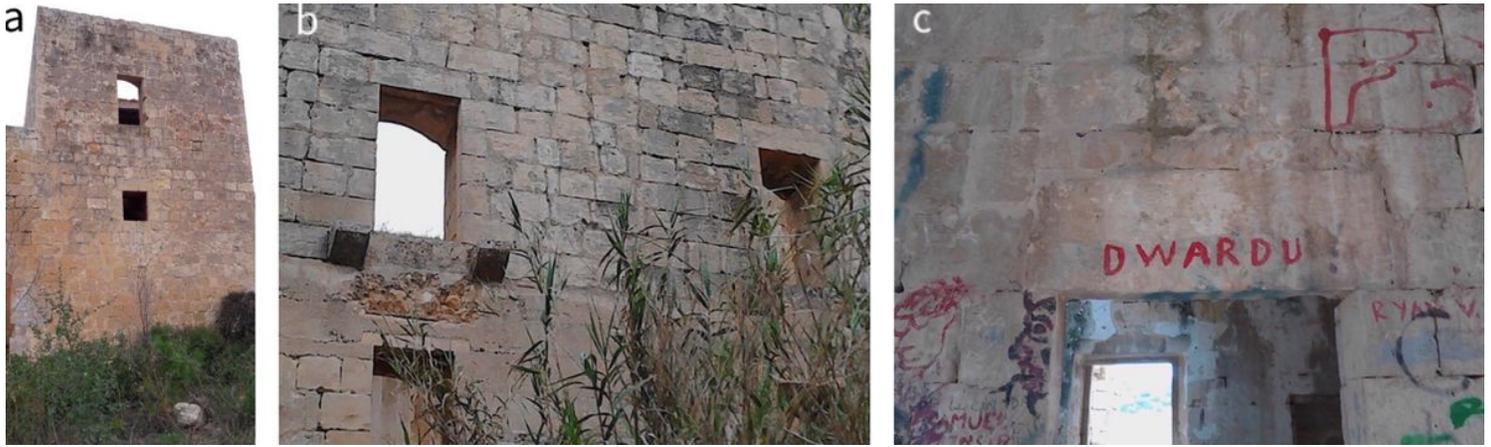
Figure 10

Spanning openings of apertures and roofs had been one of the biggest challenges in architecture. The spanning solutions for apertures in Malta’s traditional architecture are listed in Table 4. LGL can withstand compression but not tension; the rule of thumb was that a stone lintel could be loaded without failure in tension up to a 0.9m maximum span; any longer than this and a relieving arch would have had to be introduced (Fig. 10a). When such an arch was absent, “the stones directly above the lintel were often notched out so that they did not rest on the top corners of the lintel” [11: 198] (Fig. 10b). Another solution used at Casa Ippolito was to increase the depth of the lintel by 50% for a 0.9m span (Fig. 10c). Failures in masonry lintels for spans less than 0.9m occurred due to corrosion and the subsequent expansion of the iron grills, which causes typical cracking in stone masonry – lintels, jambs, etc. – when the inserted metal corrodes. For larger openings, masonry arches were used.

Masonry lintels: a the lintel loaded without failure in tension up to a span $\leq 0.9\text{m}$; otherwise a relieving arch was introduced, b the stone above the lintel was notched, c depth of lintel increased by 50% the height of a building course
