Keywords: Hygroscopic effect, Impact-resistance, Moisture content, Carbon fiber, Low-velocity impact

**Enhanced Impact-Resistance of Aeronautical Quasi-Isotropic Composite Plates Through
Diffused Water Molecules in Epoxy**

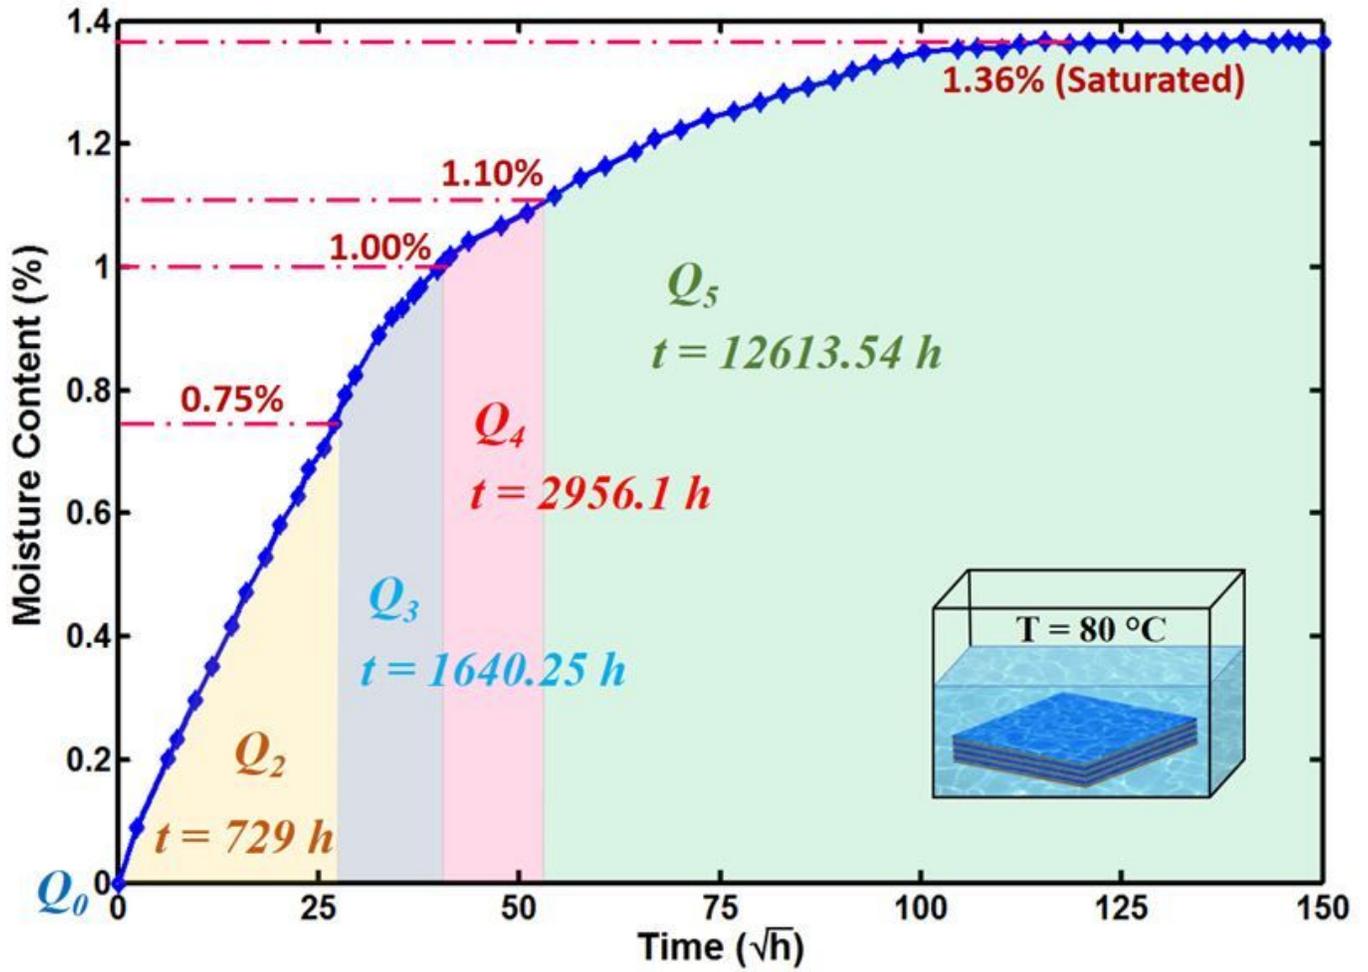
Figure 1

Water absorption behavior of quasi-isotropic composite plate at 80 °C.

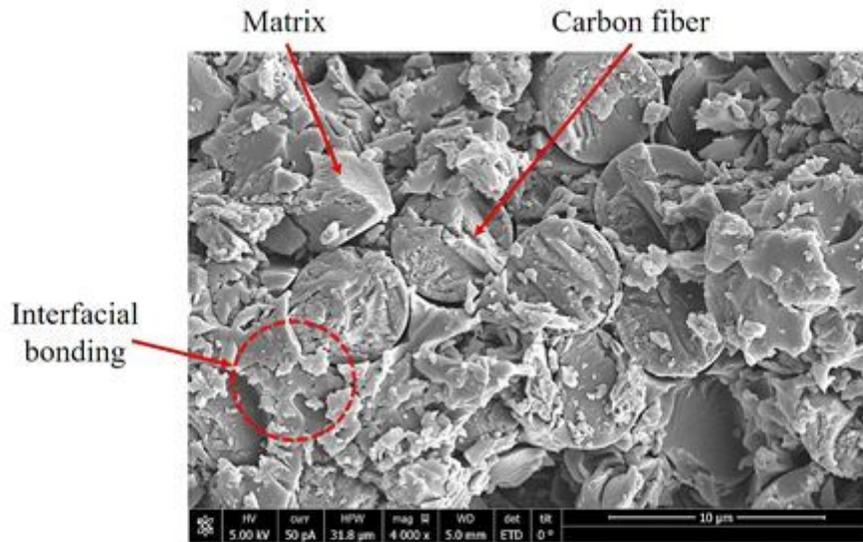
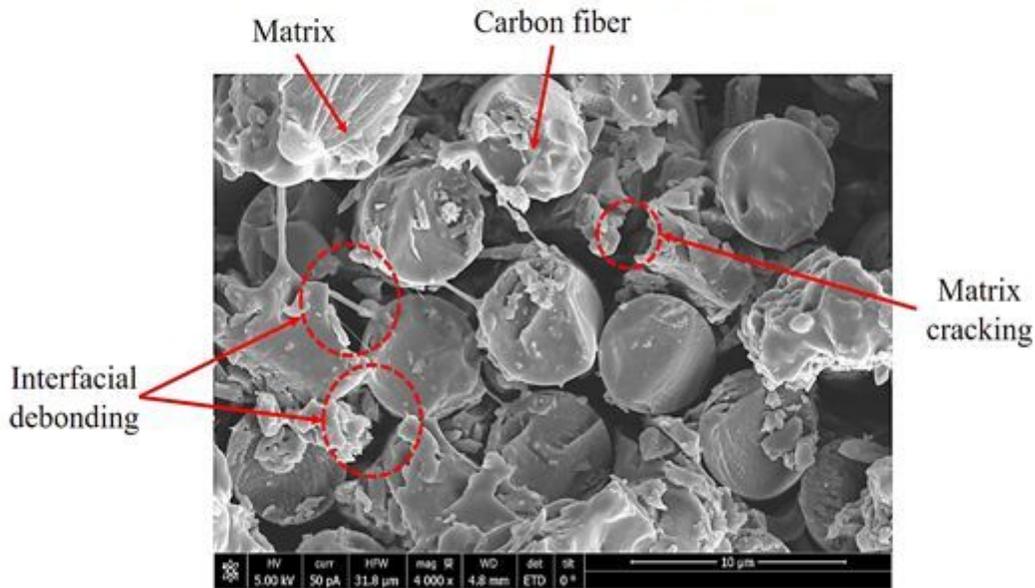
(a) Fractography of fully dry quasi-isotropic composite plate (Q_1).

(b) Fractography of fully saturated quasi-isotropic composite plate (Q_5).

SEM fractographies for (a) fully dry and (b) fully saturation quasi-isotropic composite plates.

matrix has a high moisture expansion coefficient and absorbs almost all of the water molecules. Due to absorbing water molecules, the epoxy matrix swelled up and caused interfacial debonding with the carbon fibers as shown in Figure 2 (b).

Based on the low-velocity impact test results, it can be concluded that the elastic deformation capacity of the composite plates was improved by absorbing the MC. From the SEM fractography (Figure 2) of fully dry (Q_1) and saturated (Q_5) composite plates, it was observed that absorbed MC had minimal effects on the carbon fibers and had some effect on the interfacial bond between fiber and matrix. Therefore, it can be postulated that absorbed MC affects the matrix resin and improve the elastic deformation capacity of composite plates.^{5,6} Compare to the water molecules, the molecules of the cured epoxy are large in size. That's why water molecules can diffuse into the epoxy resin network easily and reside in the vacancies between the chains of the epoxy molecules and cause an increase in the overall thickness of the composite plate and expansion of its volume. The covalent bond force between the small molecules are normally greater in magnitude (one to two times) compare to the Van der Waals force. Polymers molecules have long structural chains and greater in the number which characterized them huge molar mass structures. The inter-molecular force (Van der Waals force) of the long structural chain of the polymer molecule is comparatively high than the covalent bond force. Figure 10 shows the formation of the crosslinked polymers from reactants (epoxy and amine hardener). During the curing cycle, each amine group of the hardener molecule (Diethylenetriamine (DETA) or Meta Phenylene Diamine (MPDA) hardener) have two active atoms of the hydrogen which react with the epoxy (Diglycidyl Ether of Bisphenol A (DGEBA))

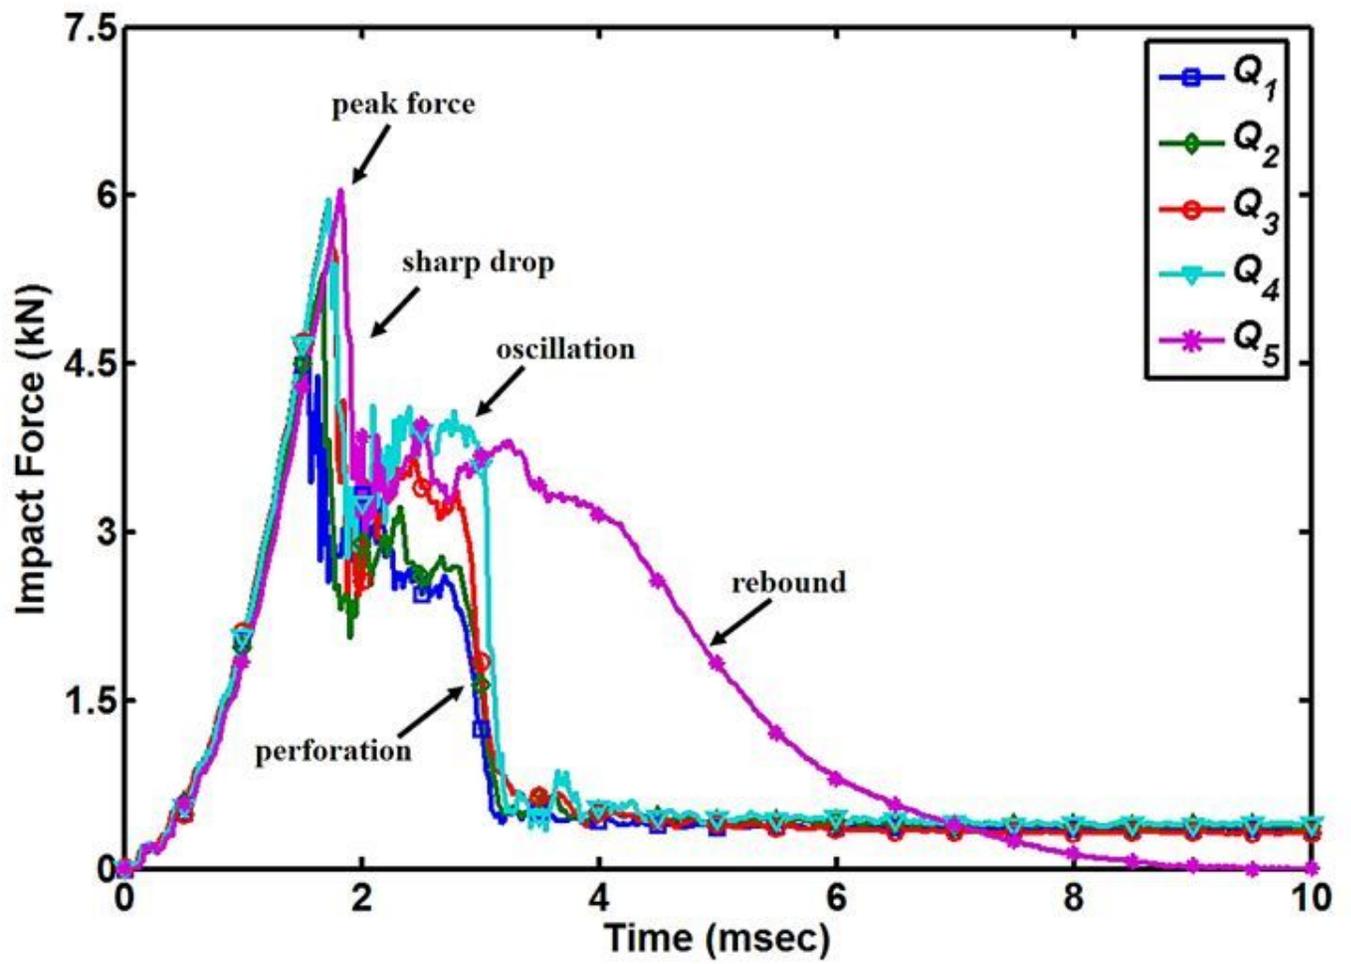
Figure 3

Impact force versus time diagram for all quasi-isotropic composite plates

As shown in Figure 3, time to reach the peak force point is a delay with the increase of MC and the occurrence of the first significant damage or a sharp drop in the time-force curves also delayed. This delay in the first significant damage can also be observed in Figure 6 which shows that damages in Q_5 composite plate started at the larger displacement of the impactor corresponding to higher strain level compare to Q_1 composite plate. This delay in the occurrence of the damages shows that the ductility of matrix resin improved due to the presence of MC. The improved ductility would benefit the laminate by hindering the initiation of inter-laminar cracks and matrix cracking but debonding and fiber breakage will not be delayed. Improved ductility of the matrix resin, increased the strain to first significant failure and hygroscopic conditioned quasi-isotropic composite plates preserved their structural integrity up to a large displacement of the impactor. The ductility of matrix resin increase with the increase of the percentage of MC.

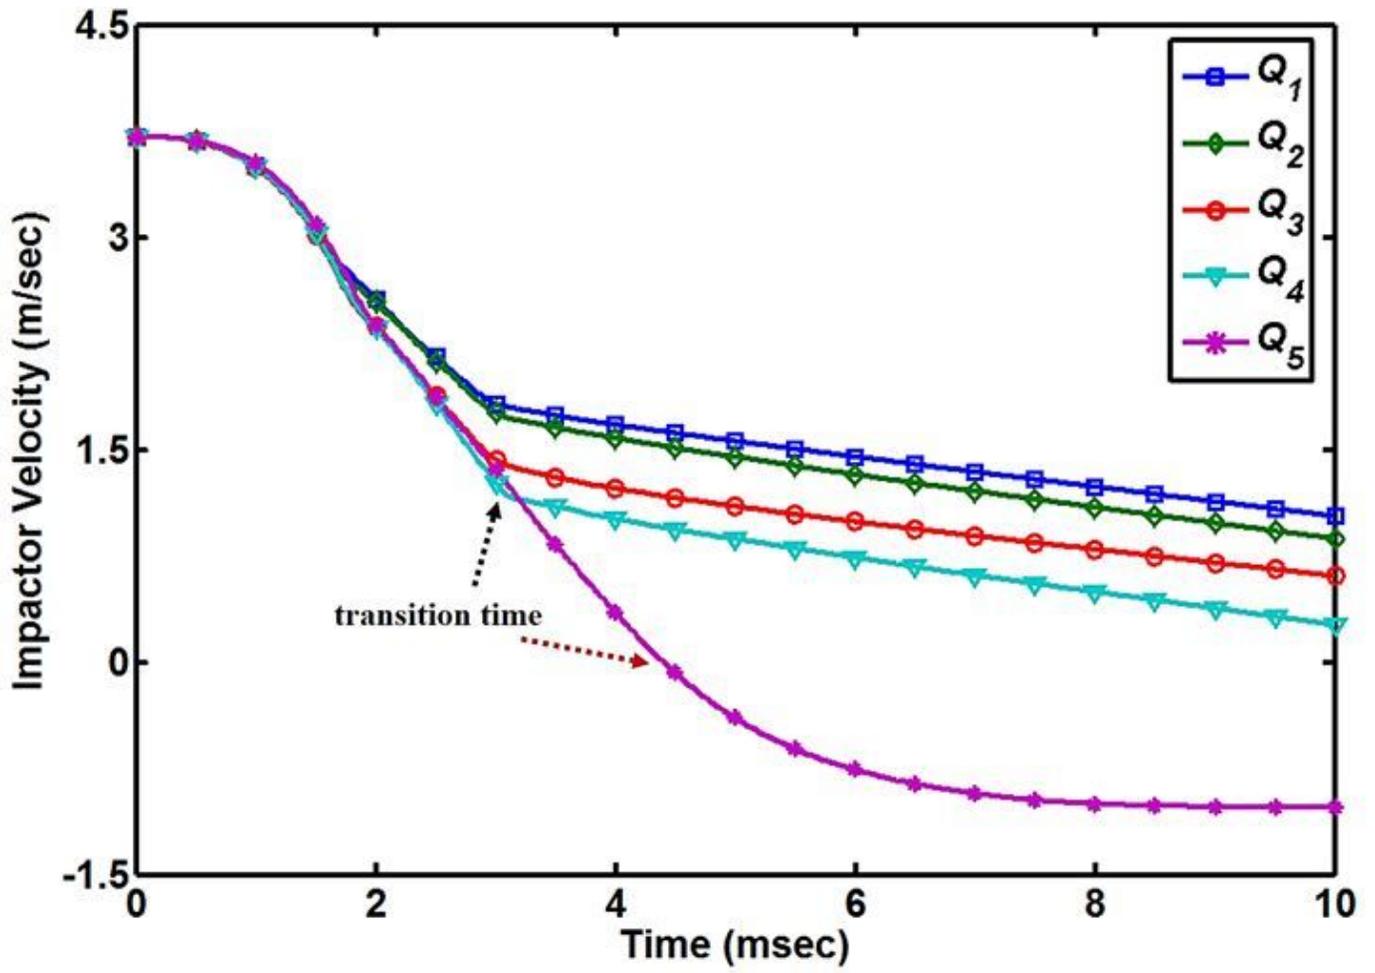
Figure 4

Impactor velocity versus time diagram for all quasi-isotropic composite plates.

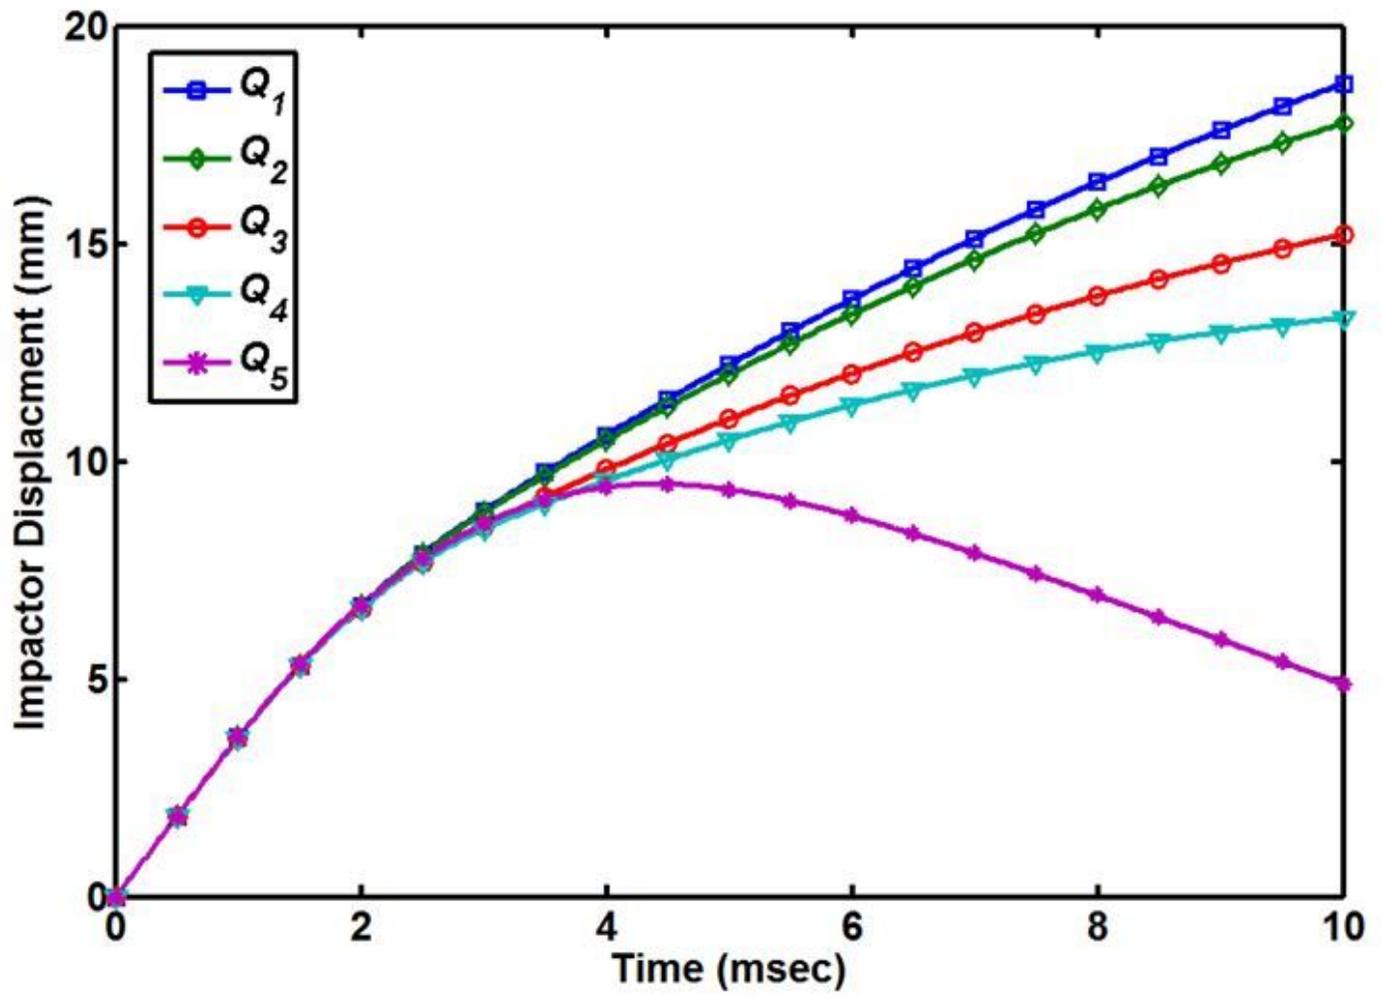
Figure 5

Impactor displacement versus time diagram for all quasi-isotropic composite plates

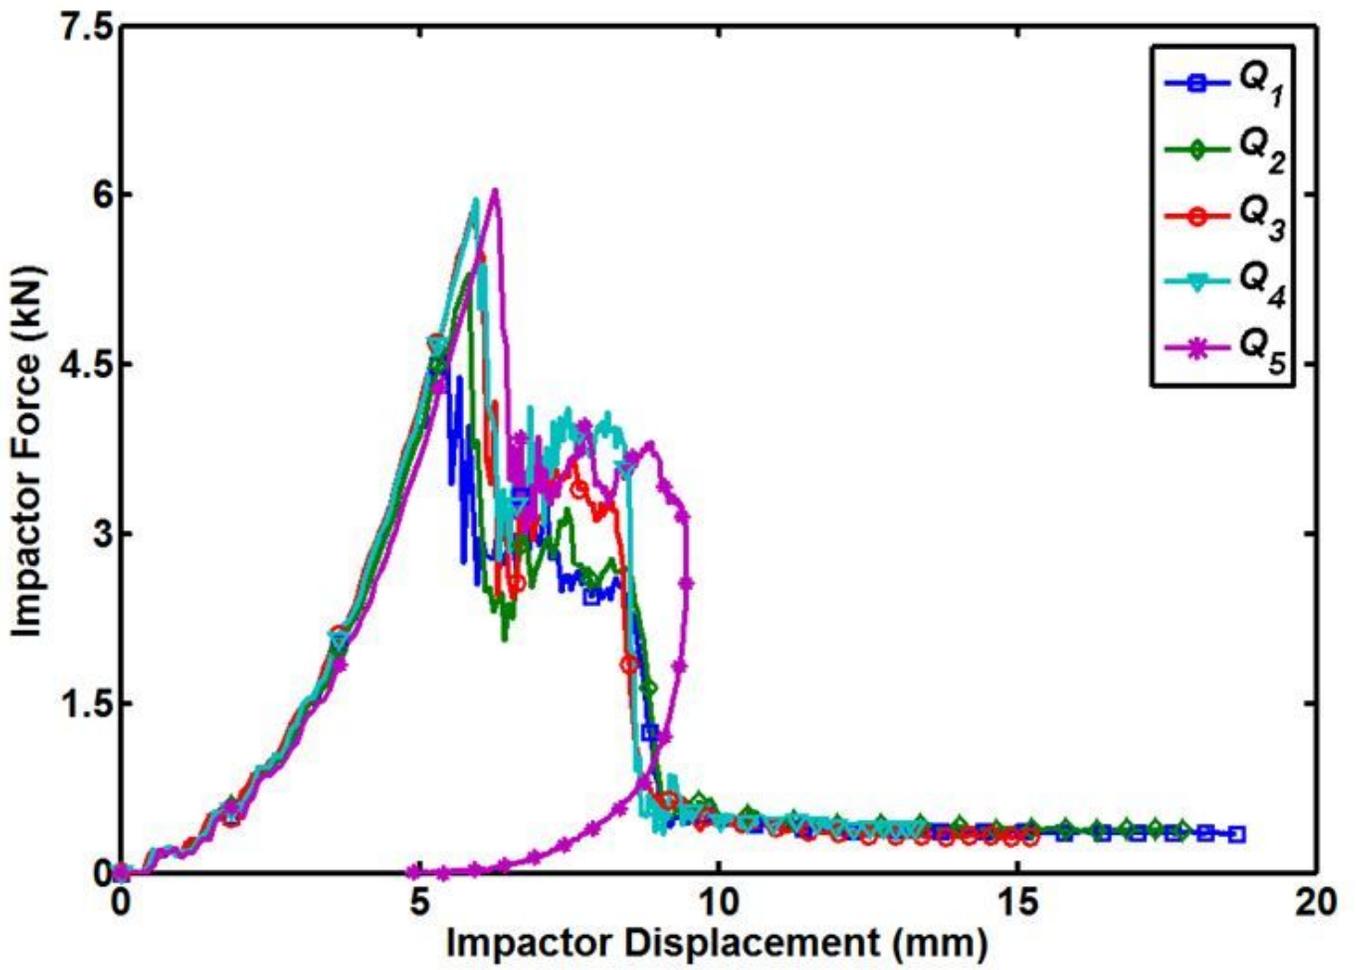
Impact force versus displacement diagram for all quasi-isotropic composite plates

head impactor can also be observed in Figure 6 where displacement versus force curve started to fold with decreasing displacement of the impactor. As impactor perforated through the first four quasi-isotropic composite plates (Q_1 to Q_4), there is no fold of displacement versus force curves observed for these specimens. Displacement of the impactor decrease with the increase of MC and impactor rebound back for Q_5 specimens indicated that the impact-resistance of quasi-isotropic composite plates improved under hygroscopic effect.

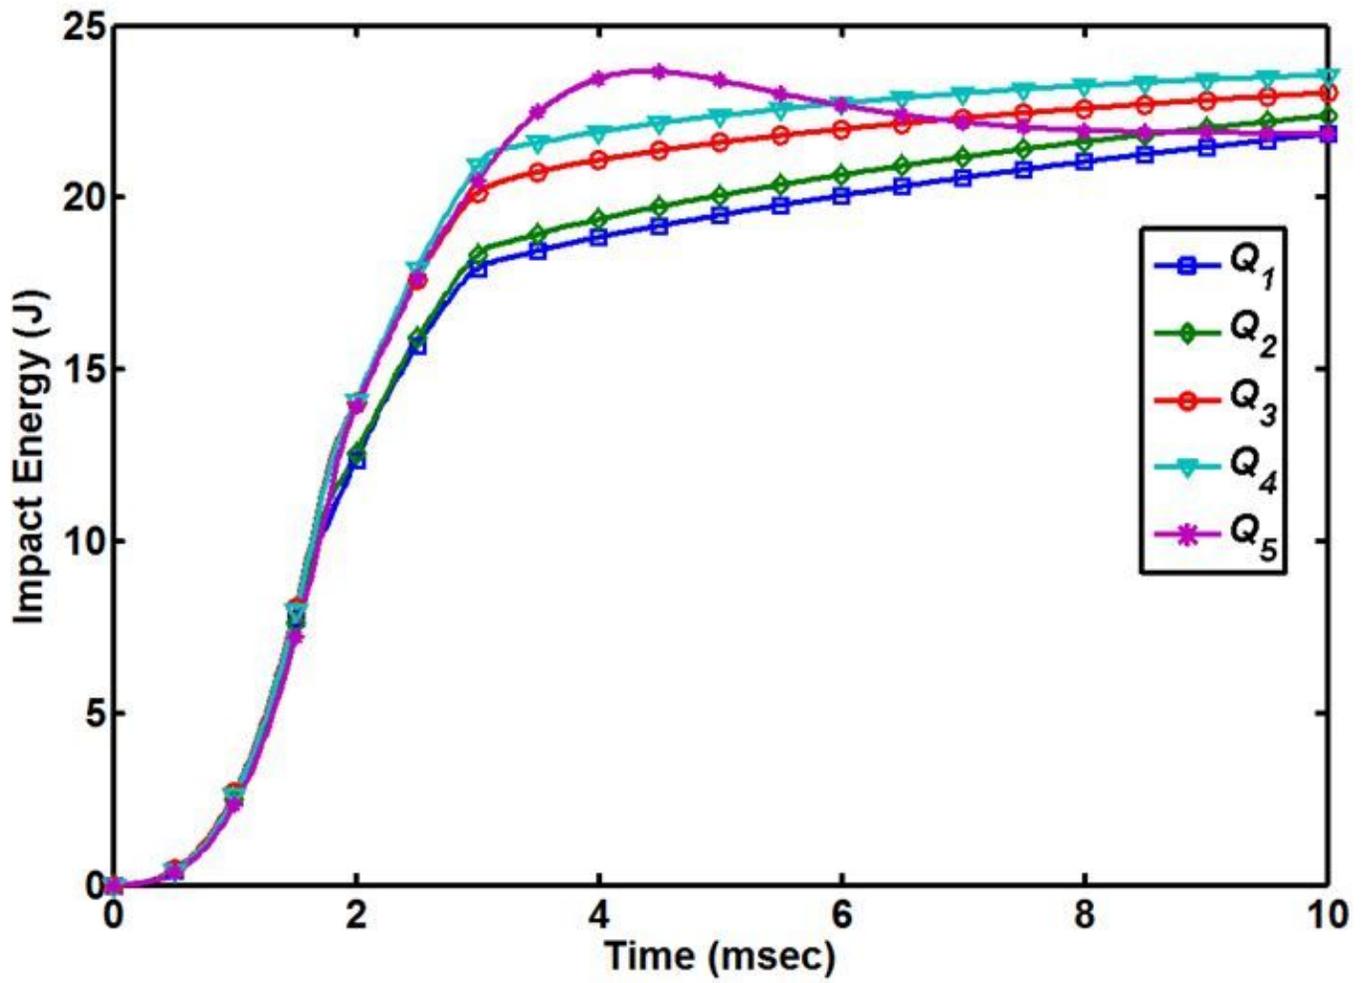
Figure 7

Absorbed energy versus time diagram for all quasi-isotropic composite plates.

To analysis the hygroscopic effect on the impact-resistance of the quasi-isotropic composite plates, impact tests were performed under the same level of impact energy of 23.67 J. Energy versus time graphs for all the quasi-isotropic composite plates are shown in Figure 7. During the impact tests, energy absorbed by the quasi-isotropic composite plates from the energy applied by the impactor was calculated as

where E_i is the initial or applied energy and E_a is the absorbed energy. In Figure 7, energy curves can be categorized into two cases: impactor perforated through the plates (for first four cases Q_1 to Q_4) and impactor penetrated into the plate (for Q_5 composite plate) and rebound back. Initially, the rate to absorb the impact energy was very low for all the composite plates which attributed as the initiation of damage in form of dent on the top surface and crack along the thickness direction at the point of impact. After that between the time period of 1 to 2 msec, the composite plates absorbed the impact energy during the deflection of the composite plates and the slopes of

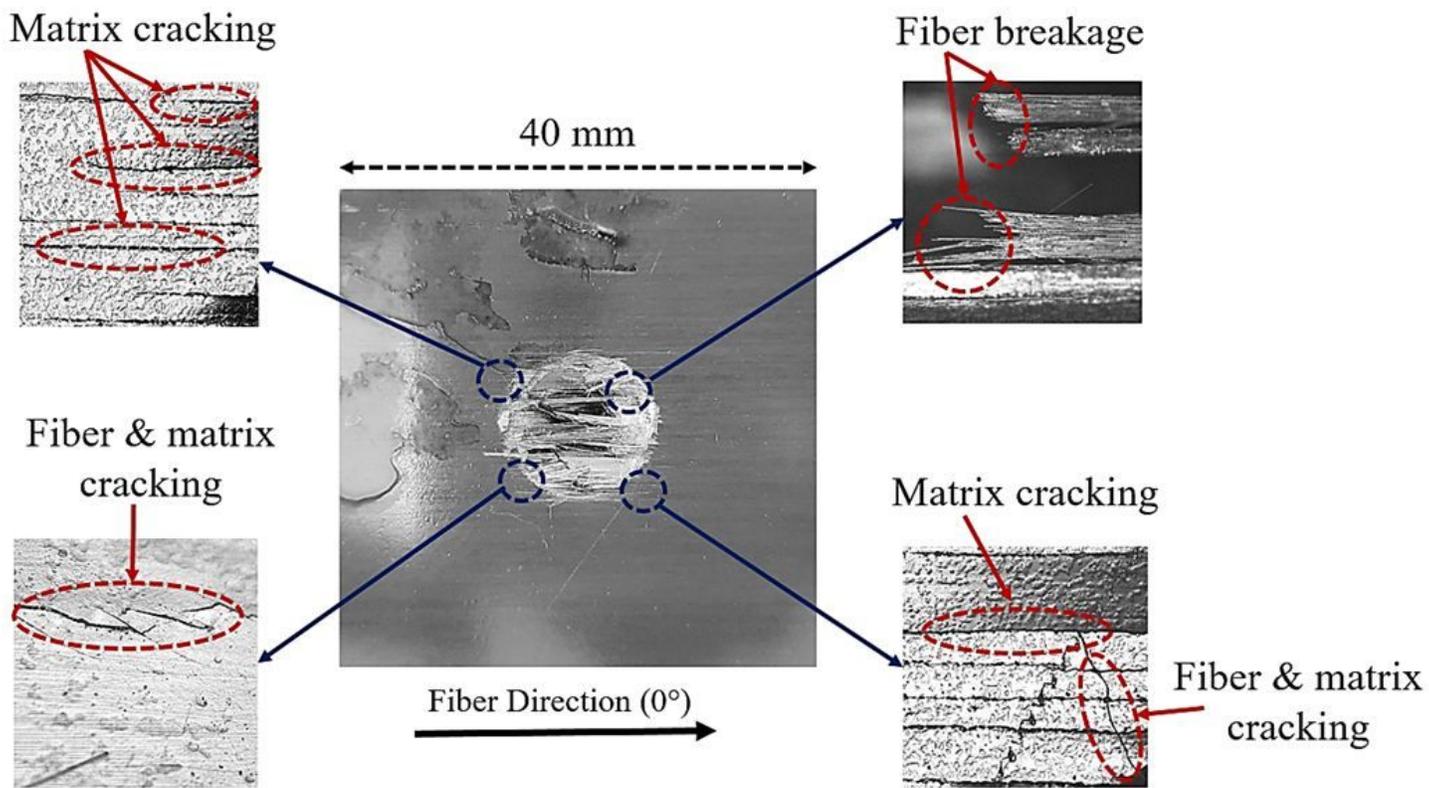
Figure 8

Damages on the top face of fully dry composite plate (Q1).

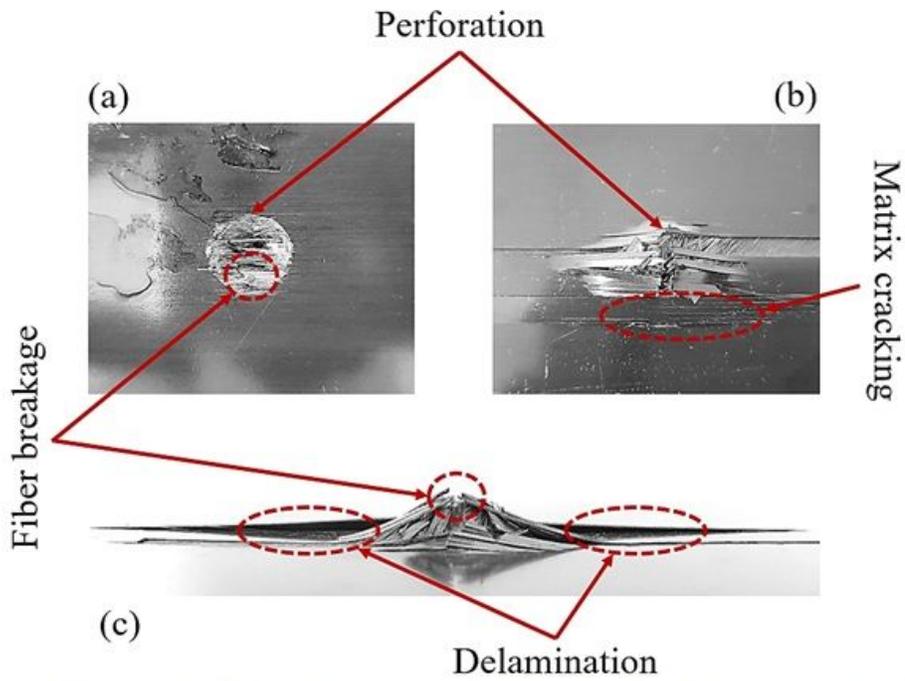
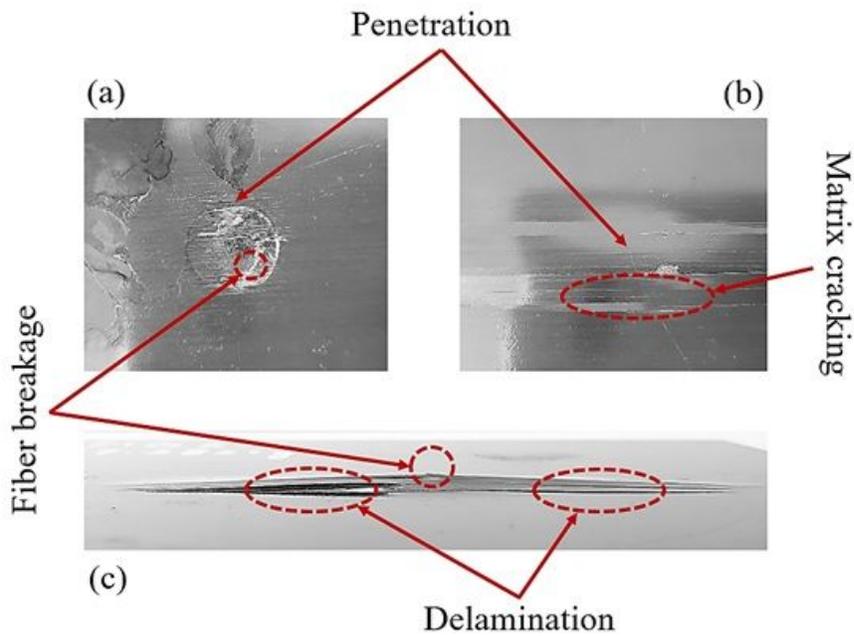
Figure 9

i) Damages in the fully dry (Q_1) composite plate (a) top view, (b) bottom view and (c) side view.

ii) Damages in the fully saturated (Q_5) composite plate (a) top view, (b) bottom view and (c) side view

Different views of damages in i) fully dry (Q_1) and ii) fully saturated (Q_5) composite plates

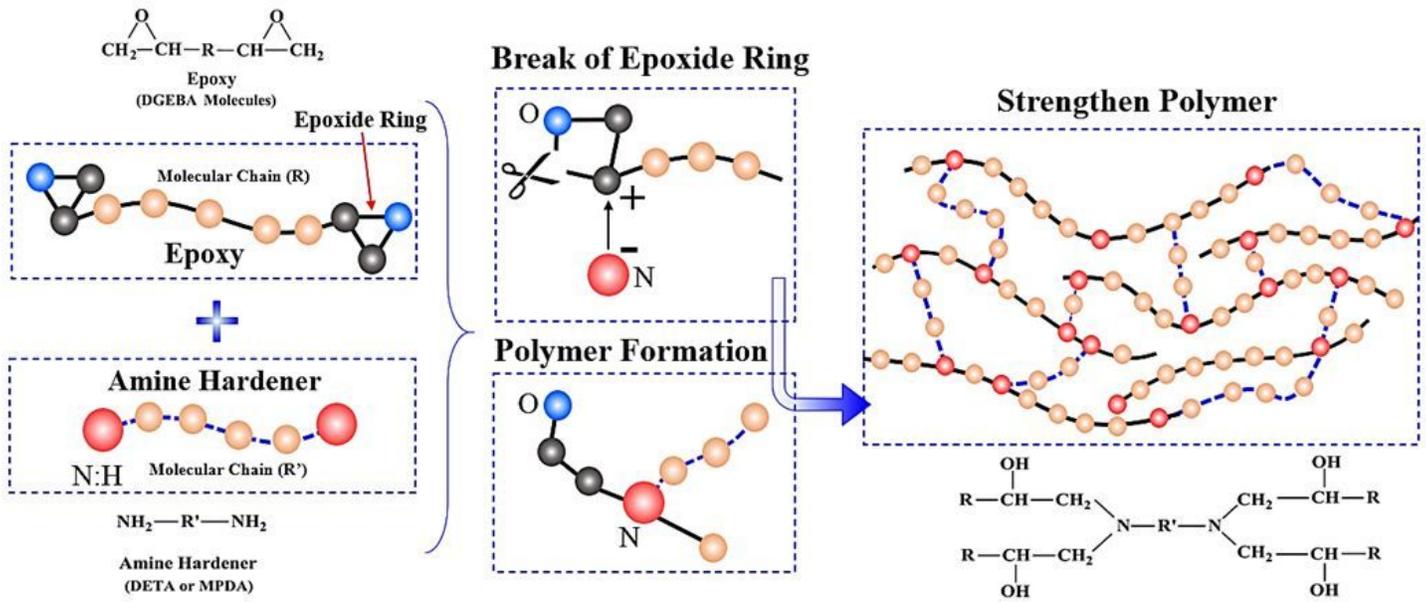
Figure 10

Schematic representation of reactants and formation of crosslinks in epoxy resin

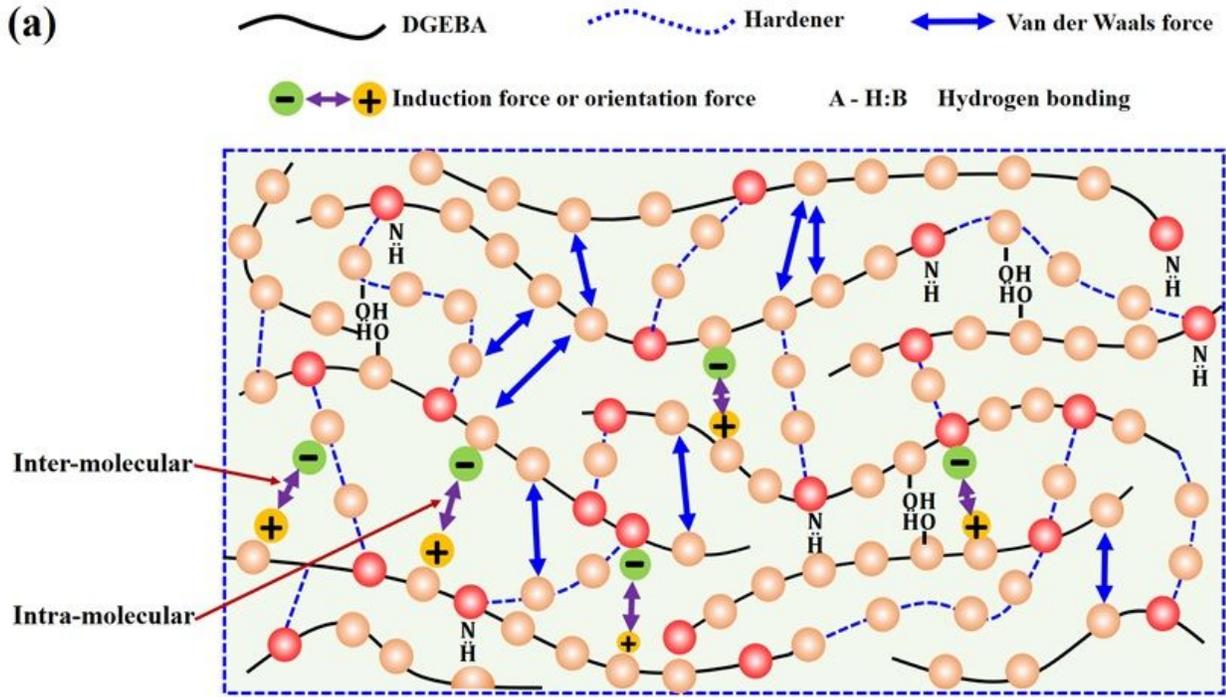
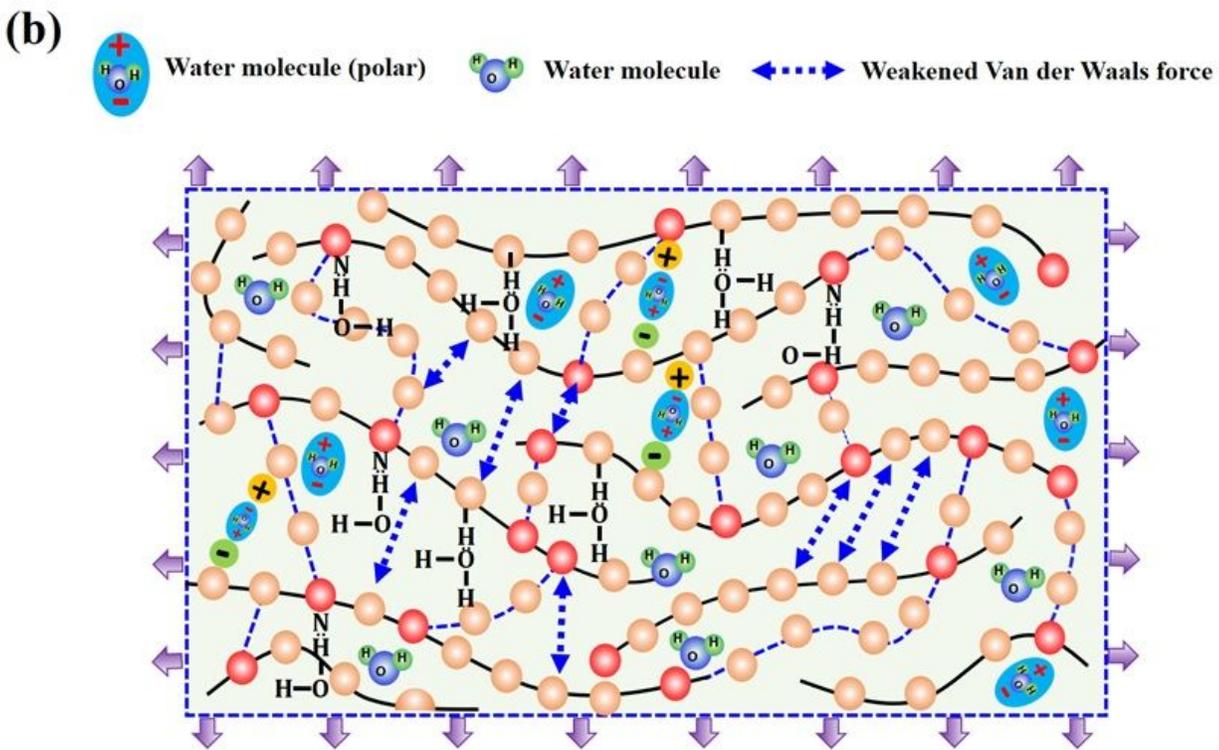
Figure 11

Schematic diagram of the (a) Van der Waals force, induction force or orientation force, and hydrogen bonding of epoxy molecules before absorbing the moisture content and (b) interaction between the moisture content and epoxy, weakened Van der Waals force, and disruption of hydrogen bonding of epoxy molecules after absorbing moisture.

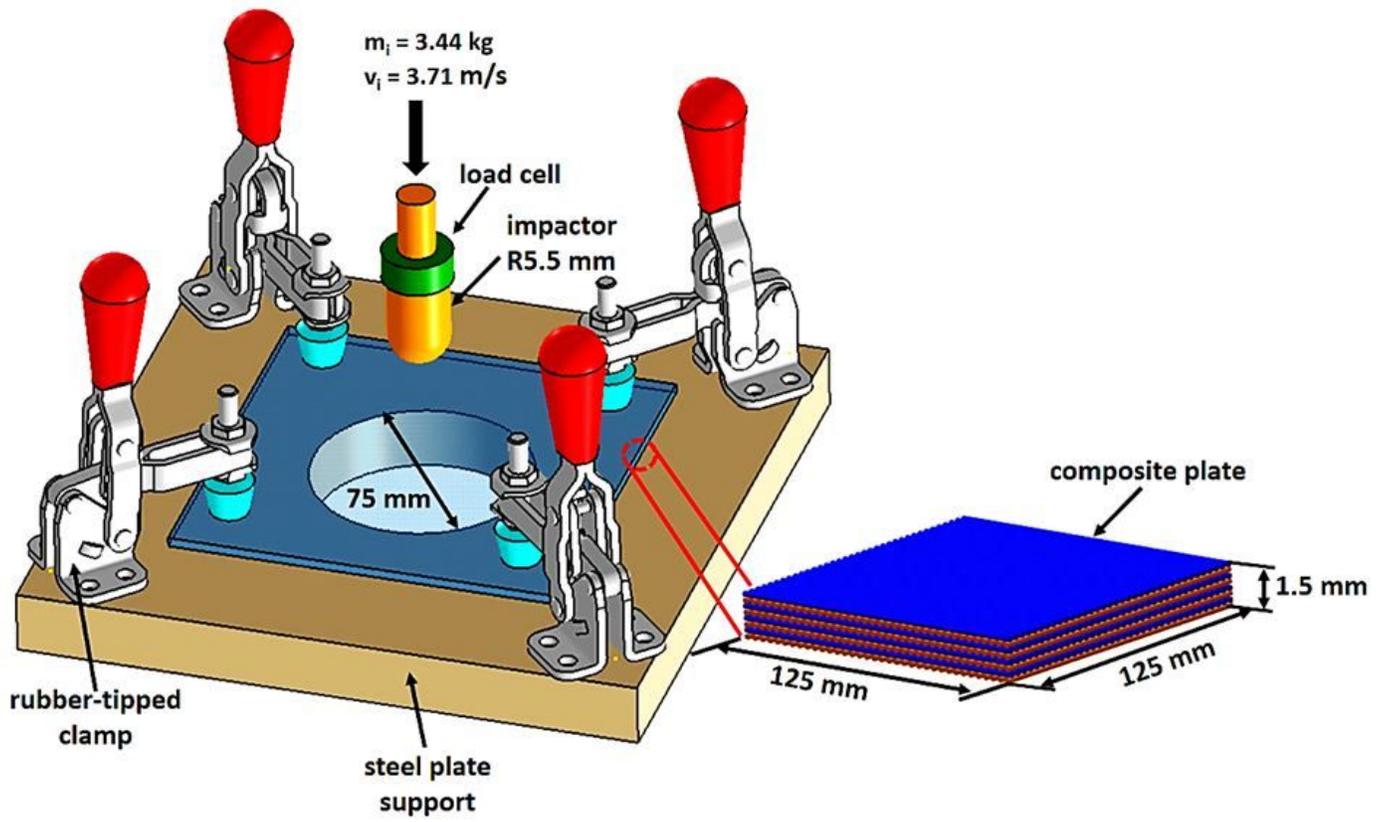
Figure 12

Schematic diagram low-velocity impact test for quasi-isotropic composite plates.

Vertical impact testing machine was used to perform the low-velocity impact tests on dry and hygroscopic conditioned quasi-isotropic composite plates. Schematic diagram of the complete low-velocity impact testing set up is shown in Figure 12. The total mass of impactor (m_i) including all add-on weights and load cell was 3.44 kg and 0.7 m height of impactor (h_i) was selected corresponding to initial impact velocity (v_i) of 3.71 m/sec and provide the impact energy of 23.67 J. To analyze the hygroscopic effect, all the composite plates were tested under constant boundary conditions. Composite plates were put on the steel plate support that has a circular cut of 75 mm diameter at the center to allow perforation of impactor through the thickness of plates without any interference. To prevent the in and out of plane movement of the composite plate, the plates were clamped at four corners by the rubber-tipped clamps those applying the light clamping pressure. All this arrangement simulates the simply-supported boundary condition. For each hygroscopic condition, three impact tests were performed to avoid the experimental error and after impact test, composite plates were removed from the fixture with care for the post-impact damage analyses.
