An Approach For The Reconstruction of a Traditional Masonry-Wooden Building Located In An Archeological Area. Part I: Methodology

Research Article

Keywords: Cultural asset, Demolished building, Reconstruction methodology, Ground penetration method, Archeological excavation

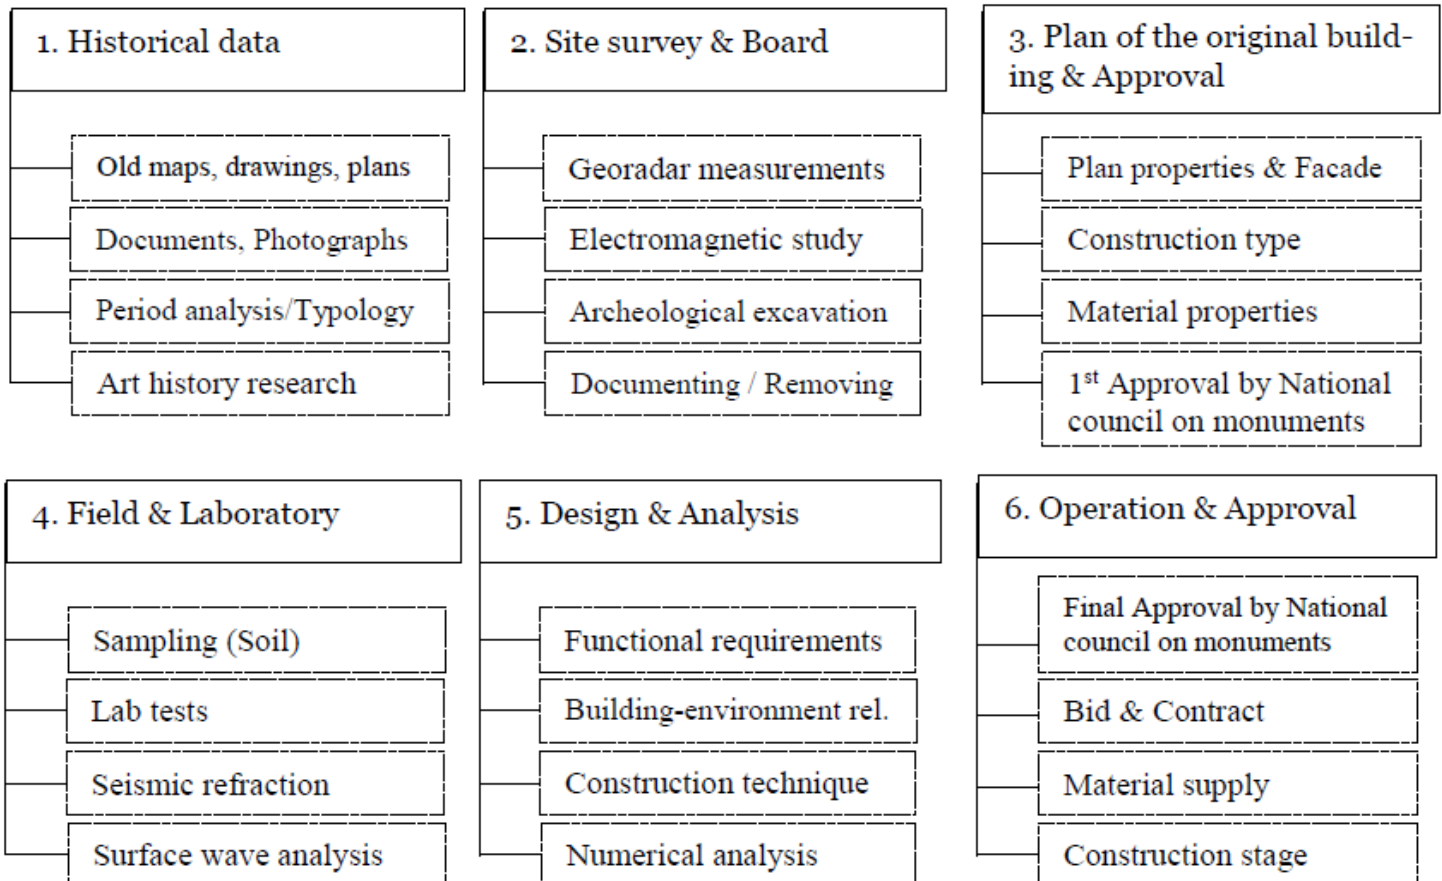
Figure 2

Flowchart detailing the methodology followed for the building reconstruction (Stages 1 to 6).

The proposed methodology can be considered a comprehensive and appropriate approach to the reconstruction of demolished or destroyed buildings, and is conducted in six stages, with each stage providing data for the subsequent stages. Fig. 2 presents the methodological approach to perform the reconstruction process.

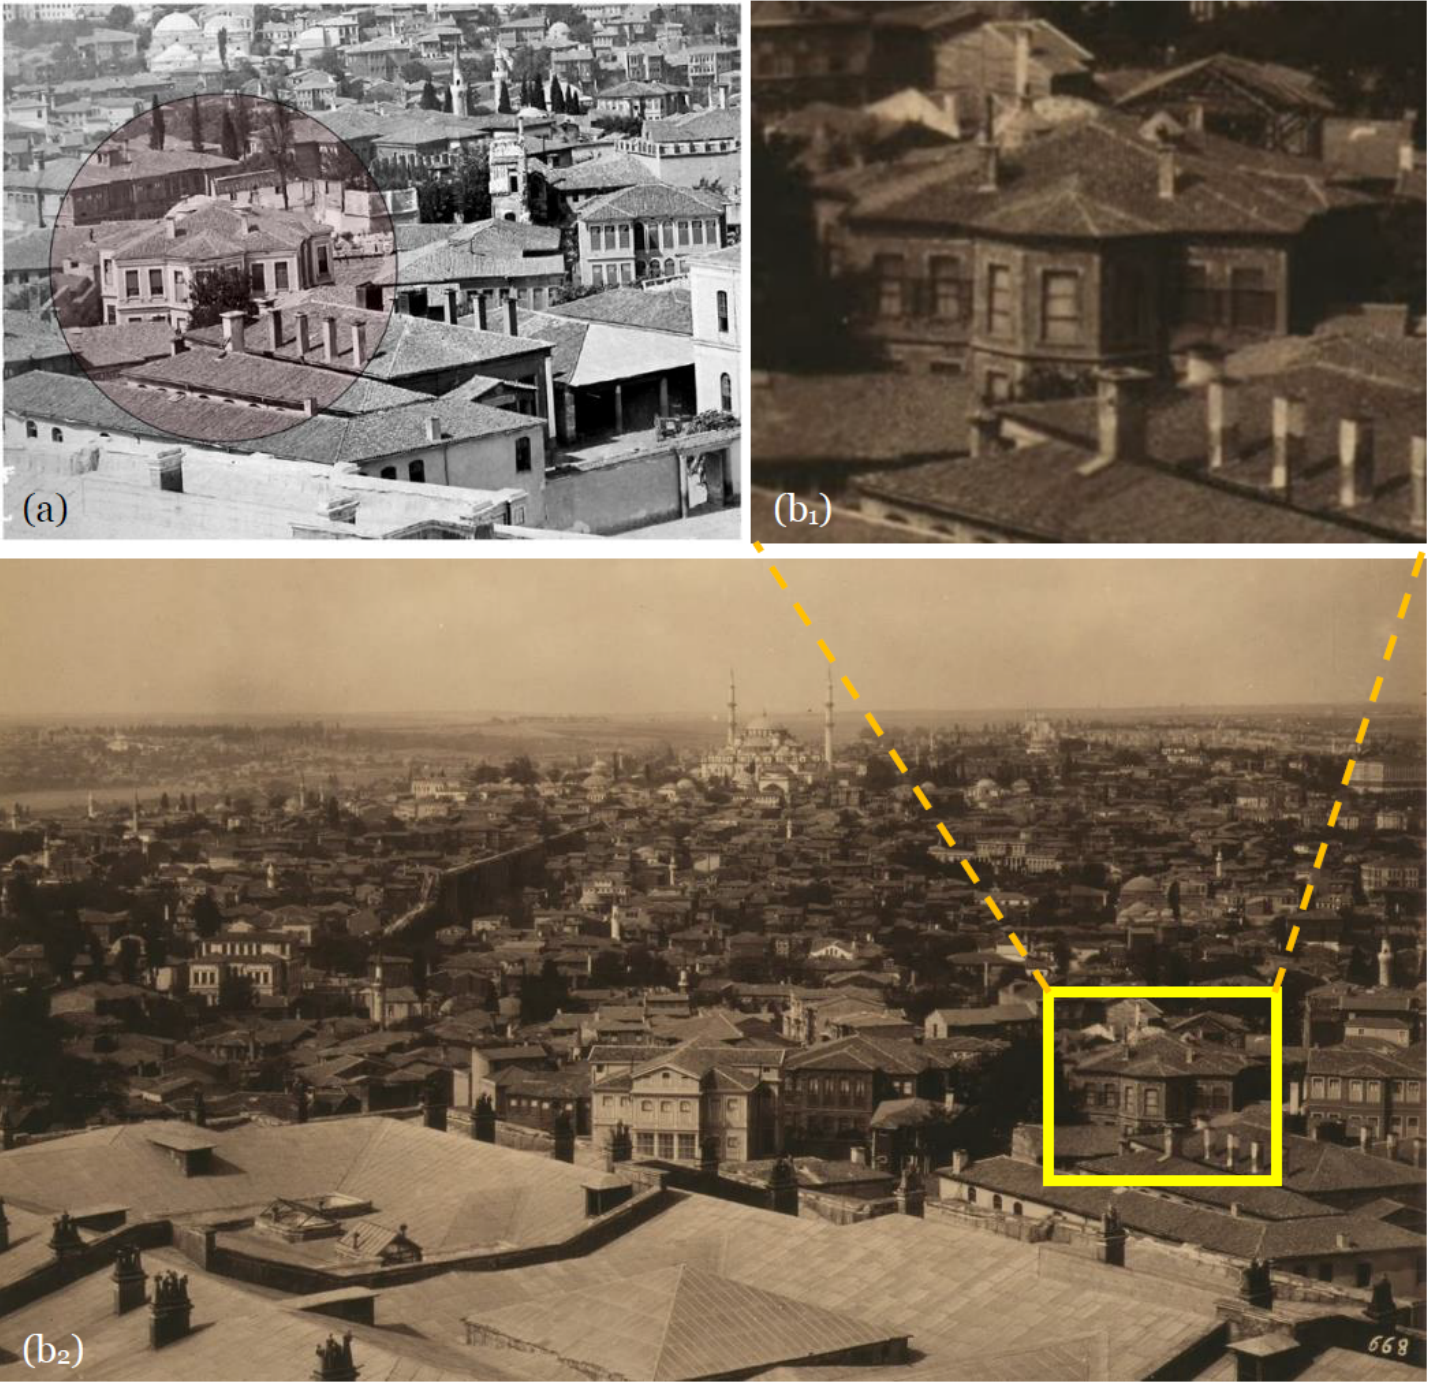
Figure 4

The view of the mansion building in the 1880s from (a) DAI [37] and the (b1, b2) Abdulhamid II Collection [38].

The masonry-timber building detailed in the present study, known as *İbrahim Efendi Konağı*, was constructed in Istanbul in the 1880s (Fig. 3), and comprised a partial basement, a ground floor, and two further floors (Fig. 4). The mansion original stood on a site that now belongs to Istanbul University in the Süleymaniye neighborhood of the Fatih district on the historical peninsula of Istanbul, which has been included on the UNESCO World Heritage list [30]. The examined building is located in a renovation area [31, 32]. The area and the subsurface remains were decided to be registered as a cultural asset by the Istanbul Renovation Areas Protection Regional Board of Cultural and Natural Assets, based on the qualifications specified in Law 2863 on the Protection of Cultural and Natural Assets [33], and in accordance with Article 18 of the Law, the building falls under Protection Group II. The reconstruction application was accepted upon a decision of the Superior Council of Cultural and Natural Heritage [34, 35]. Based on photographs in the archives of the German Archeology Institute and the Abdulhamid II Collection, we concluded that the examined building was constructed in the 1880s. The building is described as a secondary school on the German blue maps from 1913, the Pervititch maps of 1935 and the Istanbul aspect map of 1945. The building is absent from a photograph dated 1948 (Figs. 5 and 6), leading us to conclude that the building was demolished some time between 1945 and 1948. In photographs dated 1950 and 1966, in the decades following the demolition of *İbrahim Efendi Konağı*, two buildings can be seen on the site (Fig. 6a, 6b), while a 1982 photograph shows the site to be empty (Fig. 6c), and no construction has taken place since.

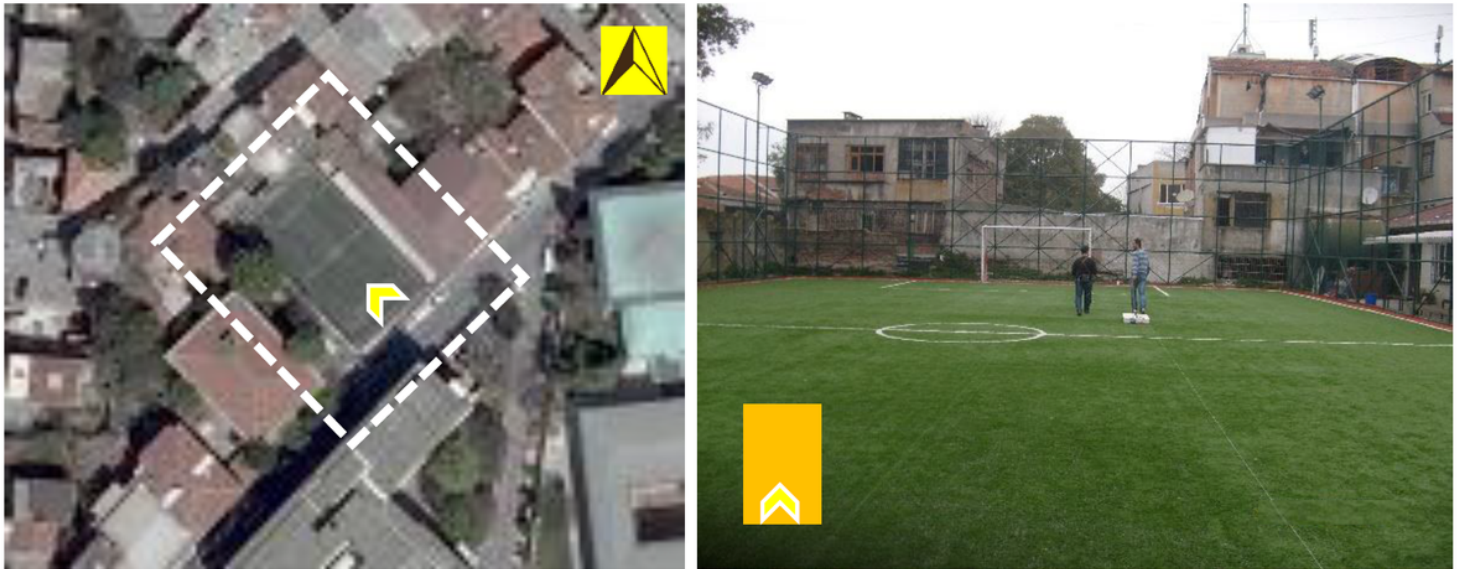
Figure 8

The area subjected to georadar study (*marked by dashed lines*).

A field study was made of the site of the building (Figure 8). The area is currently serving as an outdoor sports facility within Istanbul University. For the GPR measurements, a Zond 12e-brand georadar control unit, transceiver antennas and battery were used, and a total of 1480 m measurements were taken on the site along 41 lines with 300 and 500 MHz antennas. Accordingly, two- and three-dimensional radargrams were obtained from the continuous form measurements along with parallel profiles, and any anomalies detected on the radargrams were transferred to radargram diagrams. Using 2D radargram sections and 3D radargram block diagrams, the anomaly distributions were specified, and the anomaly images were thought to indicate the foundations of the original İbrahim Efendi Konağı. In the 3D radargram sections, the distribution of anomalies below ground was determined in 3D sections prepared by selecting the equivalent amplitude distributions.

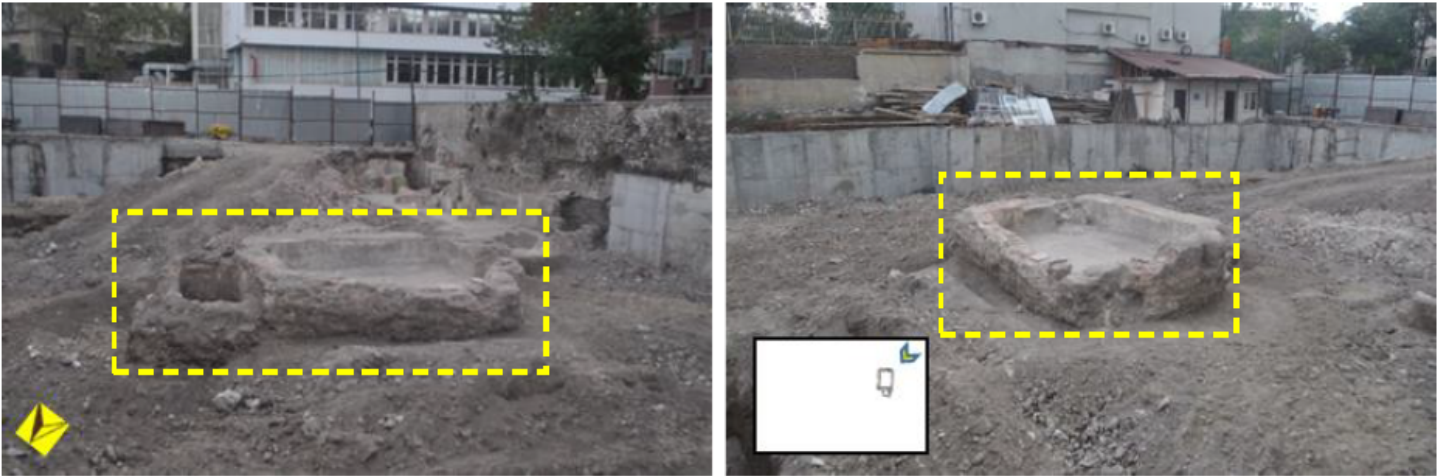
Figure 10

Views of the cistern on the project site.

Borehole no. 4 in the center of the site produced a remnant of which the formal features and architectural characteristics were unclear (Fig. 10). An examination of the general appearance and the construction technique applied to the item suggested that it came from a cistern (reservoir, water tank) that was probably built in the Late Ottoman era (the 18th or 19th centuries). The mass of the item was around 400 kN, and in situ observations and examinations showed that material deterioration had occurred in some structural materials, such as brick, stone, joints, fillings and plaster mortars. Furthermore, another small reservoir with relatively weak joints and grouts was identified in the northern part of the first construction area. In parallel to this, it was understood that the mortar on the architectural find had significantly lost its binding properties. The Cultural Assets Preservation Board decided that the finding had no architectural or historical value, and could thus be removed from the area. After the completion of the documentation procedures, the remains were removed, and excavations restarted for the construction of the retaining system. The justification for the selection of a well foundation as the retaining system is presented in detail in Part II, Section 4.1 of the study [29].

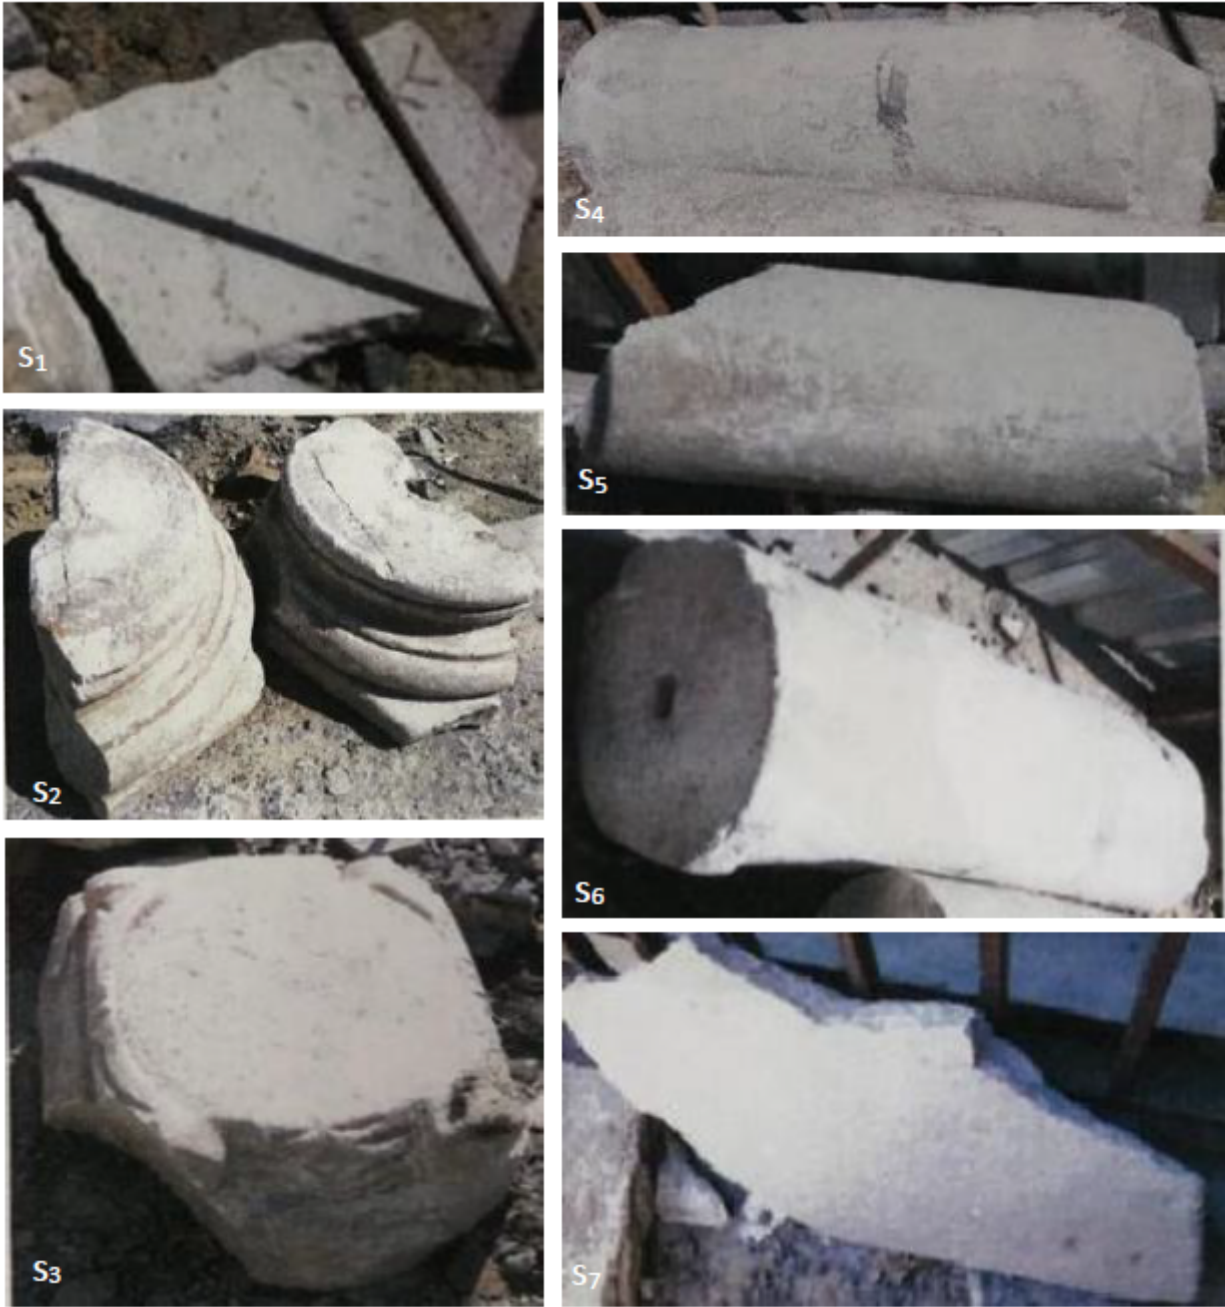
Figure 12

Archeological finds during excavations for the well foundation

During the excavations for the construction of the well foundation, marble finds of various types and dimensions were identified at different depths (Fig. 12), the geometric and material properties of which are given in Table 2. It was decided to carry out an excavation work of the entire area under the supervision of the Directorate of Istanbul Archeology Museums, since it was believed that more unearthed remains could exist across the construction area [45], although no such cultural assets, whether movable or immovable, were found during these excavations. All remains were documented with survey reports and photographs and were removed from the site [46]. Thus, no ruins of the foundations of the mansion building were identified during either the archeological or well foundation excavations.

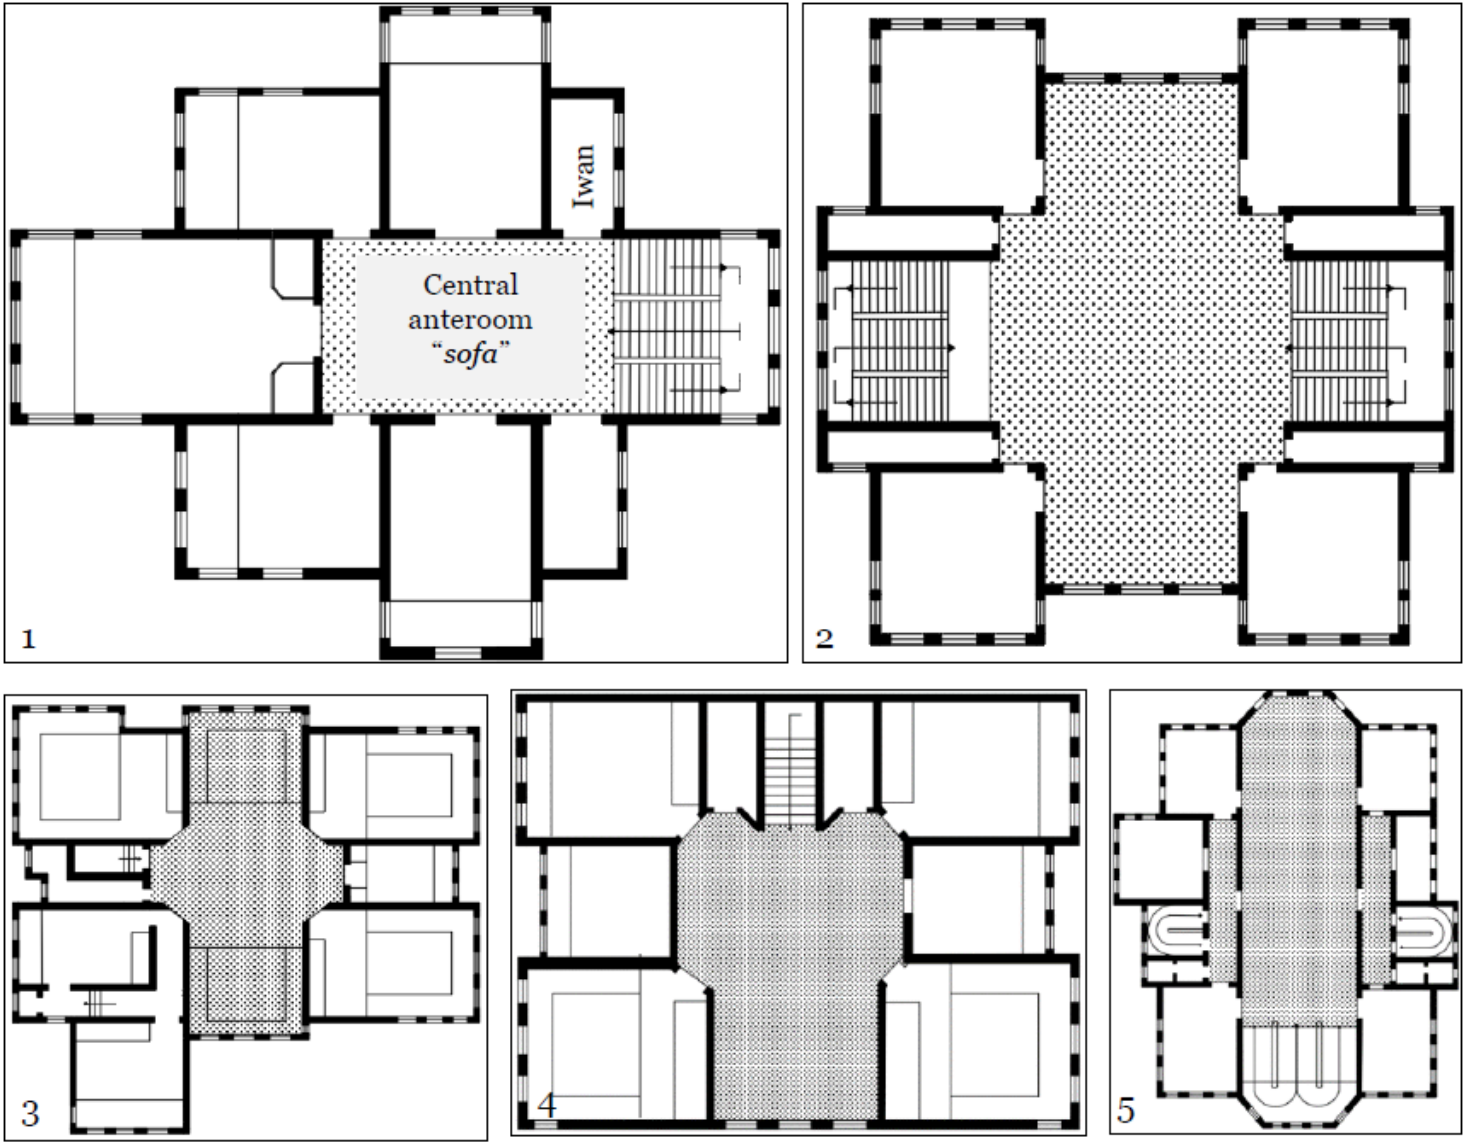
Figure 13

Mansion plan types with central anterooms in 19th century [50]. 1: Kalamış, İstanbul, 2: Çengelköy, İstanbul, 3: *Türkmenzade İsmail Konağı*, İstanbul, 4: Kavafyan, İstanbul, 5: *Yusuf İzzeddin Efendi pavilion*, İstanbul.

İbrahim Efendi Konağı. In such traditional Turkish houses, all rooms are located around an anteroom – known traditionally as a *sofa*. In this plan type, possible changes to the shape, size or qualities of rooms are limited, although the *sofa* can take various forms. Iwans, known traditionally as *eyvan*, are recessed spaces within the central anteroom that are added to bring air, light and decoration to the anteroom. The main factors behind the preference for anterooms in such mansions are the shelter and effective heating the design provides. Turkish house-plan types can be classified as: i. without anteroom, ii. with an outside anteroom, iii. with an inner anteroom, and iv. with a central anteroom. Locating the sofa in the center gives the house plan a squarer or nearly square rectangular form. In this house-plan type there are generally four large rooms and four corners, between which, service spaces such as stairs, iwans, storerooms and kitchens are located. The plan type with a central sofa allows alternative plan layouts, and so this type was generally preferred over other types in the larger mansions and palaces in Istanbul. *İbrahim Efendi Konağı* features a central anteroom, giving it a symmetrical plan. In other words, the plan of the mansion matches with the buildings in this typology (Fig. 13).

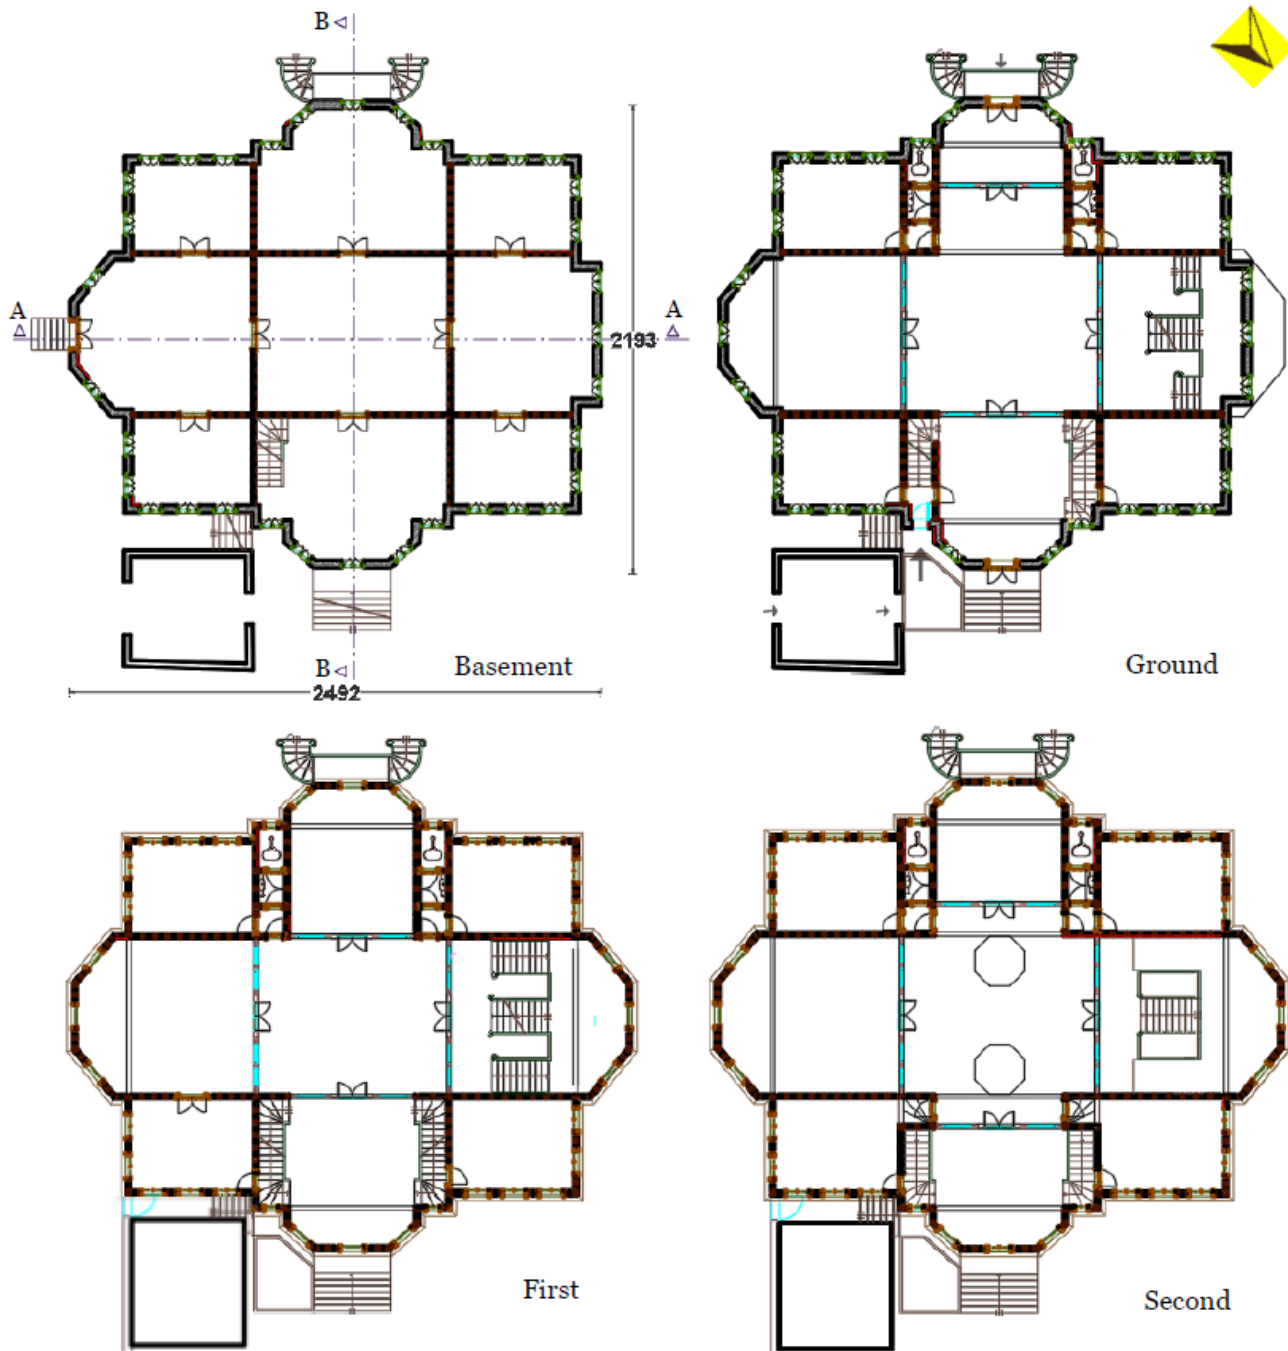
Figure 14

Floor plans of the building.

period, traditional geometric decoration forms were created using timber slats on the building, and it is believed that similar ornamentations could be seen in other houses, although with minor differences [49]. As stated earlier, the dimensions and proportions of the façade of *İbrahim Efendi Konağı* were garnered from historical maps, photographs and old documents. The internal organization of the spaces was based on the typology of the building and from references obtained from the façades. In the light of all this information, in addition to the floor and roof plans prepared for the building, the estimated sectional elevations and façade views are presented in Figs. 14 to 17.

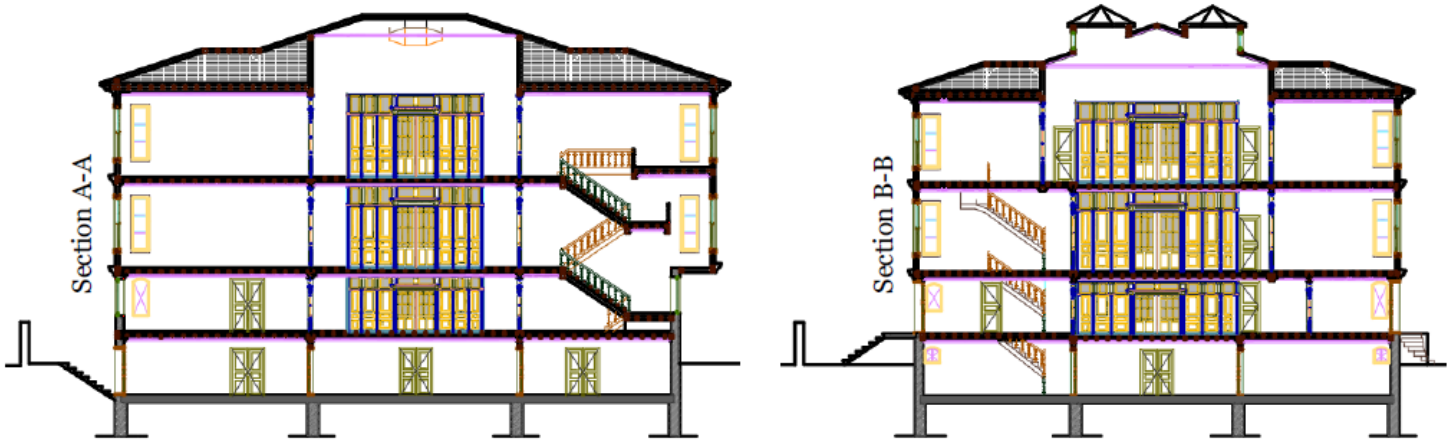
Figure 15

Sectional elevations of the building (*Section lines shown in Fig. 14*).

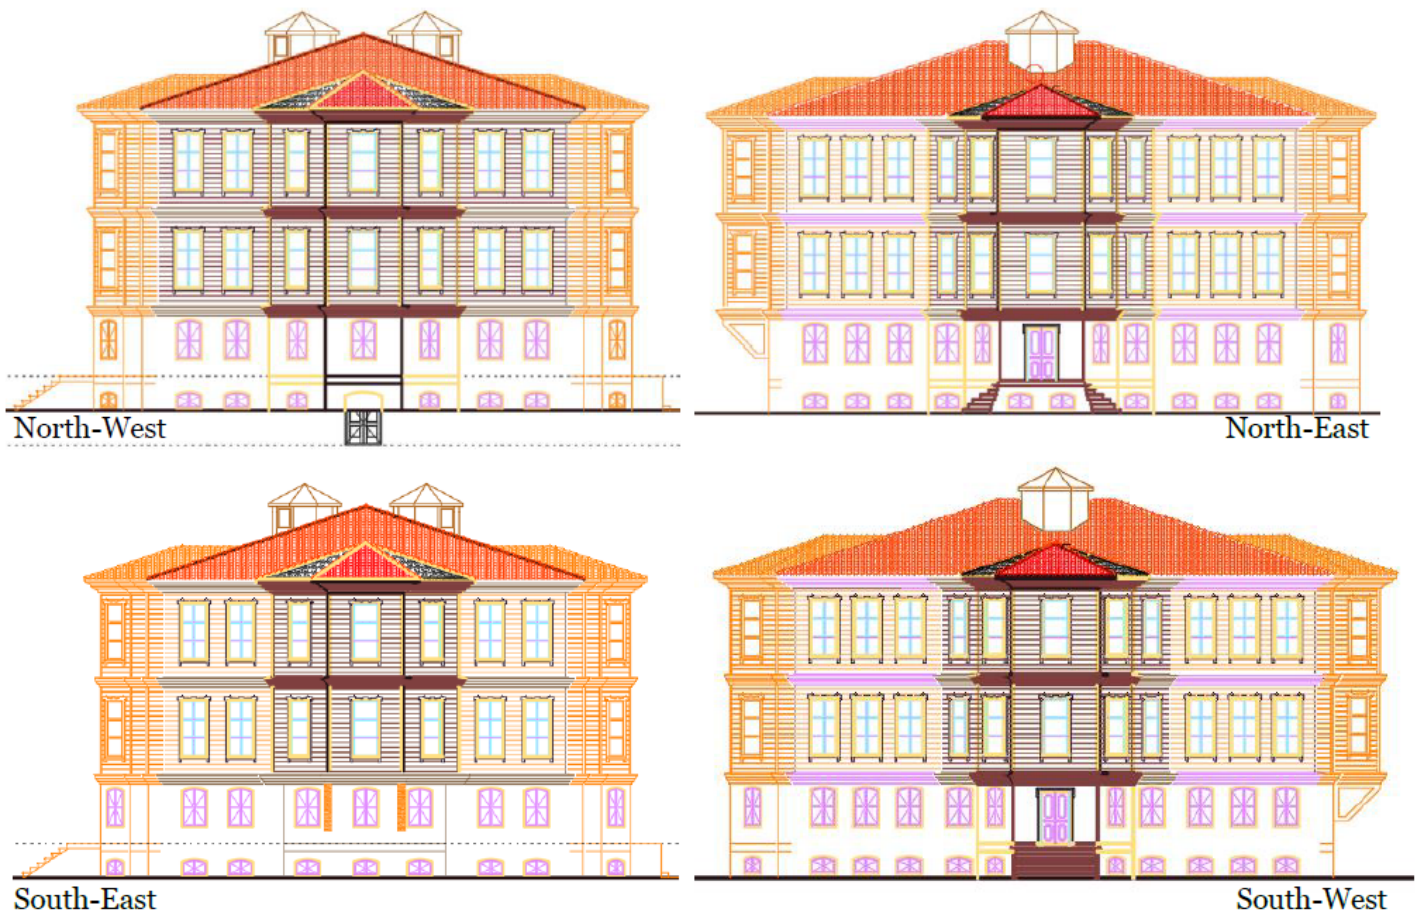
Figure 16

Façade views of the building.

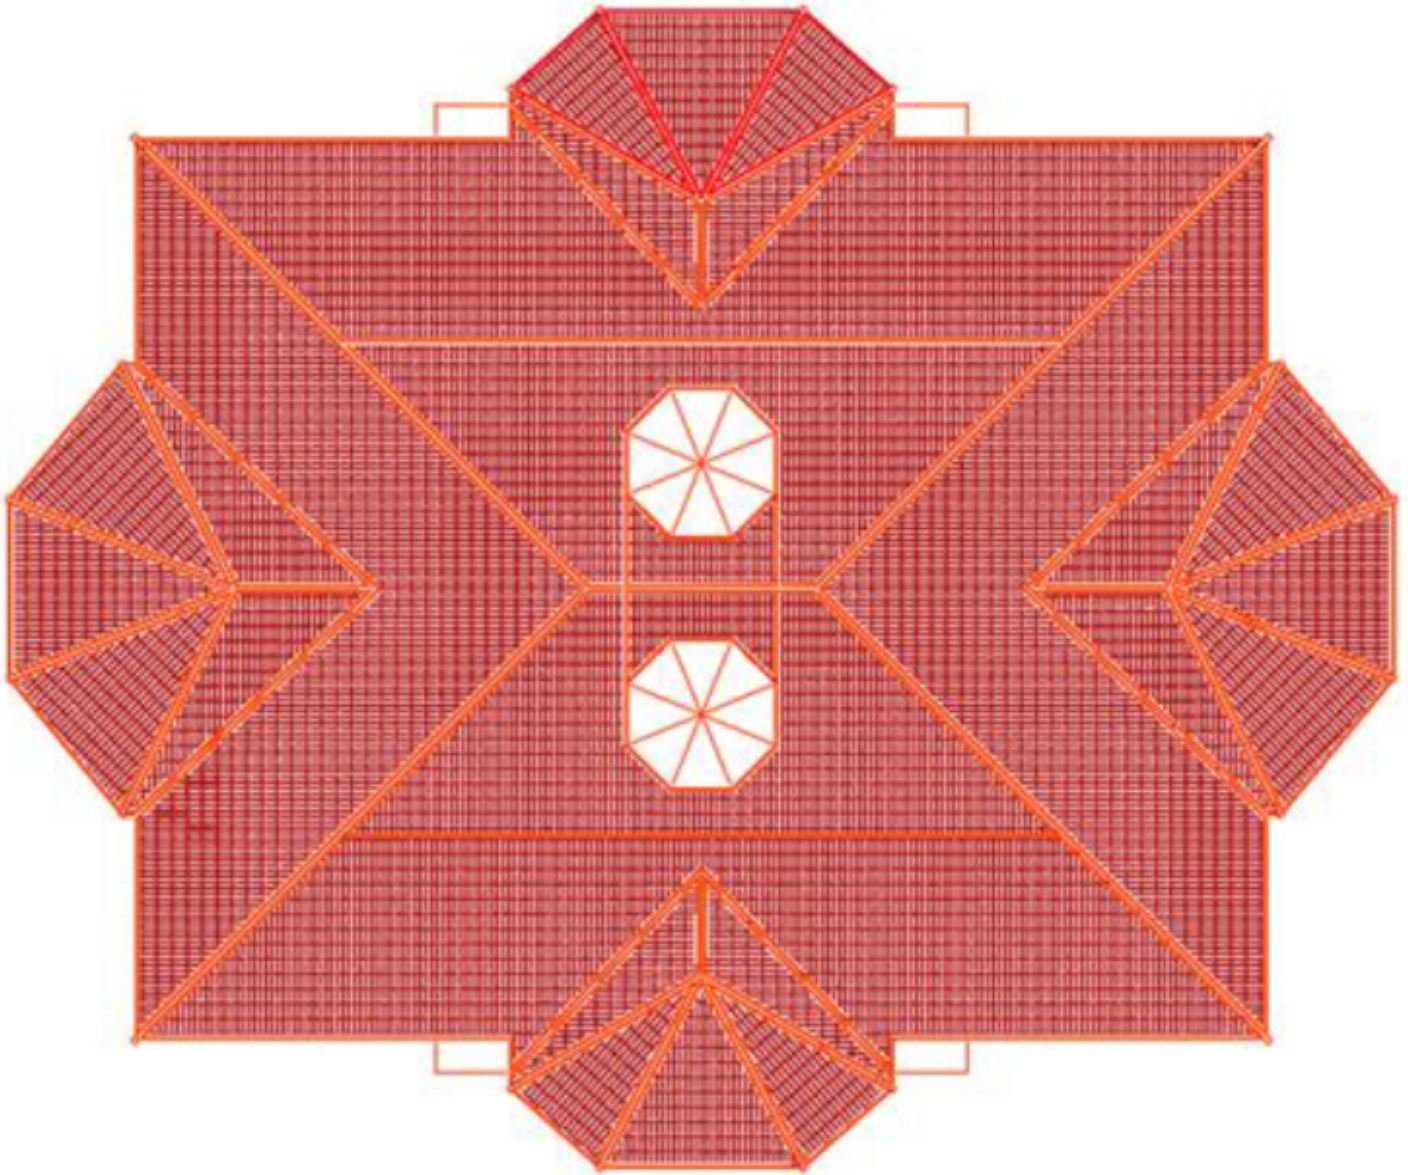
Figure 17

Roof plan of the building.
