# Artificial Lightning Strike Tests and Coupled Electrical–Thermal Analysis on Roofing Glazed Tiles of Ancient Buildings

**Keywords:** Glazed tiles, Lightning damage testing, Coupled electrical–thermal effect, Temperature, Thermal stress

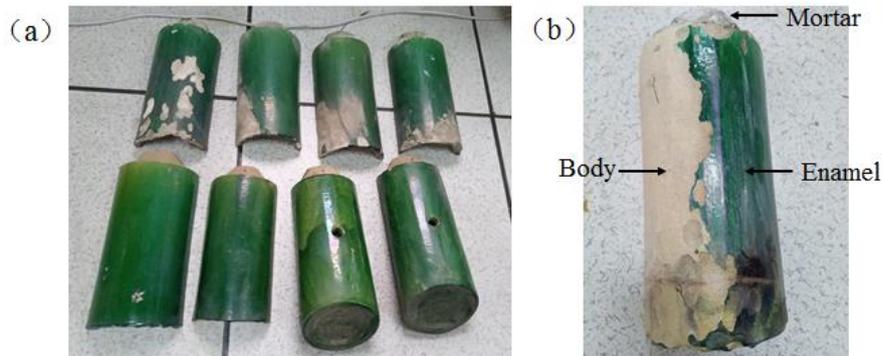
**Fig. 1. Specimens of (a) relatively intact glazed tiles; (b) half enamel and half body tile.**

The specimens used in this study were provided by Beijing Research Institute of Architectural Heritages (Fig. 1a). The glazed tiles comprise round and plate tiles with the same material but different shapes and structures. The round tile is covered at the connection point of the two ridges of the plate tiles and has a raised arc shape and semicircular section, whereas the plate tile is above the round tile and is likely to be struck by lightning. The glazed round tiles (hereinafter referred to as glazed tiles) were selected in this study. Glazed tiles were fired using aluminum silicates with enamel applied to the surface. The specimens had a width of 1.8 cm, a full-block length of 35 cm, an outer cross-sectional diameter of 14.4 cm, and a height of 7.2 cm.

The glazed tile is made of body, enamel, and mortar (Fig. 1b). The body is the main part of the glazed tile. The major components of the body are  $\text{SiO}_2$  and  $\text{Al}_2\text{O}_3$ , accounting for 37%–

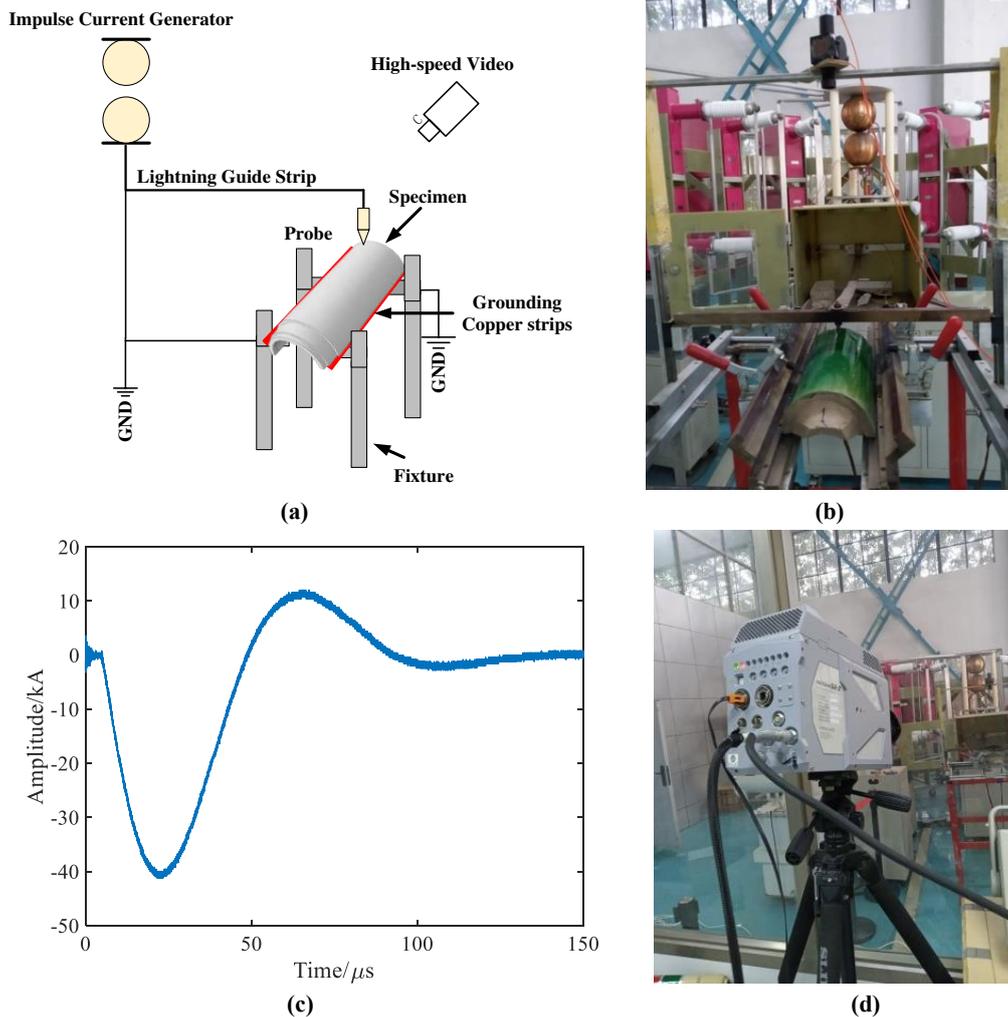
**Fig. 2. Experimental setup for artificial lightning strike Test, (a) Schematic of experimental setup; (b) Image of experimental setup; (c) Waveform of the impulse current in the experiments; (d) High-speed camera.**

simulated using a customized impulse current generator shown in Fig. 2(a), and the waveform it generated was  $8/20 \mu\text{s}$  (rise time/half-peak time). The lightning current was conducted by the diversion strip, and then injected into the specimens through a copper probe fixed above the glazed tiles. The distance between the copper probe tip and the specimens was set to 2 mm to ensure the arc discharge. The specimens were clamped with a custom fixture, and grounded by two copper guide rails fixed on two sides, as shown in Fig. 2(b).

The peak value of the impulse current is selected as 40 kA and Fig. 1(c) shows the waveform of the current collected using an oscilloscope (MDO 3024, Tektronix Co., America) during the experiments. A high-speed camera (FASTCAM SA-Z, Photron, Japan) (Fig. 1d) was used in the experiments to monitor the formation, development of the arc channel at the probe tip, and its interaction with the specimens. The frame rate of the high-speed camera was set to 700,000 frame/s.

The lightning current showed in Fig. 2(c) was applied in the simulations of the coupled electrical–thermal effect to testify the effectiveness of the method. Fig. 8 shows the simulated temperature field distributions at different times. When the lightning current was loaded at 8  $\mu\text{s}$  (wave head), the high-temperature field was mainly in the mortar. At the end moment of lightning current loading (100  $\mu\text{s}$ ), the temperature field magnitude was quite high, and the temperatures in all the parts of the mortar had reached a very high value. The temperature of the adjacent body also significantly increased to more than 100  $^{\circ}\text{C}$ , as shown in Fig.8(a). After the loading of the lightning current was completed, the temperature of the glazed tiles started to reduce instead of continuing to increase. It took approximately 10

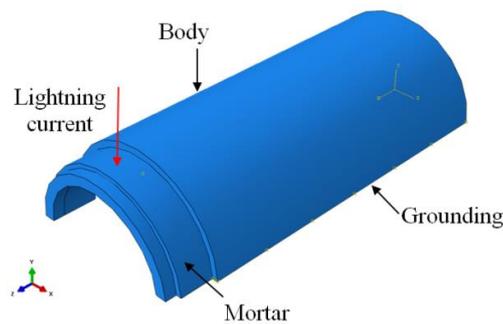
Fig. 3. Electrical–thermal coupling FEM of mortar-containing glazed tile

The coupled electrical–thermal analysis is carried out with commercial finite element software ABAQUS 6.14. The dimension and the electric boundary condition of the model are both the same as the experimental setup, and the center of the mortar area is selected as the lightning attachment point, as shown in Fig. 3. For thermal stress analysis, the mechanical boundary condition is set to be completely fixed. Thermal radiation is given for all of the external surfaces except the grounded ones, and the emissivity is assumed as 0.9.

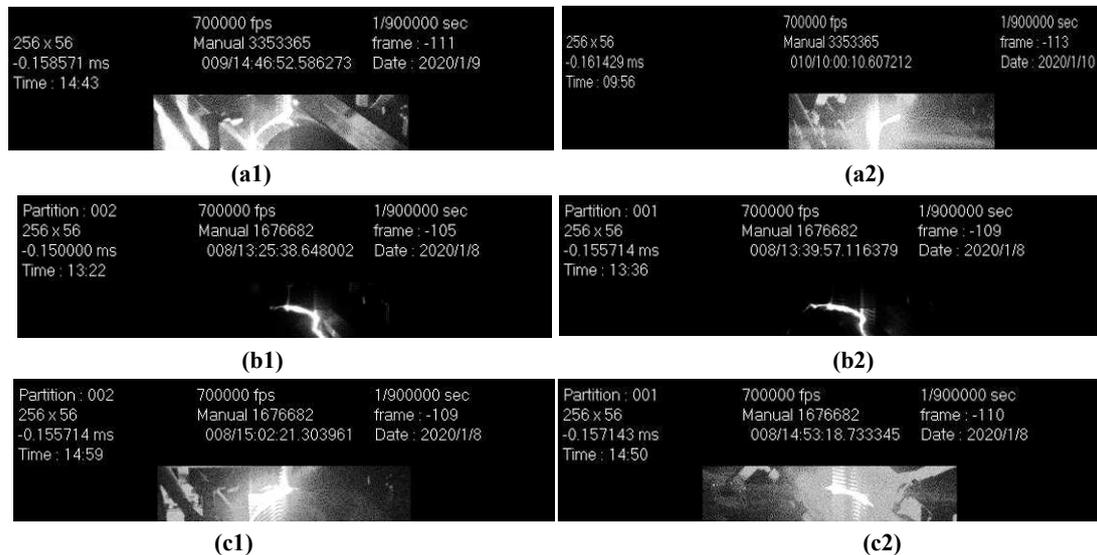
**Fig. 4. Lightning channels at different attachment positions based on high-speed camera observation, (a1) 1# full-enamel glazed tile specimens; (a2) 2# full-enamel glazed tile specimens; (b1) 3# full-body glazed tile specimen; (b2) 4# full-body glazed tile specimens; (c1) 5# semi-enamel and semi-body glazed tile specimens; (c2) 6# semi-enamel and semi-body glazed tile specimens.**

Fig. 4 shows the monitored results of the lightning strike at different attachment positions (excluding the mortar) on the glazed tile specimens obtained using the high-speed camera. Clearly, a complete flashover channel is formed along the surface of the specimens due to the lightning current, indicating that no current was injected into the specimens, and the appearance integrity of the glazed tile is well maintained even after the experiment. Lightning ablation pits (Fig. 5a) or surface ablation along the flashover path (Fig. 5b) can be found on the full-enamel specimens following the experiment. Detailed pit damage resulting from Joule heat could be observed using scanning electron microscopy, as shown in Fig. 5(c). The results demonstrate that when the lightning current struck a location with a lower electrical conductivity, the energy was released mainly by flashover through the surface of the glazed tile, and it was difficult for the lightning current to enter the tile before the accumulation of Joule heat. This was why no significant damage effect,

such as fracturing or cracking, was observed in the tile in the experiments. Additionally, Figs. 4(c1) and (c2) show that the flashover channel tends to develop along the body surface when the enamel and body exist simultaneously (that is, semi-enamel and semi-body glazed tile).

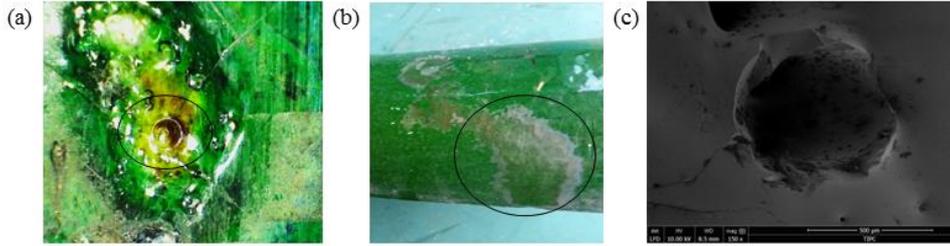
**Fig. 5. Damage to enamel of glazed tile due to lightning strike, (a) Ablation pit in enamel; (b) Surface ablation in enamel; (c) Pit damage observed by SEM.**

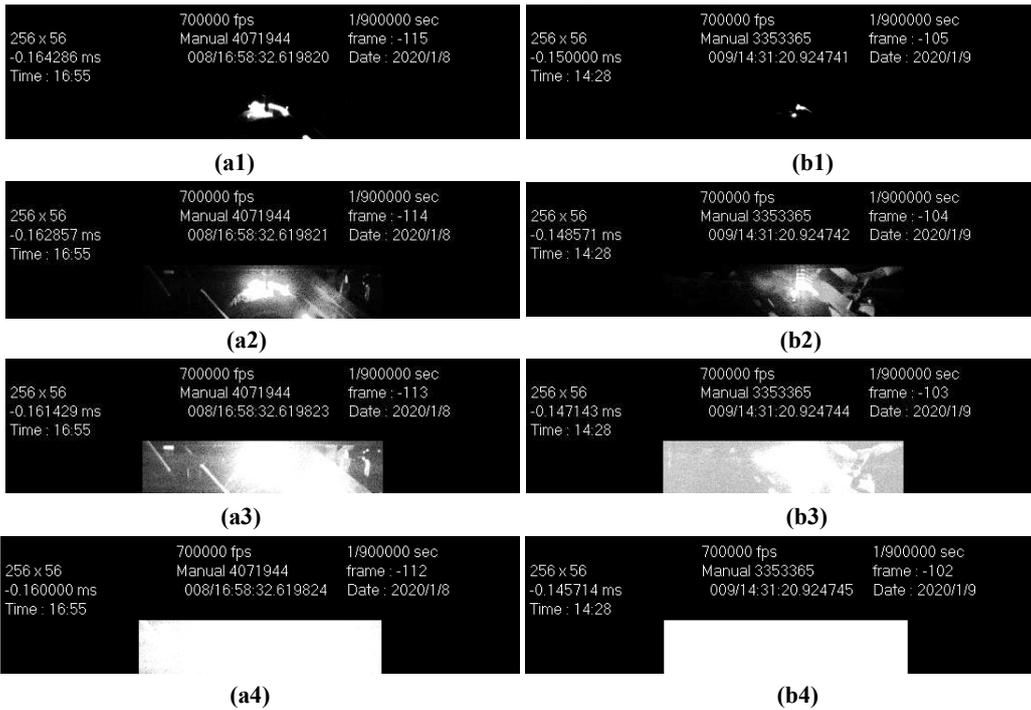
**Fig. 6. Lightning channels at mortar attachment positions based on high-speed camera observation, (a1) Position of 7# mortar; (b1) Position of 8# mortar; (a2) Position of 7# mortar; (b2) Position of 8# mortar; (a3) Position of 7# mortar; (b3) Position of 8# mortar; (a4) Position of 7# mortar; (b4) Position of 8# mortar**

Fig. 6 shows the observation results of four continuous frames of the artificial lightning current-attached mortars in the two mortar specimens. The “bear head” of the glazed tiles in both the experiments nearly covered the complete mortars, with a thickness of approximately 1 cm. The entire propagation process of the flashover channel along the tile surface was not observed. The brightness of the entire mortar areas was enhanced before the monitored areas were fully exposed (Figs. 6 a3 and b3), which might be due to the increase in temperature produced by Joule heat effect after the lightning current was injected into the mortar. In addition, an explosion-like loud sound was heard in both the experiments, and all the glazed tiles burst completely with scattered tile debris under the test platform after the experiment, as shown in Fig. 7(a) and Fig. 7(b).

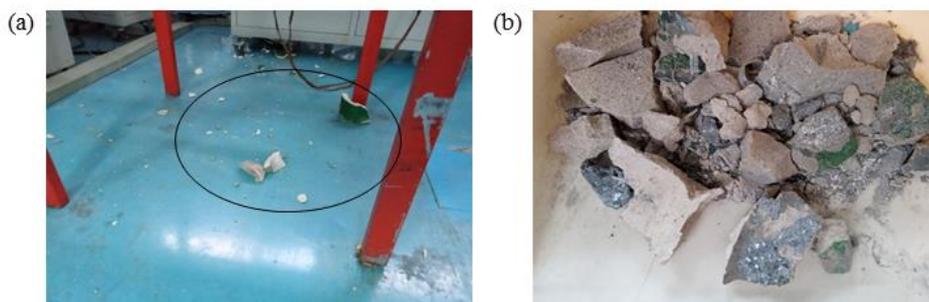
**Fig. 7. Damage to glazed tiles after artificial lightning strike on mortars, (a) Fractures of glazed tiles after lightning strike under the platform; (b) Collected fractures of glazed tiles.**

heat during conduction and increased the mortar temperature. Subsequently, through the heat exchange, the temperatures of the body and enamel that were connected to the mortar also started to increase. The temperature changes resulting from Joule heat had at least two implications. The first was the destructive power or thermal stress resulting from the temperature changes due to Joule heat and local heterogeneous temperature distribution. The second was the rapid vaporization and expansion of the water in the internal voids of the glazed tiles, which produced a strong pressure or even local explosion (explosive force). Under the combined effect of these two forces, the strength and stability of the glazed tiles changed, and ultimately, the yield strength of the material was exceeded, causing the glazed tiles to fracture and finally undergo significant damage, as shown in Figs. 7 (a) and (b).

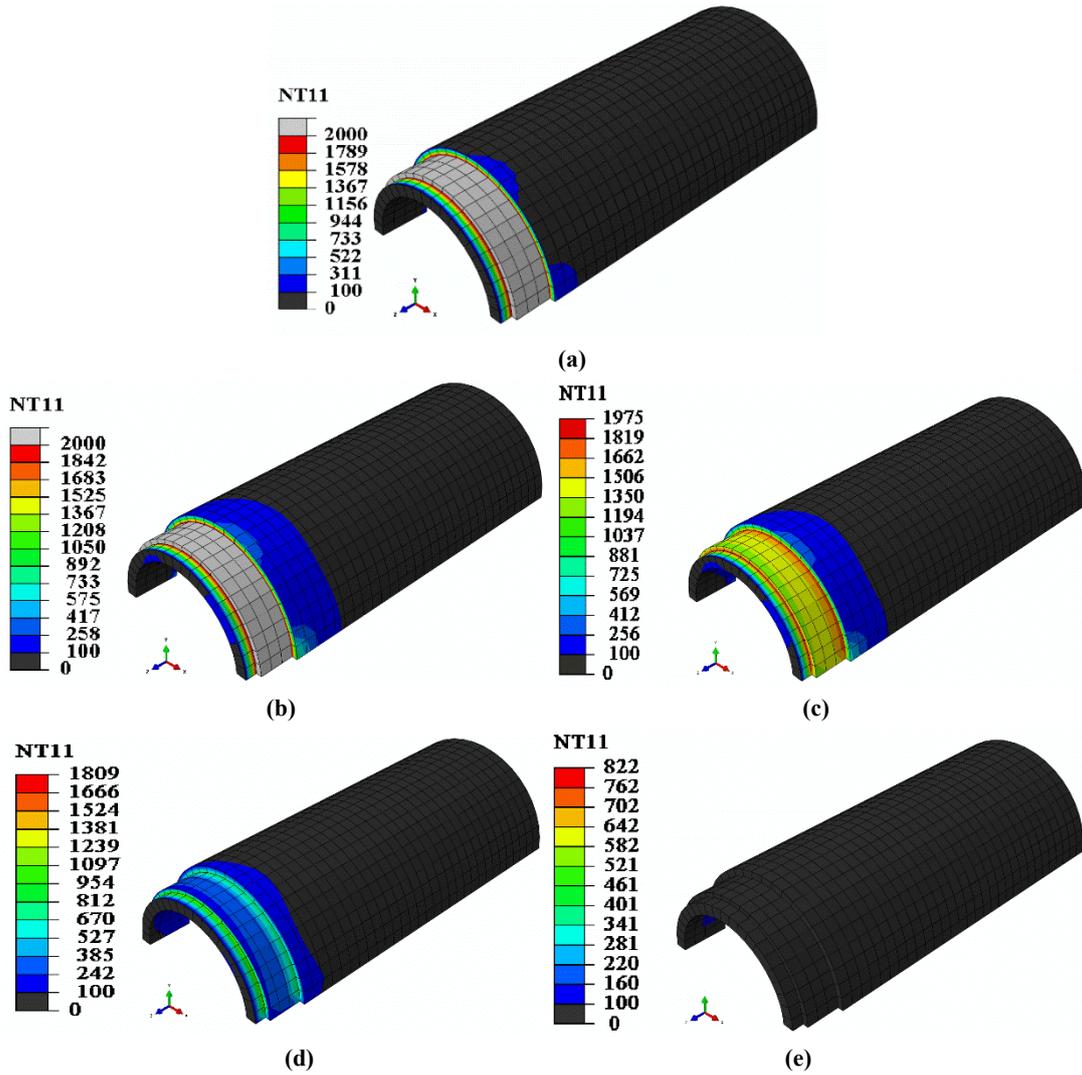
Fig. 8. Temperature distributions of mortar-containing glazed tiles at different times under 8/20  $\mu$ s lightning current waveform with peak of 40 kA, (a) 8  $\mu$ s; (b) 100  $\mu$ s; (c) 0.16 s; (d) 1.19 s; (e) 9.78 s.

s for the temperature of the glazed tile to reduce to 25  $^{\circ}\text{C}$ , as shown in Figs. 8(b)–(d).

Under the effect of lightning current, the temperature in the glazed tiles showed an uneven gradient distribution. The temperature of the mortar exhibited an evident increase because of its high electrical conductivity. However, the body had a narrow temperature spread range because of its lower conductivity, and a significant rise in the temperature was only observed in the part of the junction between the mortar and the body.

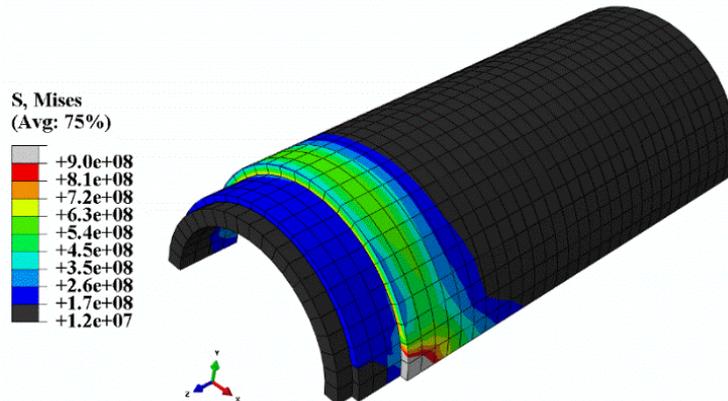
Fig. 9. Thermal stress distribution of mortar-containing glazed tile at the end of the 8/20  $\mu$ s lightning waveform current with peak of 40 kA (at 100  $\mu$ s)

Fig. 9 presents the thermal stress distribution of the glazed tiles at the end of the 8/20  $\mu\text{s}$  lightning current waveform with peak of 40 kA. As observed, under Joule heat, the thermal stresses of the mortar and adjacent body zone of the tile reach the upper damage threshold limit, 0.172 GPa, whereas the thermal stress at the junction of the mortar and body as well as the grounding rail was more significant, even higher than the upper damage threshold limit of 0.9 GPa. Comparing Fig.9 with Fig. 8, the area with a thermal stress greater than 0.172 GPa is mainly concentrated in areas with significant temperature differences, such as the connection between the mortar and body as well as the connection between the body and the grounding rail. Under the thermal stress induced by the regional uneven temperature distribution and explosive force inside the tiles due to vaporization, the swelling in the internal tiles accelerated and finally surpassed the yield strength, leading to deformation, cracks, and even fractures. From the results shown in Fig. 9, the spatial distribution and change range of the thermal stress are in good agreement with the experimental results; thus, the effectiveness of the simulations is validated.

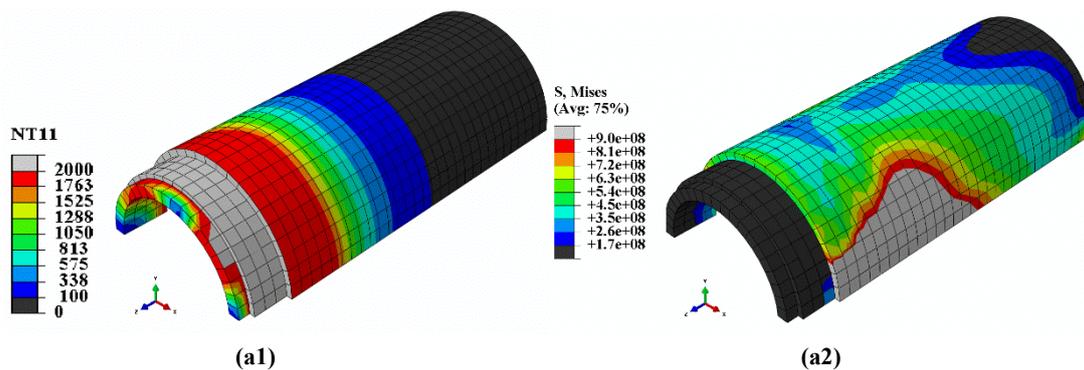
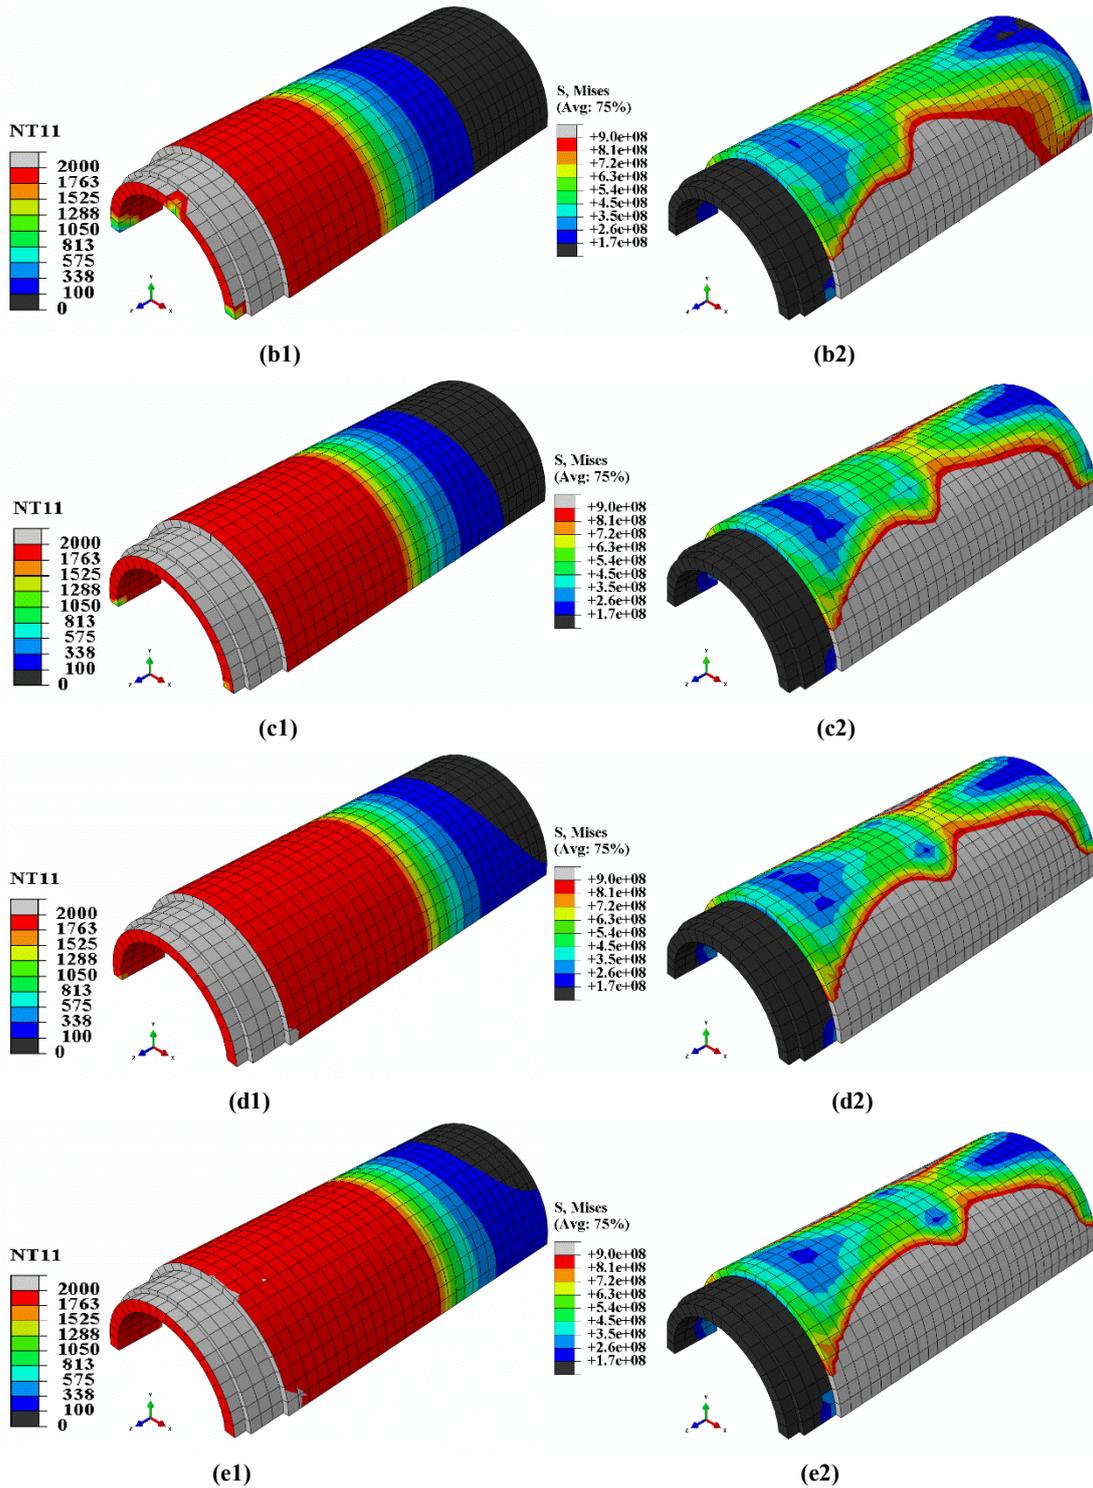
Fig. 10. Temperature and thermal stress fields of mortar-containing glazed tiles on completion of 10/350  $\mu$ s current waveform with different peaks (at 2 ms), (a1) Temperature at 40 kA; (a2) Thermal stress at 40 kA; (b1) Temperature at 80 kA; (b2) Thermal stress at 80 kA; (c1) Temperature at 120 kA; (c2) Thermal stress at 120 kA; (d1) Temperature at 160 kA; (d2) Thermal stress at 160 kA; (e1) Temperature at 200 kA; (e2) Thermal stress at 200 kA.

thermal stress of the mortar-containing glazed tiles at the end (2 ms) of the 10/350  $\mu\text{s}$  lightning current waveform were obtained through simulations, to study the effect of the change in the peak lightning current on the damage to the glazed tiles. Fig. 10 shows the simulation results. A comparison of the temperature distribution and thermal stress under different peak currents shows that, as the peak increased, the expanding range continues to increase despite the same loading duration of the current, and the high thermal stress area also keeps increasing and expands toward the tile ridge. The areas with the thermal stress over the damage threshold of 0.172 GPa are mainly at locations that show heterogeneous temperature distributions. Fig. 10(b) shows that, when the peak lightning current reaches 80 kA, the thermal stress in almost the entire body zone have surpassed 0.172 GPa, suggesting that the total fracturing damage is likely to occur in the glazed tiles.

As the lightning current enhanced, the areas with high temperatures and thermal stress in the initial stages sharply increased (Figs. 10 a1-b1-c1, Figs. 10 a2-b2-c2), and the increments were significant; as the lightning current continued to enhance in the following stages, the ranges of the high temperature and thermal stress showed a gradual increase in their magnitude (Figs. 10 c1-d1-e1, Figs. 10 c2-d2-e2). A preliminary analysis concluded that the tile had a limited capacity to conduct current in the body through

the mortar, and when the lightning current was small, the magnification in the high-temperature area was evident, whereas it was not evident due to the influence of conduction channel when the lightning current was high. Unlike the results shown in Fig. 9, despite the highest temperature in the entire mortar area shown in Fig. 10, the temperature at the connection between the mortar and body grew significantly because of the long duration of the 10/350  $\mu\text{s}$  current waveform, leading to a minor temperature difference and thus a lower thermal stress in the mortar. Additionally, similar to the results shown in Fig. 9, the high-thermal-stress area appeared in the body connected to the grounding rail, extending to the ridge of the tile, as shown in Fig. 10. This can be attributed to the ease of lightning current conduction toward the grounding rail, which caused frequent changes and an uneven distribution of the temperature in the grounding rail.

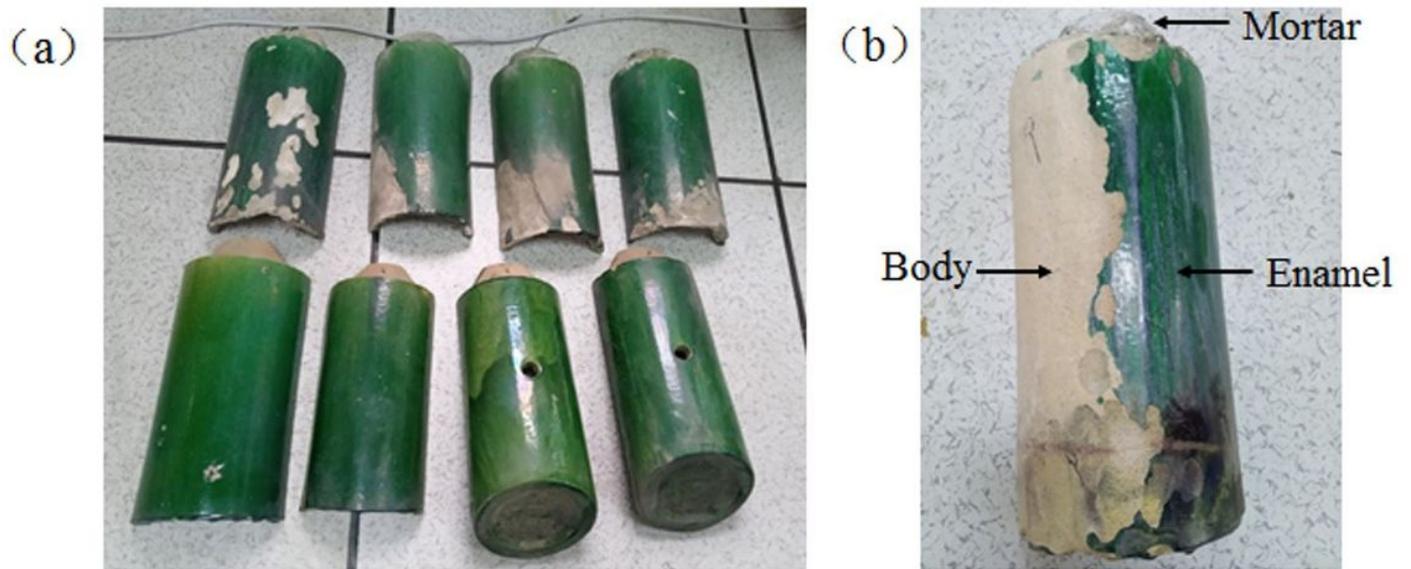
Figure 1

Specimens of (a) relatively intact glazed tiles; (b) half enamel and half body tile.

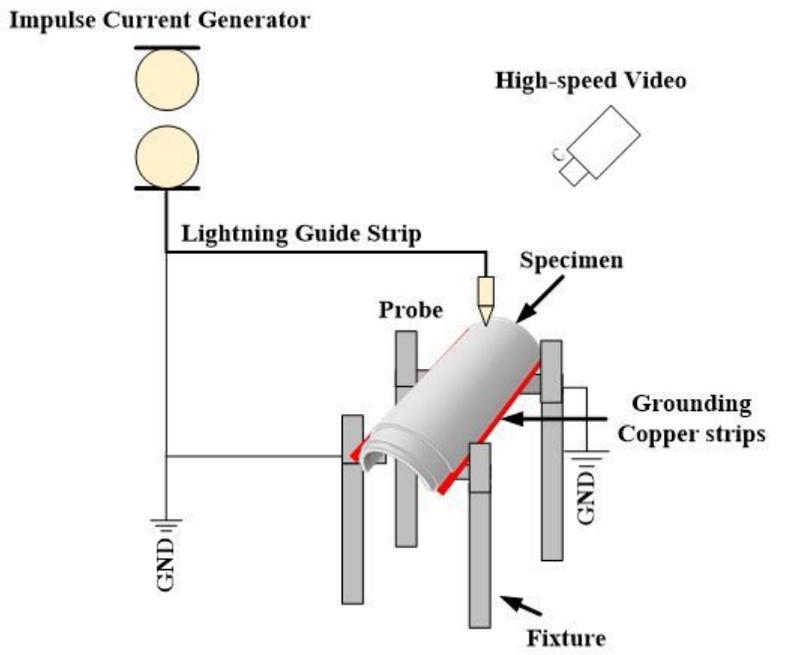
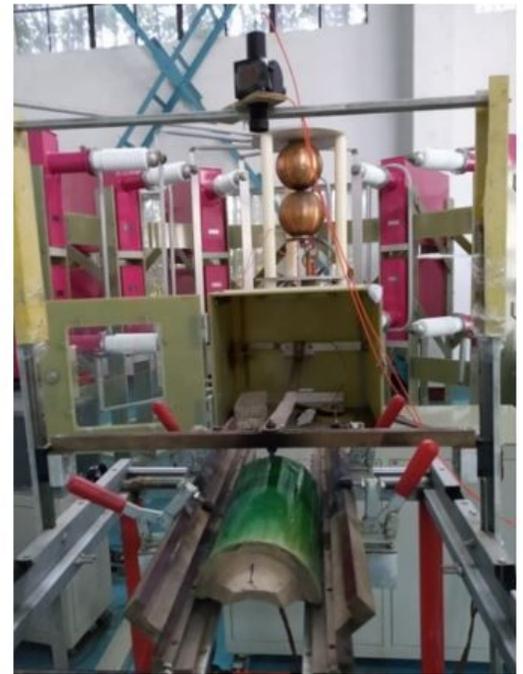
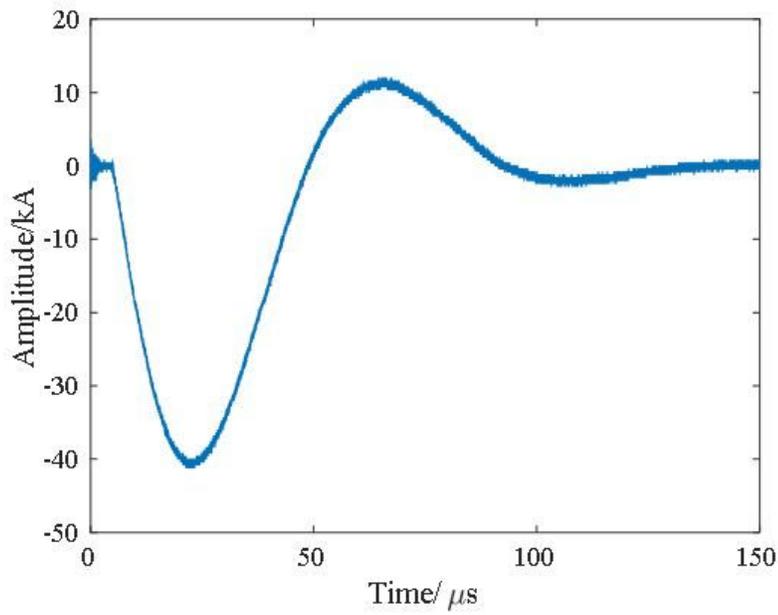
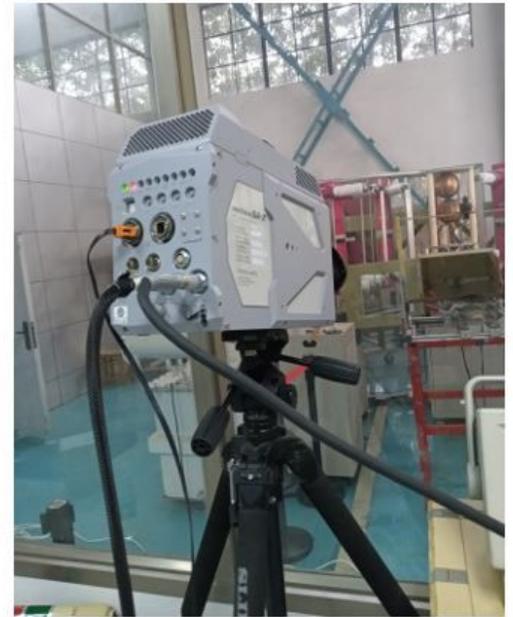
**Figure 2**

Experimental setup for artificial lightning strike Test, (a) Schematic of experimental setup; (b) Image of experimental setup; (c) Waveform of the impulse current in the experiments; (d) High-speed camera.

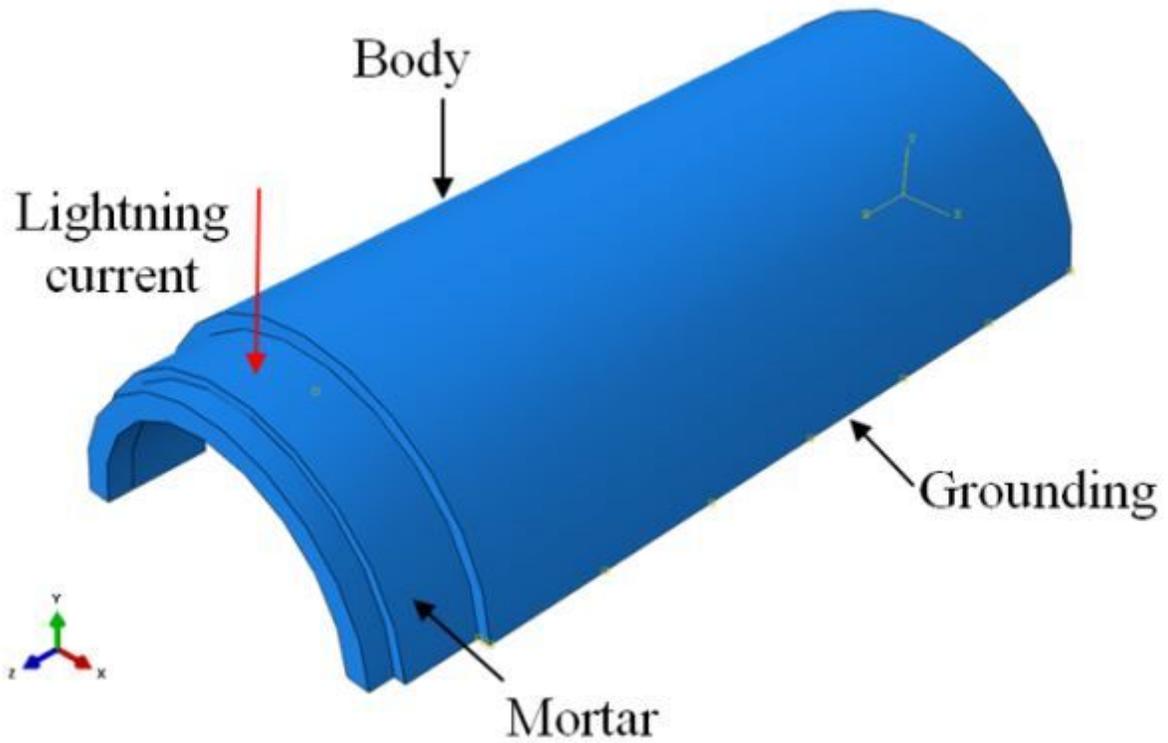
Figure 3

Electrical-thermal coupling FEM of mortar-containing glazed tile

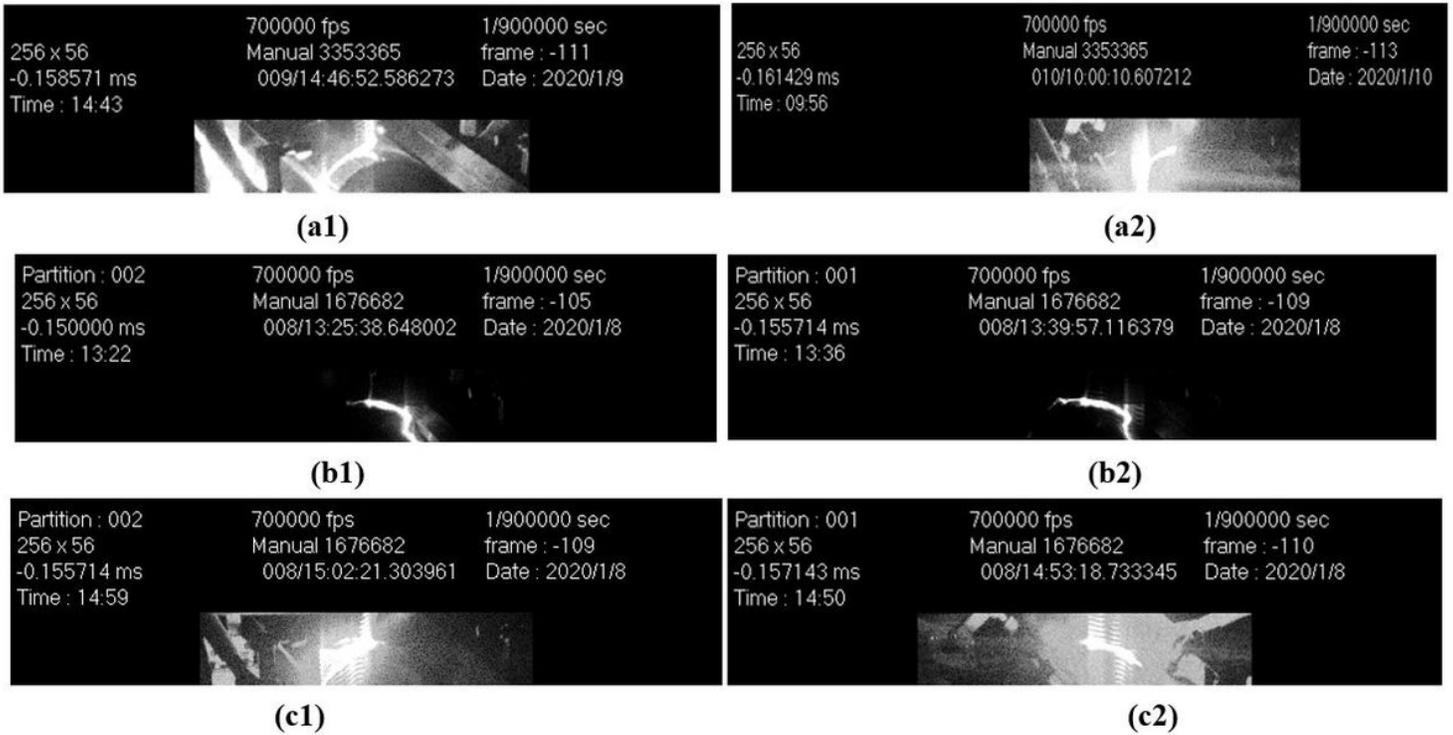
Figure 4

Lightning channels at different attachment positions based on high-speed camera observation, (a1) 1# full-enamel glazed tile specimens; (a2) 2# full-enamel glazed tile specimens; (b1) 3# full-body glazed tile specimen; (b2) 4# full-body glazed tile specimens; (c1) 5# semi-enamel and semi-body glazed tile specimens; (c2) 6# semi-enamel and semi-body glazed tile specimens.

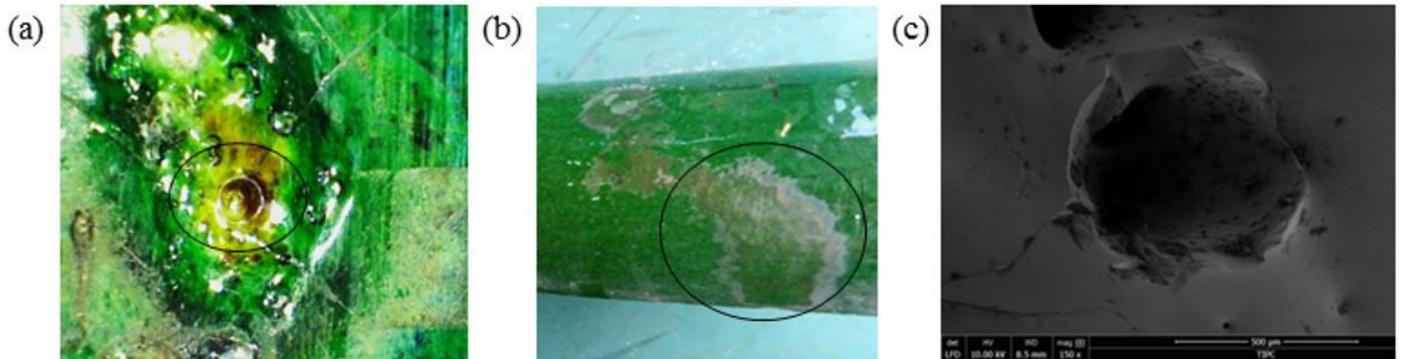
**Figure 5**

Damage to enamel of glazed tile due to lightning strike, (a) Ablation pit in enamel; (b) Surface ablation in enamel; (c) Pit damage observed by SEM.

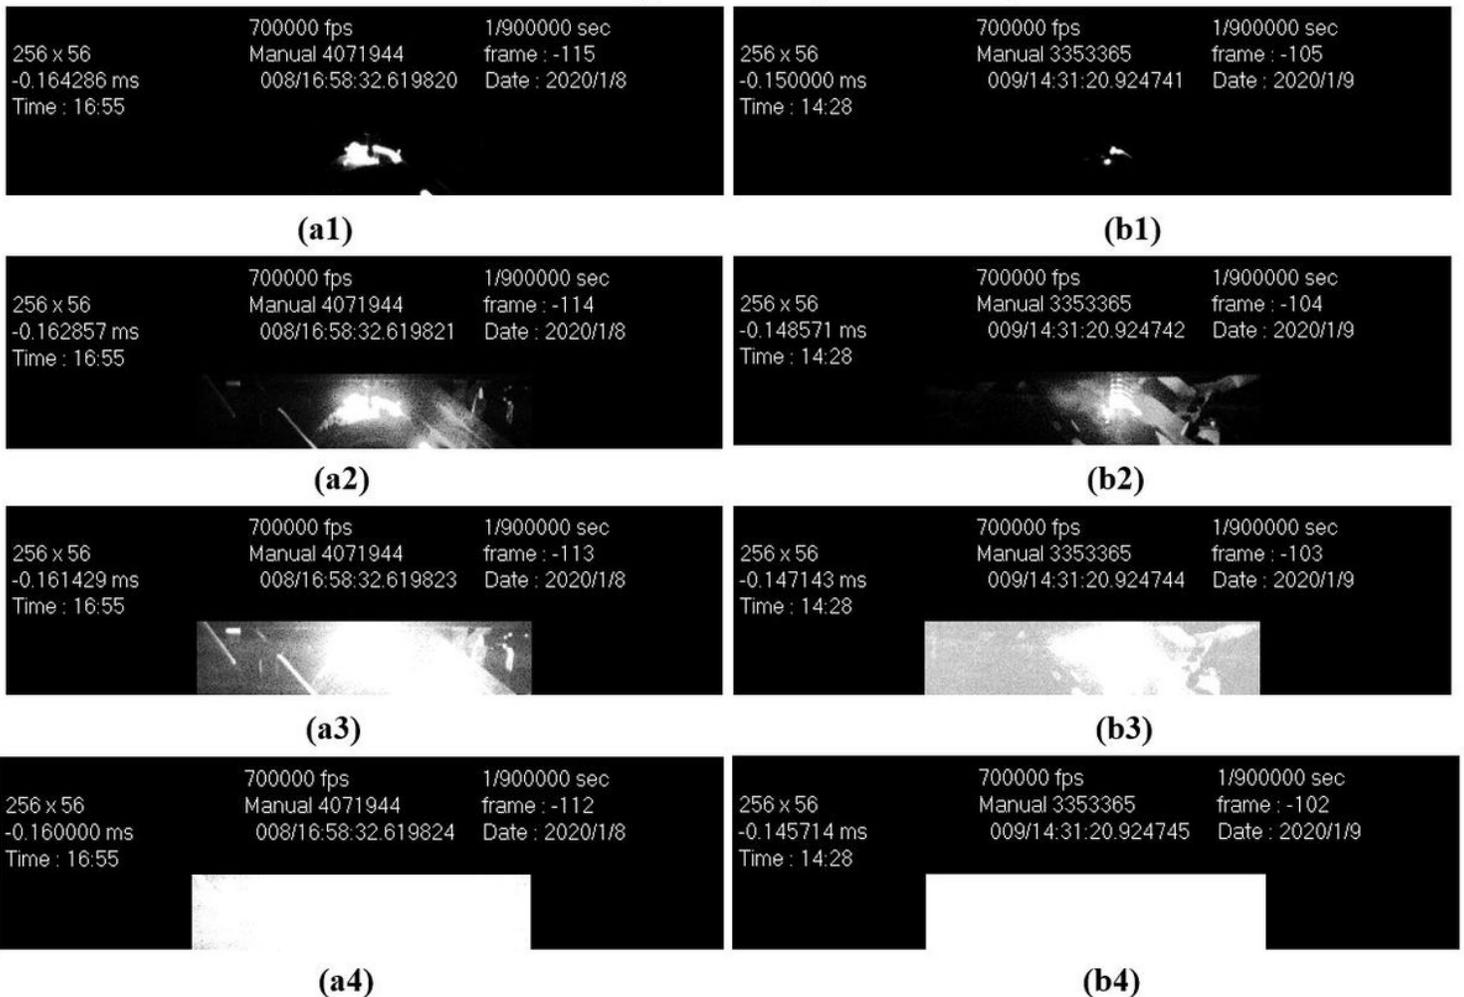
## Figure 6

Lightning channels at mortar attachment positions based on high-speed camera observation, (a1) Position of 7# mortar; (b1) Position of 8# mortar; (a2) Position of 7# mortar; (b2) Position of 8# mortar; (a3) Position of 7# mortar; (b3) Position of 8# mortar; (a4) Position of 7# mortar; (b4) Position of 8# mortar

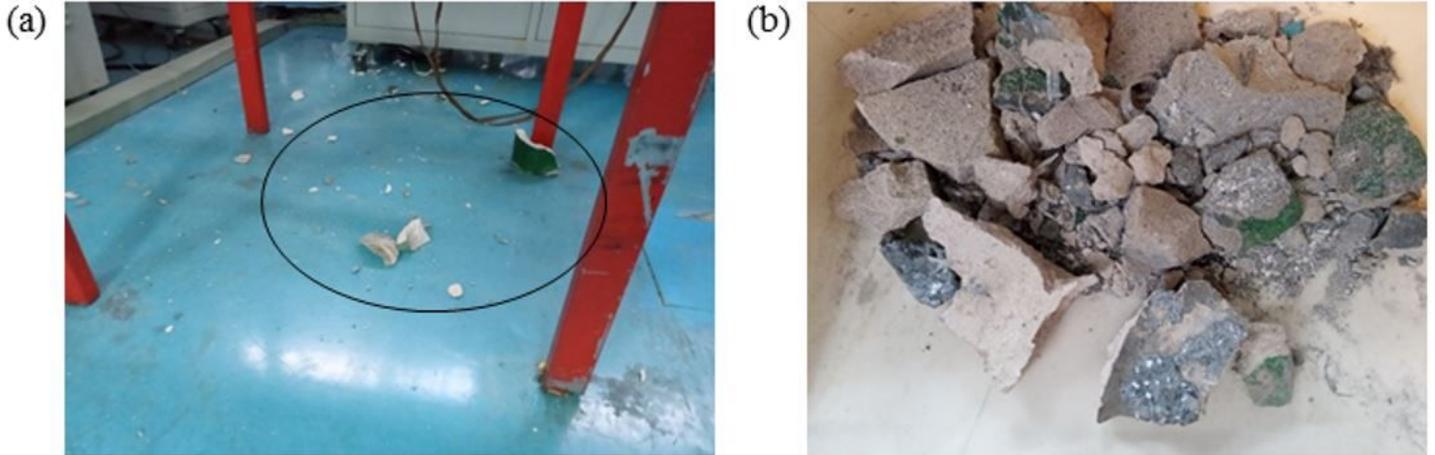
## Figure 7

Damage to glazed tiles after artificial lightning strike on mortars, (a) Fractures of glazed tiles after lightning strike under the platform; (b) Collected fractures of glazed tiles.

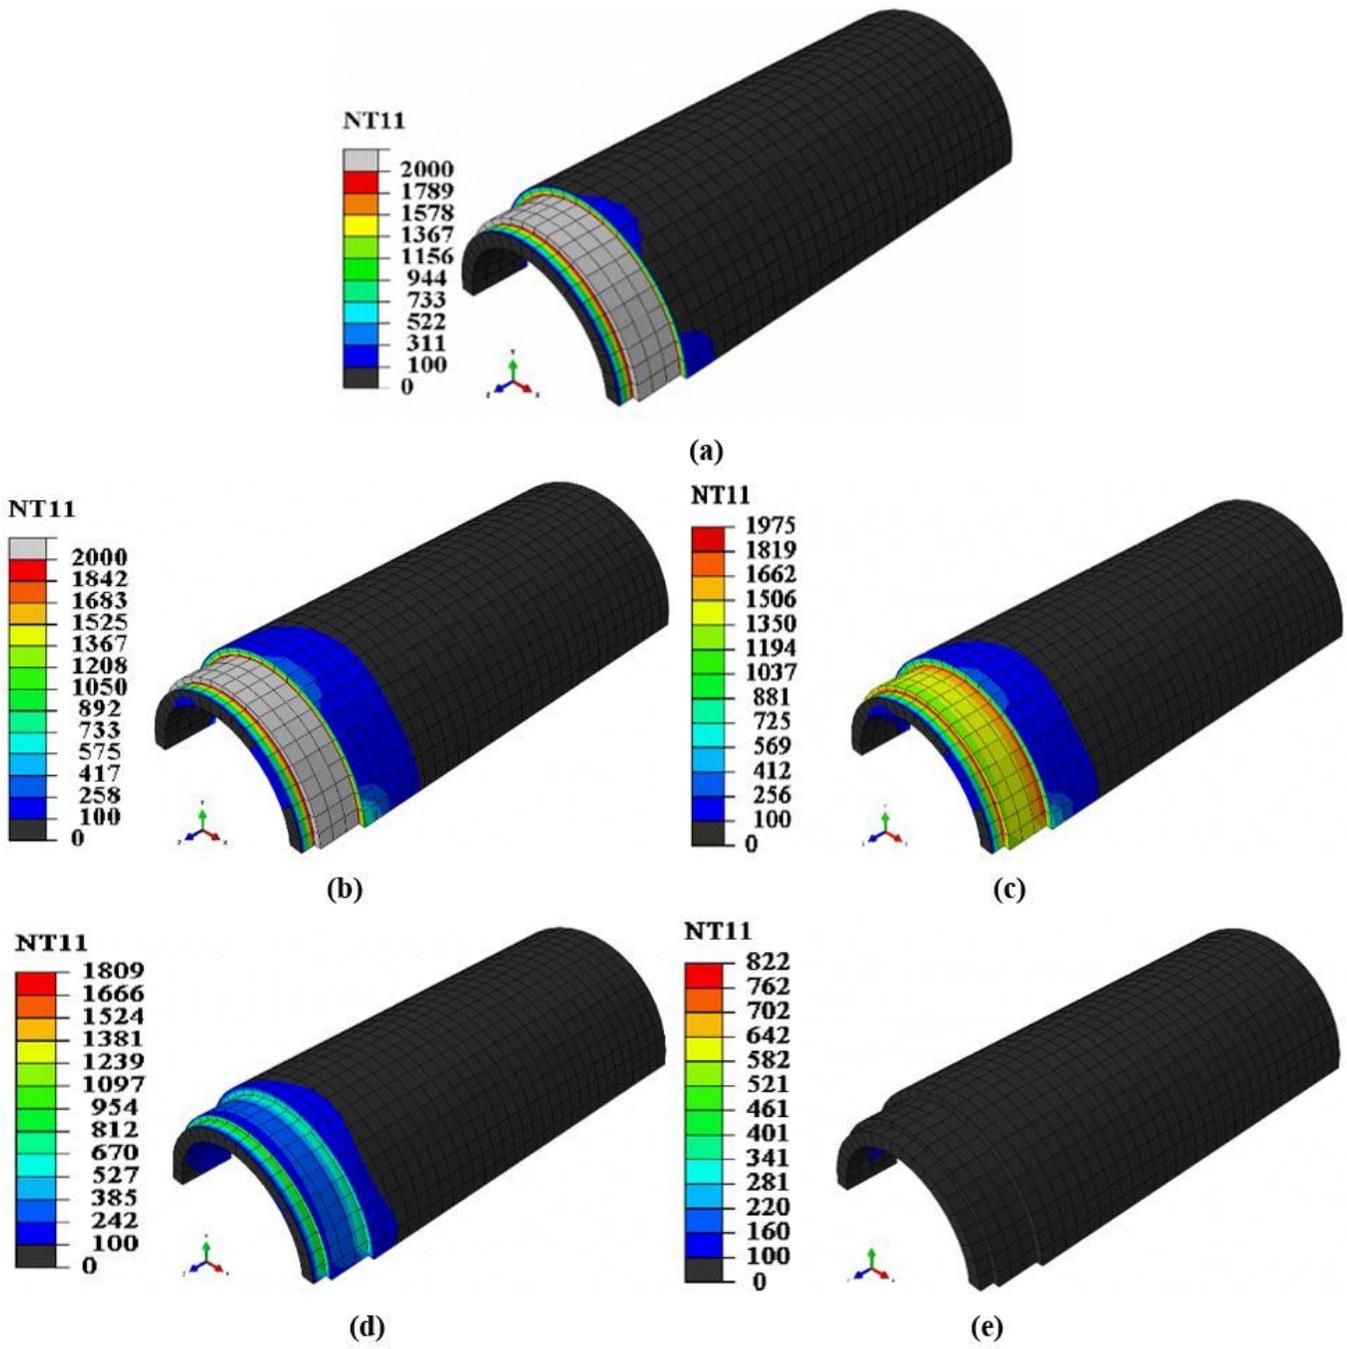
Figure 8

Temperature distributions of mortar-containing glazed tiles at different times under 8/20 μs lightning current waveform with peak of 40 kA, (a) 8 μs; (b) 100 μs; (c) 0.16 s; (d) 1.19 s; (e) 9.78 s.

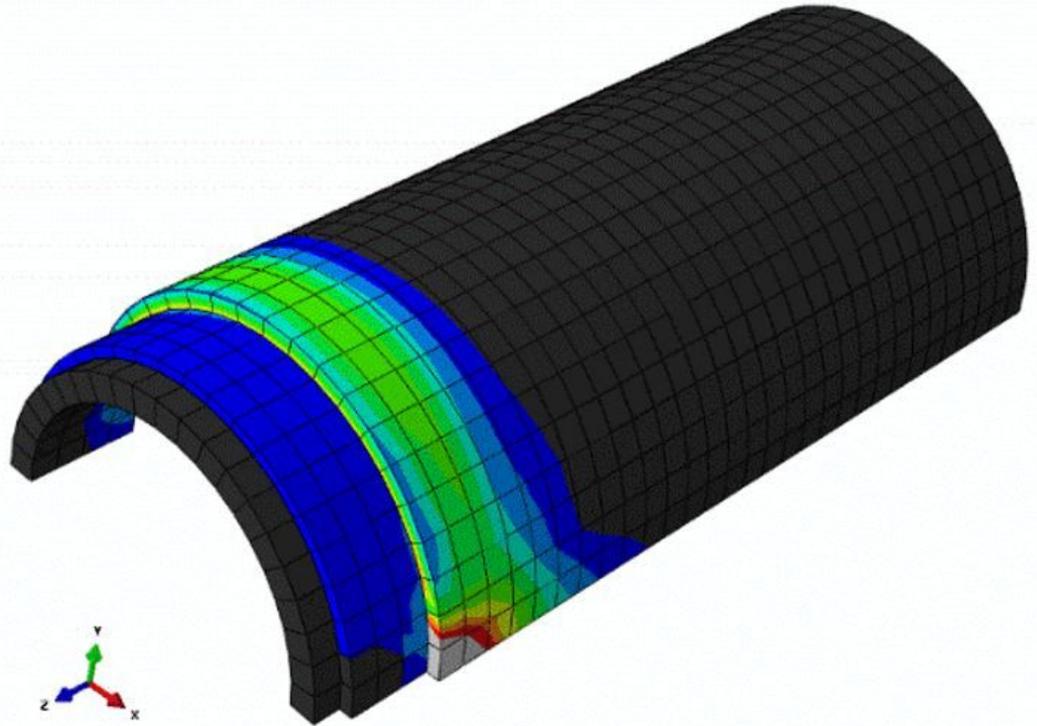
Figure 9

Thermal stress distribution of mortar-containing glazed tile at the end of the 8/20  $\mu\text{s}$  lightning waveform current with peak of 40 kA (at 100  $\mu\text{s}$ )

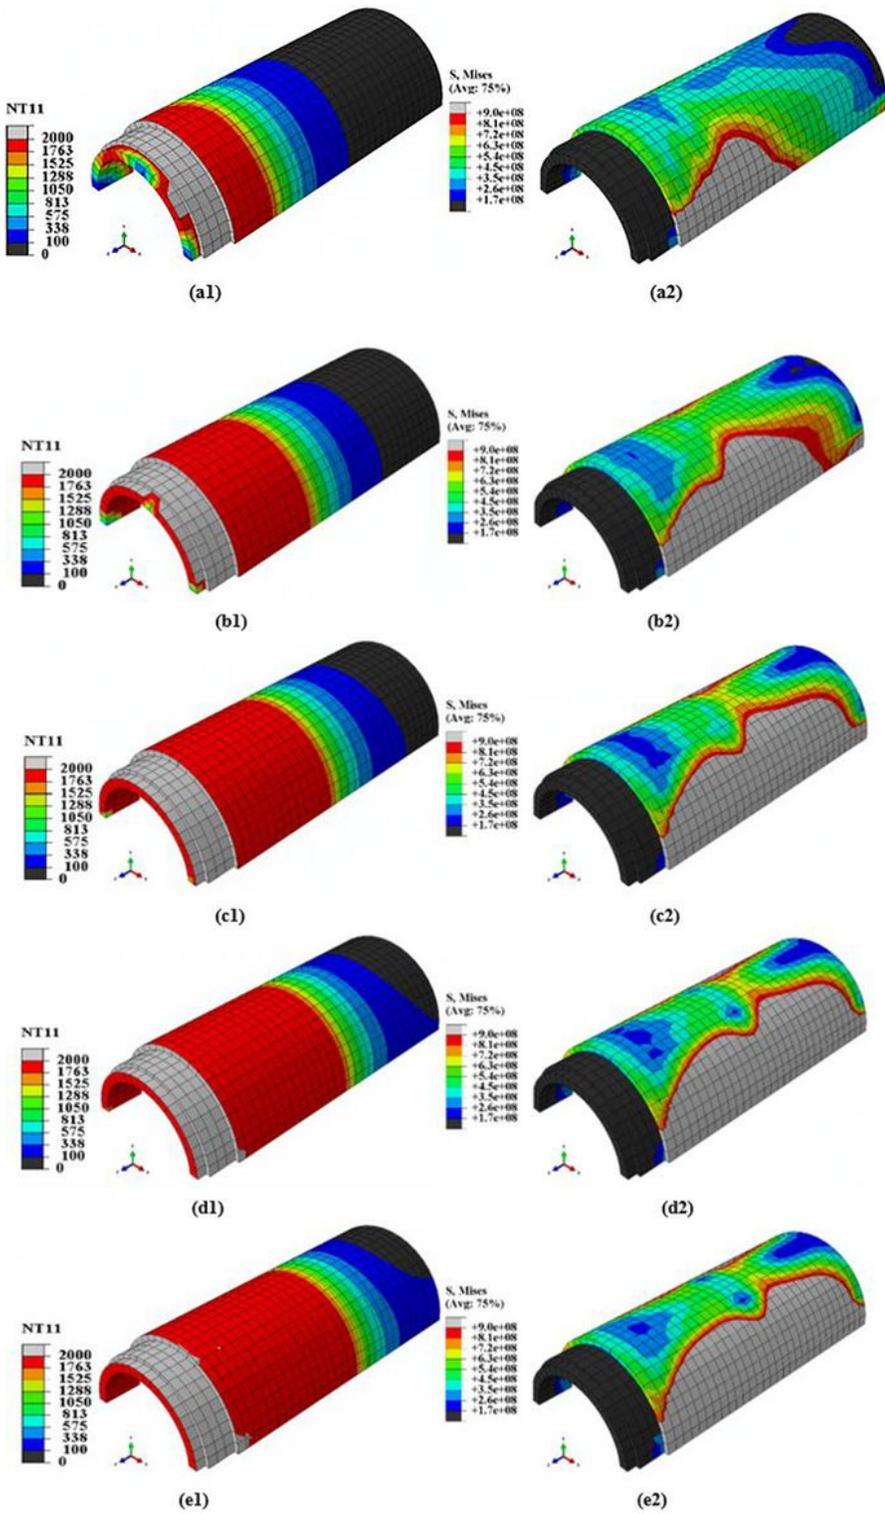
**Figure 10**

Temperature and thermal stress fields of mortar-containing glazed tiles on completion of 10/350  $\mu$ s current waveform with different peaks (at 2 ms), (a1) Temperature at 40 kA; (a2) Thermal stress at 40 kA; (b1) Temperature at 80 kA; (b2) Thermal stress at 80 kA; (c1) Temperature at 120 kA; (c2) Thermal stress at 120 kA; (d1) Temperature at 160 kA; (d2) Thermal stress at 160 kA; (e1) Temperature at 200 kA; (e2) Thermal stress at 200 kA.
