# Deformations on a Talings Dam Embankment Due to Its Heightening and Reservoir Filling

## Research Article

**Keywords:** Deformation, Displacements, Tailings Dam, Bidimensional numerical model, Tridimensional numerical modeling

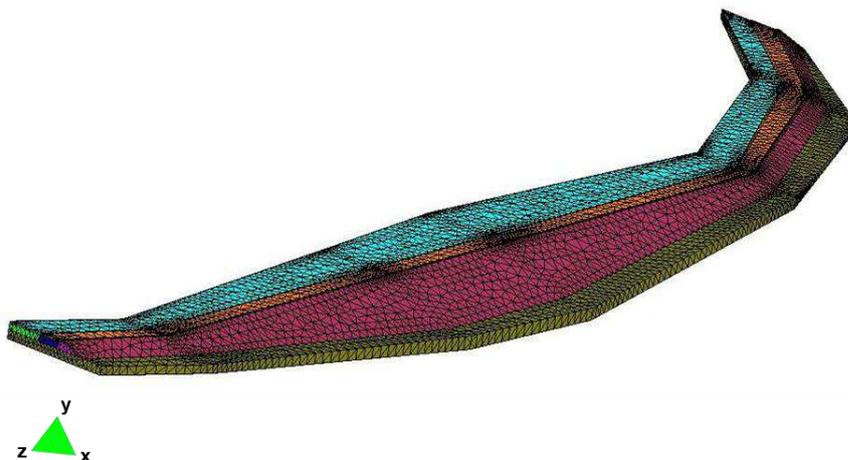
500  
501 **Figure 13. Finite elements of the surface of the model**

491  
492 The tridimensional model (figure 13) was built with the purpose to assess the construction effect  
493 of two heightening stages over the existing embankment. These stages are 12A and 13. In a  
494 preliminary stage, it was built the whole existing massif, before the heightening. Nest I was built in  
495 a single stage the heightening corresponding to stages 12A and 13, with the simultaneous  
496 construction of the compacted embankment, launched fill platform, and reservoir filling. In this  
497 way, it was evaluated the global effects of the heightening and reservoir filling over the existing  
498 embankment, referring to stages 12A and 13.  
499
