Probing inter- mixed transgranular stress corrosion cracking under the high load

Article

Abstract: Stress corrosion cracking (SCC) of non-sensitized austenitic stainless steel during immersion of MgCl₂ solutions was investigated by X-ray computed tomography and scanning electron microscopy. SCC cracks propagated transgranularly at the initial stage, and switched to the IGSCC mode under the nominal stress of 120 MPa. No dimples were present on the SCC fractography, but numerous cleavage facets, slip bands and pits emerged. The cohesive zone appeared ahead of the crack tip. It is indicated that the high-load SCC also coincides with the cleavage dissolution mechanism, predominantly originating from the corrosive environment particle assisted cleavage and the obstacle induced dislocation pinning.

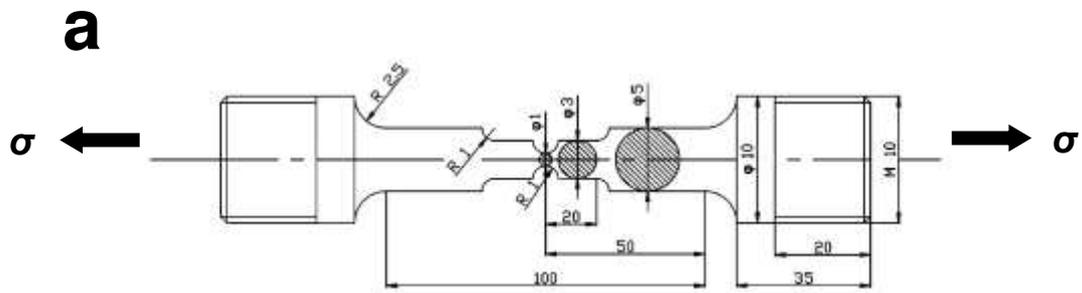
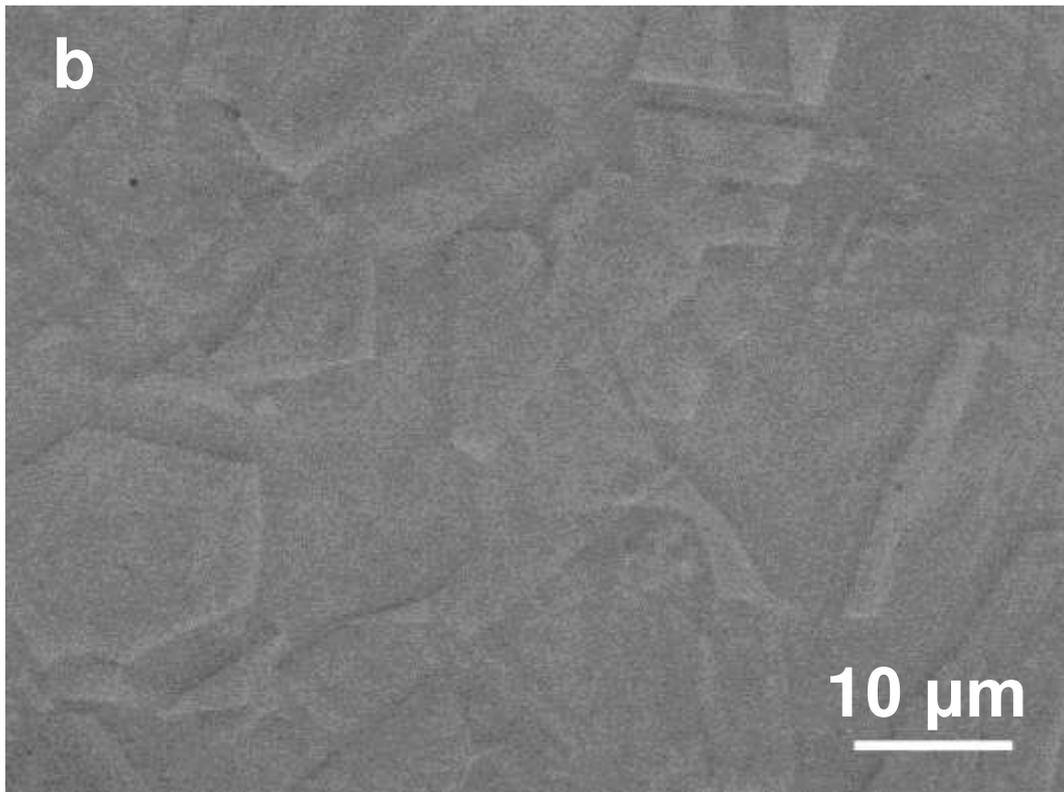
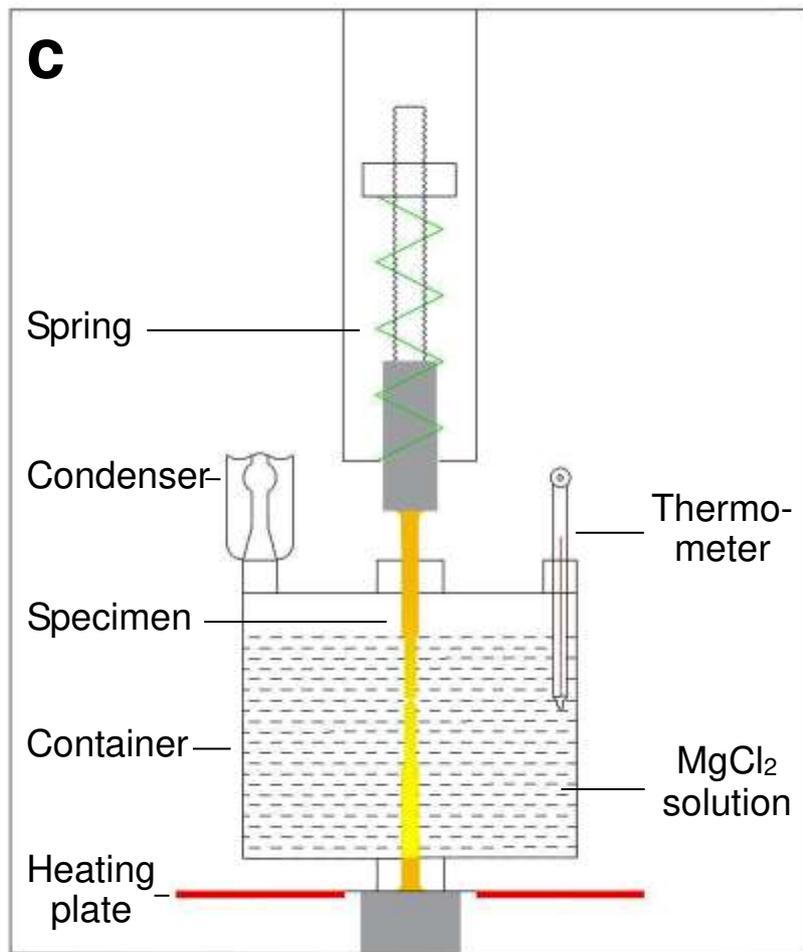
Figure 1

Fig. 1 Materials and the setup. a Schematic diagram of type 316L stainless steel cylinder specimen subjected to a constant nominal stress of $\sigma_{nom} = 120$ MPa in the narrowest section with the approximately 1 mm diameter. **b** Metallographic morphology. **c** Schematic diagram of the spring-loaded SCC setup.

The type 316L non-sensitized austenitic stainless steel were used in this study with the following chemical composition except trace amounts of C, P and S: Cr-17.40 wt.%, Ni-10.47 wt.%, Mo-2.51 wt.%, Mn-1.03 wt.%, Si-0.45 wt.%, Fe-balance. The cylinder specimens with the 1-millimeter-diameter narrowest section were prepared by the following method: wire-electrode cutting; rinsing in acetone; cleaning in deionized water; hot air drying and storing in a desiccated chamber. The schematic diagram of the cylinder specimen is shown in Fig. 1 (a). According to the ASTM G36-94 (2018), the specimen subjected to the nominal stress of $\sigma_{\text{nom}} = 120$ MPa applied by a spring-type constant load setup (seen in Fig. 1), was immersed into a boiling 45 wt.% \pm 1 wt.% MgCl₂ solution in an open circuit condition. Wherein, the condenser was exploited to keep the solution density constant in the glass container. During the SCC processes, the tested specimens were visually examined every about 2 h, and the fracture time approximated to the mean time of the last recorded time before fracture and the first recorded time after fracture. The SCC tests were successfully repeated for three times in the same experimental condition. For an initially-fractured vertical specimen, the upper half part was taken out as soon as possible to prevent the fractured specimen from general corrosion, which was eventually characterized by the X-ray computed tomography (XCT). The lower half

Fig. 1 **Materials and the setup.** **a** Schematic diagram of type 316L stainless steel cylinder specimen subjected to a constant nominal stress of $\sigma_{\text{nom}} = 120$ MPa in the narrowest section with the approximately 1 mm diameter. **b** Metallographic morphology. **c** Schematic diagram of the spring-loaded SCC setup.

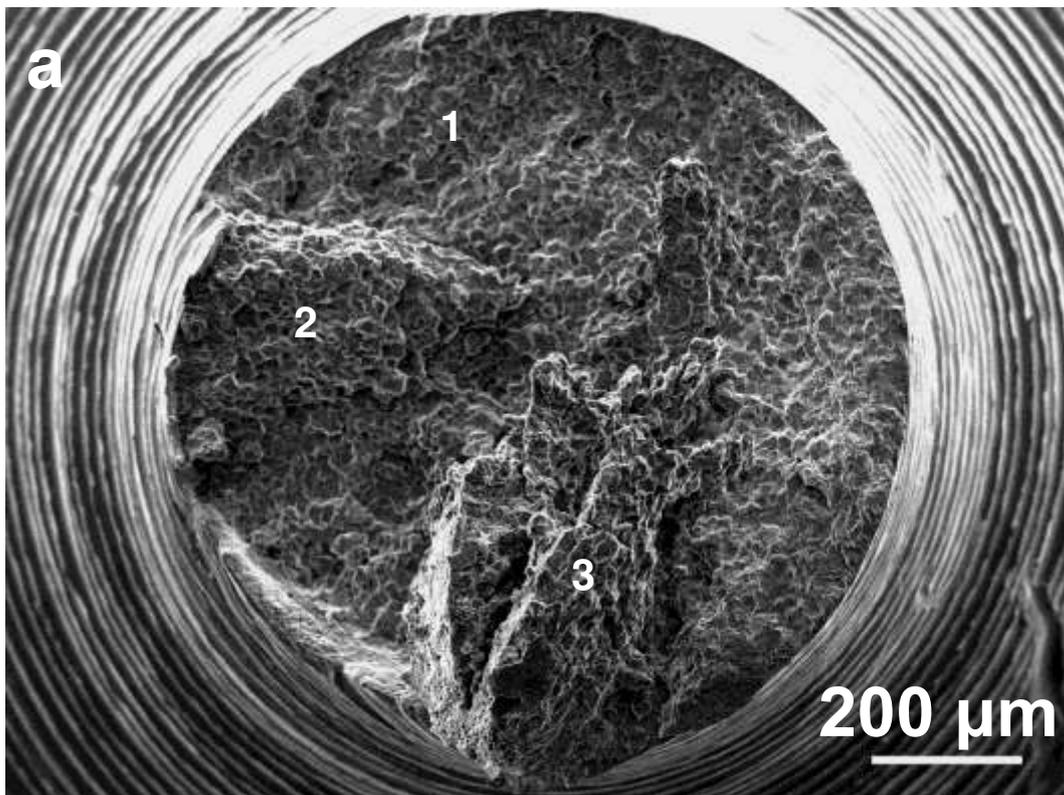
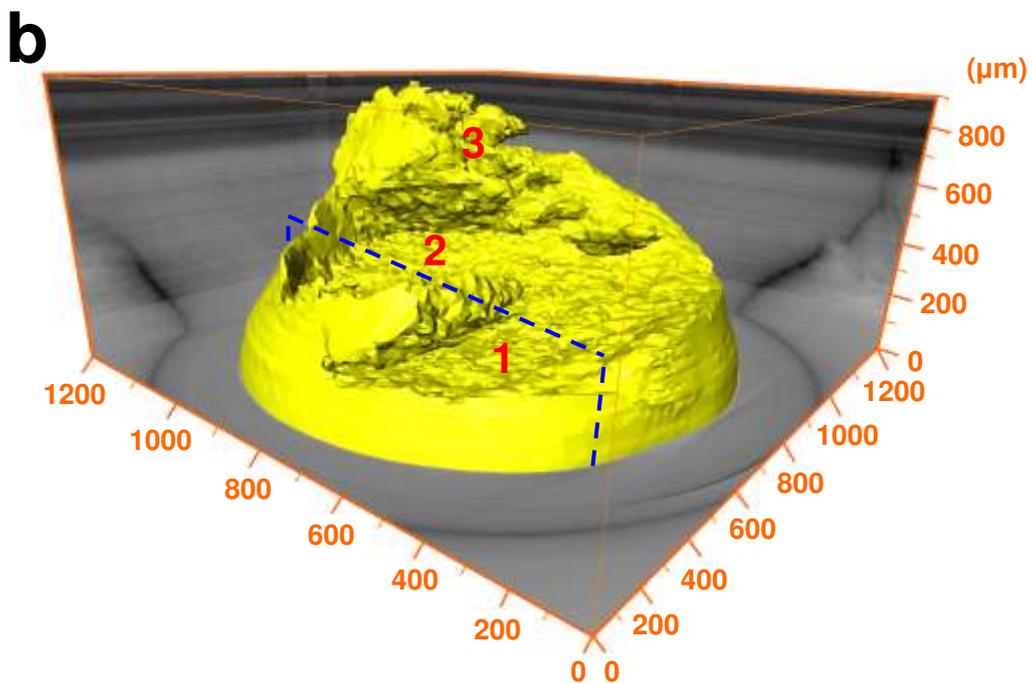
Figure 2

Fig. 2 Two- and three-dimensional fracture surface morphologies of the upper half part of an initially-fractured specimen subjected to the chloride-solution immersion of about 10 h. a Two-dimensional SEM morphology. b

Three-dimensional XCT morphology consisting of three fracture surfaces marked by '1-3' and a tomographic slice labeled by a dotted rectangle.

SCC cracks and fracture surfaces. The tested specimens fractured after the chloride solution immersion of 2 h - 10 h at $\sigma_{nom} = 120$ MPa. As seen in Fig. 2a, for the upper half part of the specimen with the fracture time of about 10 h, the diameter of the macroscopic fractography was approximately 1 mm, almost equal to the narrowest section diameter of the original specimen. Simultaneously, the necking deformation was slighter on the side surface adjacent to the '1'-marked fracture surface than near the '2'- and '3'-marked fracture surfaces, shown in Fig. 2b. Both of the two- and three-dimensional SCC morphologies indicates that there were three fracture surfaces marked by '1-3' on the macroscopic fractography. Furthermore, the two-dimensional section perpendicular to the '1'- and '2'-marked fracture surfaces was drawn from the tomographic slices, shown in Fig. 3a. There was a ligament between the '1'- and '2'-marked fracture surfaces. Especially, a cohesive zone, identically named by the

Fig. 2 **Two- and three-dimensional fracture surface morphologies of the upper half part of an initially-fractured specimen subjected to the chloride-solution immersion of about 10 h.** **a** Two-dimensional SEM morphology. **b** Three-dimensional XCT morphology consisting of three fracture surfaces marked by '1-3' and a tomographic slice labeled by a dotted rectangle.

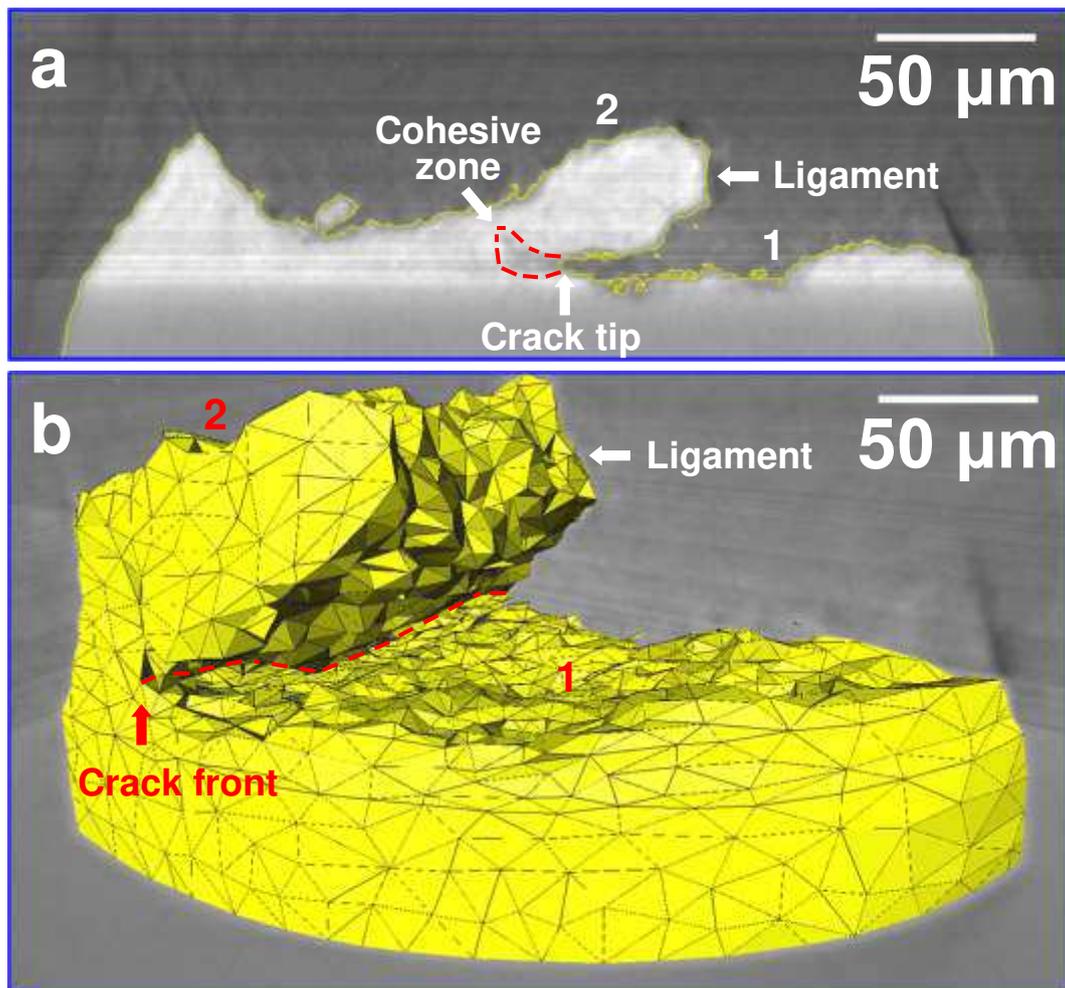
Figure 3

Fig. 3 Two- and three-dimensional SCC crack characterized by the XCT. a The two-dimensional section morphology of the tomographic slice labeled by the dotted-rectangle in Fig. 2b. **b** The three-dimensional local morphology ranging from the dotted-rectangle tomographic slice to the specimen surface. It is indicated that there was a cohesive zone ahead of the SCC crack tip.

elastic stress concentration zone [3] or the plastic zone [9], emerged ahead of the SCC crack tip. From the three-dimensional viewpoint, the corresponding SCC crack front was curved instead of being linear, shown in Fig. 3b.

Fig. 3 **Two- and three-dimensional SCC crack characterized by the XCT.** **a** The two-dimensional section morphology of the tomographic slice labeled by the dotted-rectangle in Fig. 2b. **b** The three-dimensional local morphology ranging from the dotted-rectangle tomographic slice to the specimen surface. It is indicated that there was a cohesive zone ahead of the SCC crack tip.

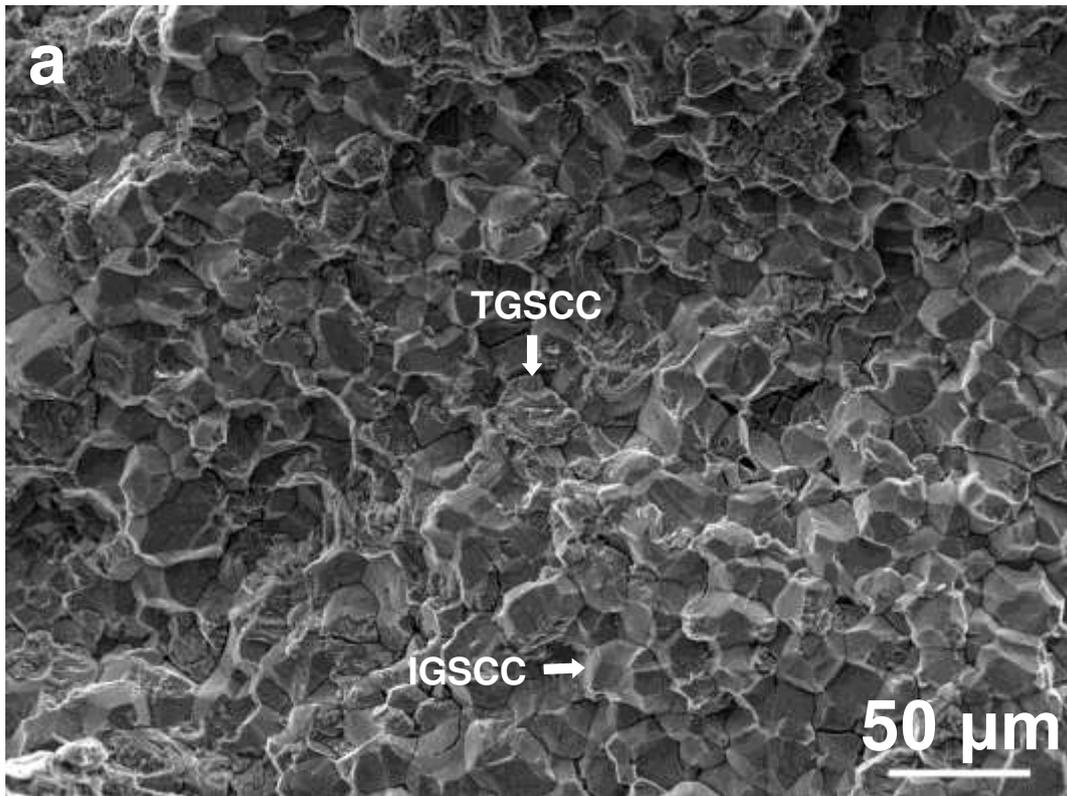
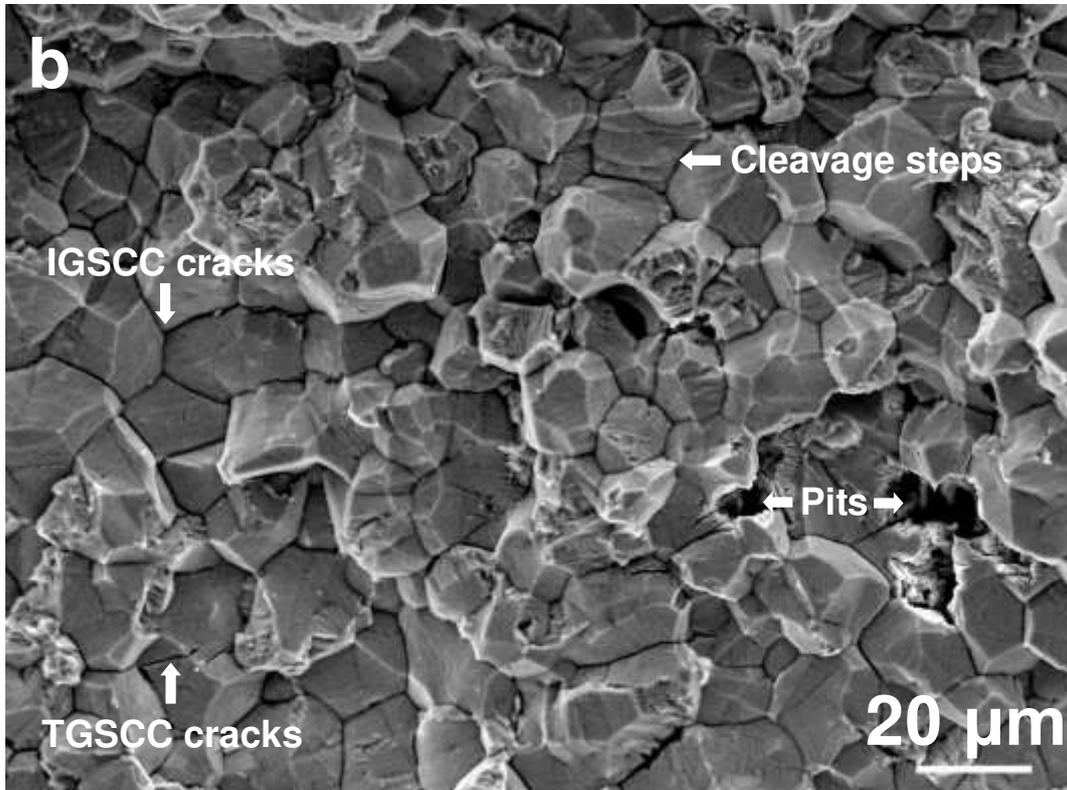
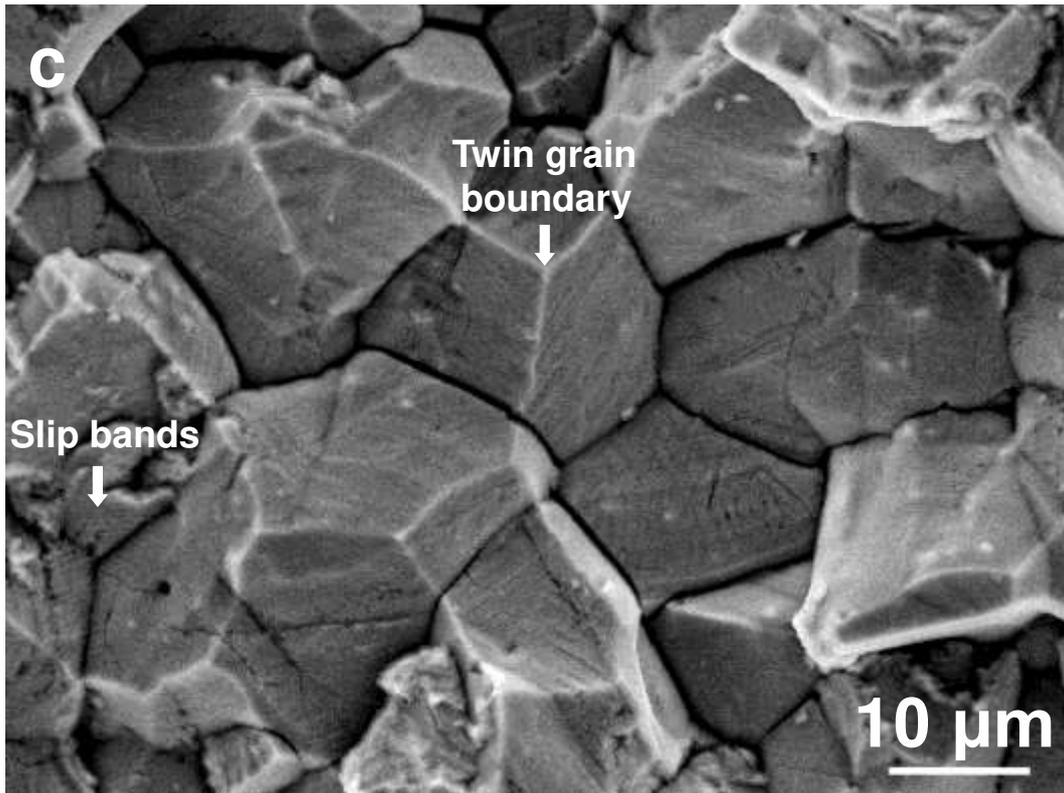
Figure 4

Fig. 4 Microscopic fractography of the upper half part of an initially-fractured specimen rinsing in acetone and cleaning in deionized water. a The IG- mixed with TGSCC. **b** The SCC cracks, the cleavage facets and the pits. **c** the slip bands during the IGSCC at the high stress level. It is apparent that no ductile dimples presented on the fracture surfaces.

IGSCC and TGSCC fractography. The microscopic fractography of the fractured specimens was exactly examined by the SEM. Akin to the specimen shown in Fig. 4a, all of the fractured specimens were susceptible to the IGSCC mixed with the TGSCC, and simultaneously there was no ductile dimple present in the IGSCC and TGSCC zones. It is also found that numerous IGSCC cracks, TGSCC cracks, cleavage facets and localized pits emerging on the microscopic fractography, shown in Fig. 4b. To clearly elucidate the high-load SCC mechanisms, the higher-resolution fractographic morphology was further detected in Fig. 4c. Most of the grain boundary facets were very flat in spite of some micron-scale-interval stripes existing on them. Meanwhile, the evident slip bands testified to occurrence of the ductile shear during the high-load fracture process. These unique phenomena reappeared in another fractured specimen after the chloride-solution immersion of about 7 h, shown in Fig. 5. The radial stripes show that the TGSCC primarily consisting of cleavage steps first initiated in the 'a₁' zone on the macroscopic fractography. Next, the IGSCC mixed with the TGSCC occurred to the accompaniment of flat facets in the 'a₂' zone with the increase of the crack-tip stress under the constant load. Ultimately, the ductile dimples were formed in the 'a₃' zone and the specimen fractured instantly. In addition, the corrosion product containing the oxygen and chlorine elements in Fig. 6 was stochastically distributed on the crystal planes or the grain boundary facets of the lower half part continuously

Fig. 4 **Microscopic fractography of the upper half part of an initially-fractured specimen rinsing in acetone and cleaning in deionized water.** **a** The IG- mixed with TGSCC. **b** The SCC cracks, the cleavage facets and the pits. **c** the slip bands

during the IGSCC at the high stress level. It is apparent that no ductile dimples presented on the fracture surfaces.

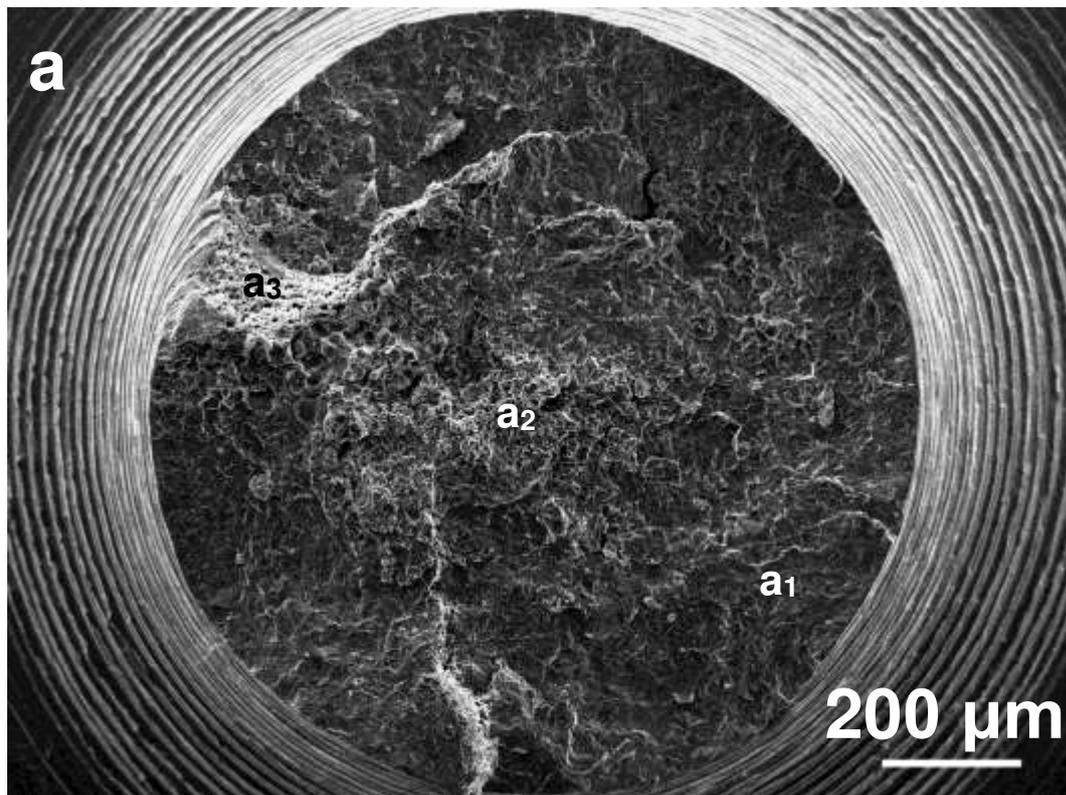
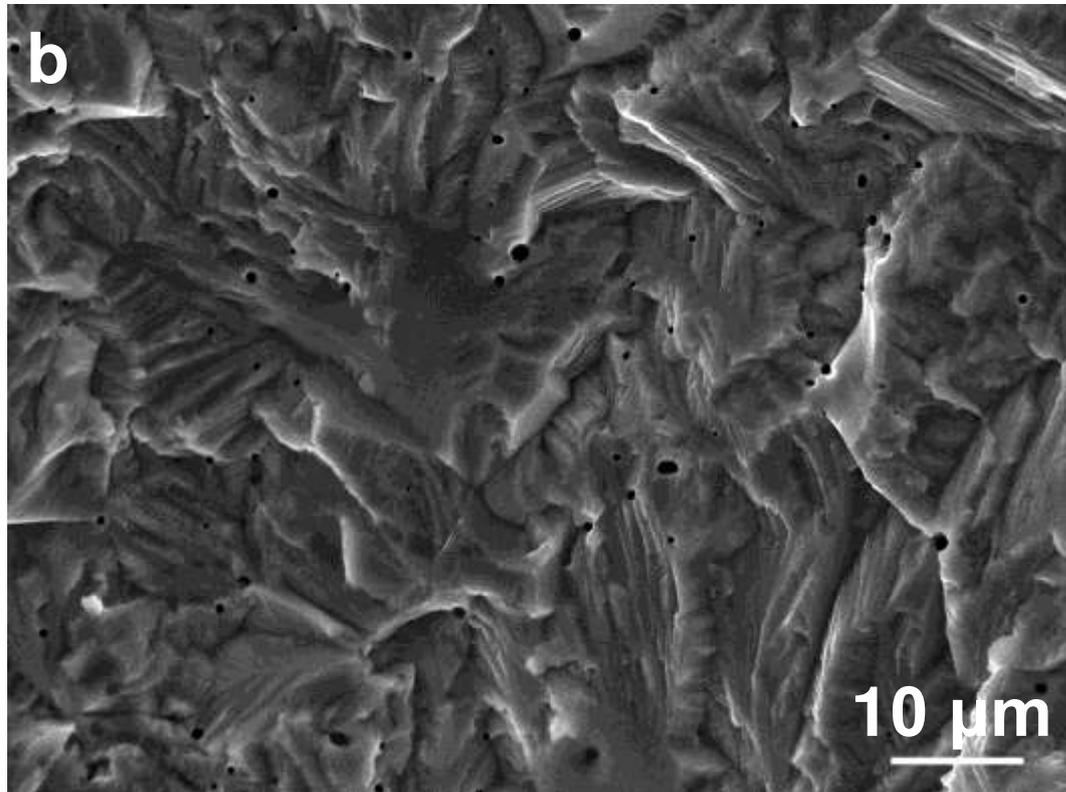
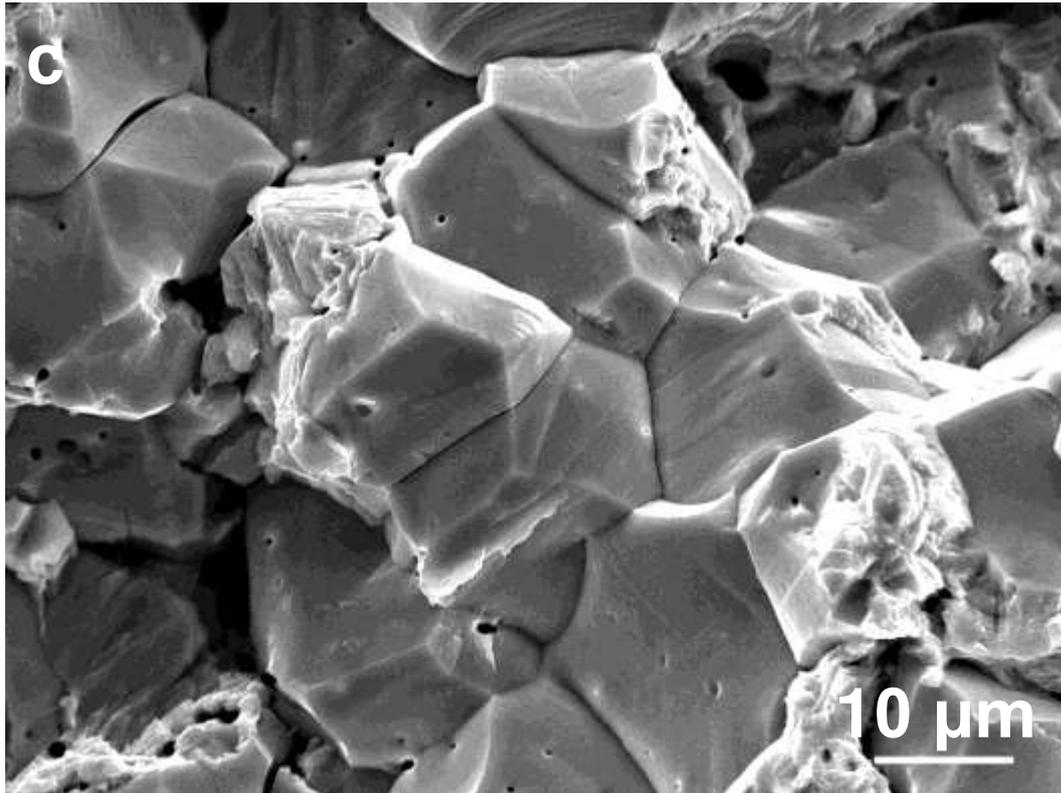
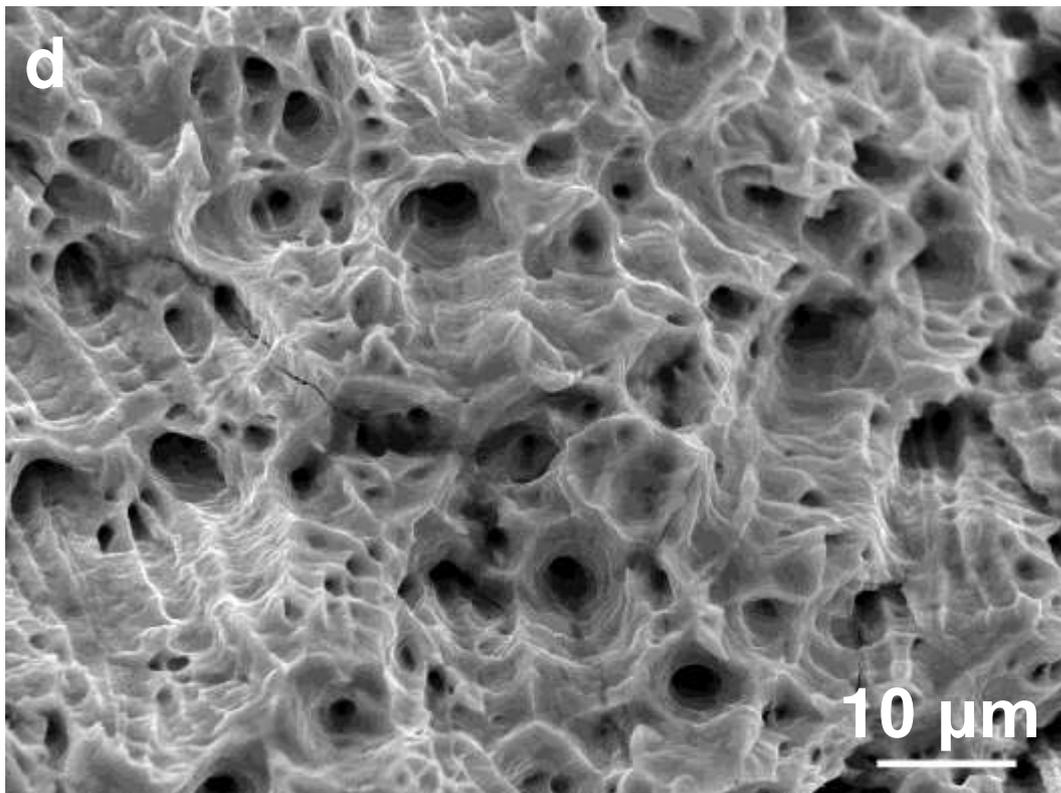
Figure 5

Fig. 5 Macro- and microscopic fractography of another initially-fractured specimen rinsing in acetone and cleaning in deionized water. a Macroscopic

fractography. **b** Microscopic TGSCC fractography in the 'a₁' zone. **c** Microscopic IGSCC mixed with TGSCC fractography in the 'a₂' zone. **d** Ductile-dimple fractography in the 'a₃' zone, where the predominant TGSCC initiated in the 'a₁' zone, subsequently propagated to the accompaniment of the IG- mixed TGSCC mode in the 'a₂' zone, and ultimately the specimen fractured in the 'a₃' zone after the chloride-solution immersion of about 7 h.

Fig. 5 Macro- and microscopic fractography of another initially-fractured specimen rinsing in acetone and cleaning in deionized water. a Macroscopic fractography. **b** Microscopic TGSCC fractography in the ‘a₁’ zone. **c** Microscopic IGSCC mixed with TGSCC fractography in the ‘a₂’ zone. **d** Ductile-dimple fractography in the ‘a₃’ zone, where the predominant TGSCC initiated in the ‘a₁’ zone, subsequently propagated to the accompaniment of the IG- mixed TGSCC mode in the ‘a₂’ zone, and ultimately the specimen fractured in the ‘a₃’ zone after the chloride-solution immersion of about 7 h.

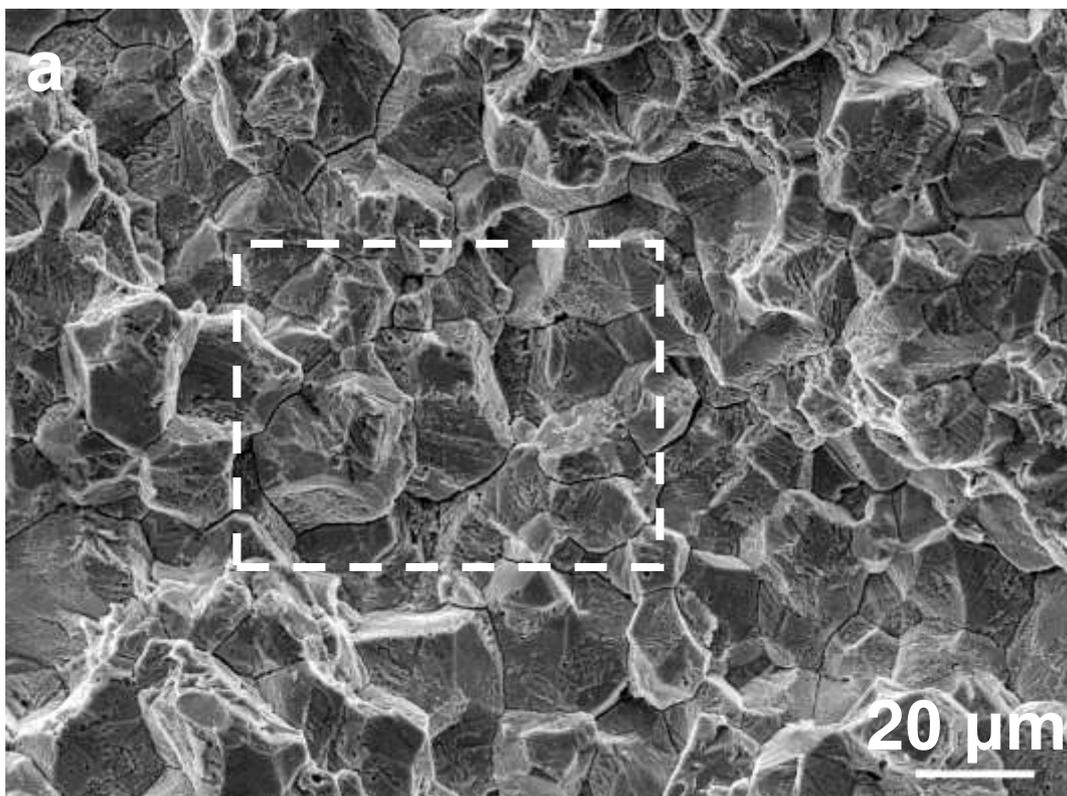
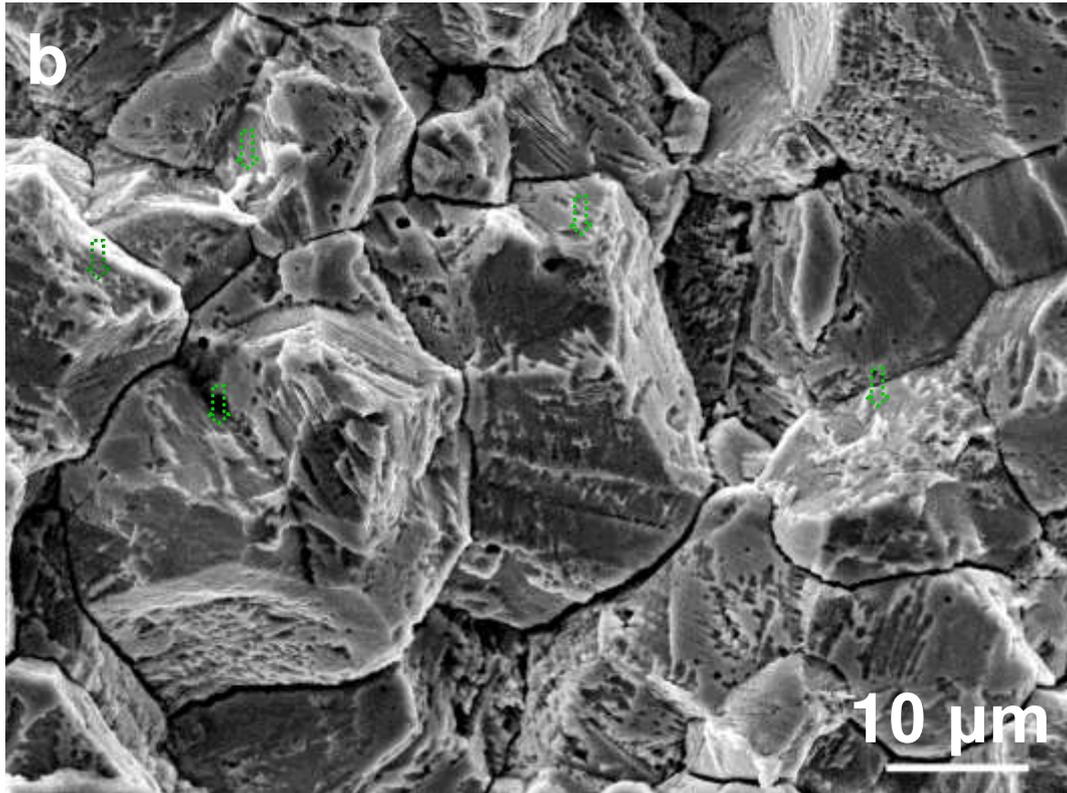
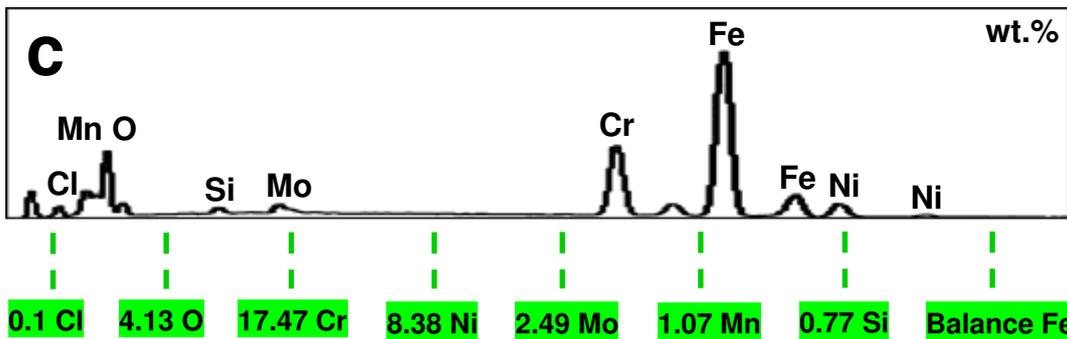
Figure 6

Fig. 6 Microscopic fractography and corrosion product composition of the initially-fractured lower half part continuously corroded for about 10 h. **a** The corroded fracture surface. **b** The stochastically-distributed arrow-labelled corrosion product in the area marked by the dotted rectangle in **a**. **c** The corrosion product composition analyzed by the EDS.

Fig. 6 Microscopic fractography and corrosion product composition of the initially-fractured lower half part continuously corroded for about 10 h. a The corroded fracture surface. **b** The stochastically-distributed arrow-labelled corrosion product in the area marked by the dotted rectangle in a. **c** The corrosion product composition analyzed by the EDS.

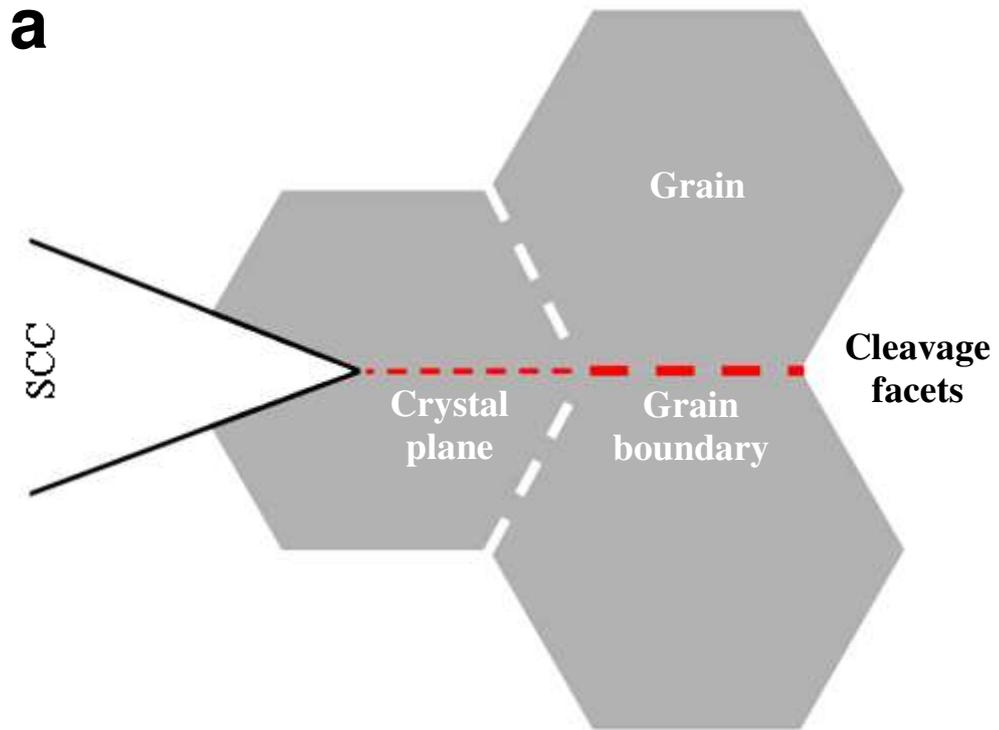
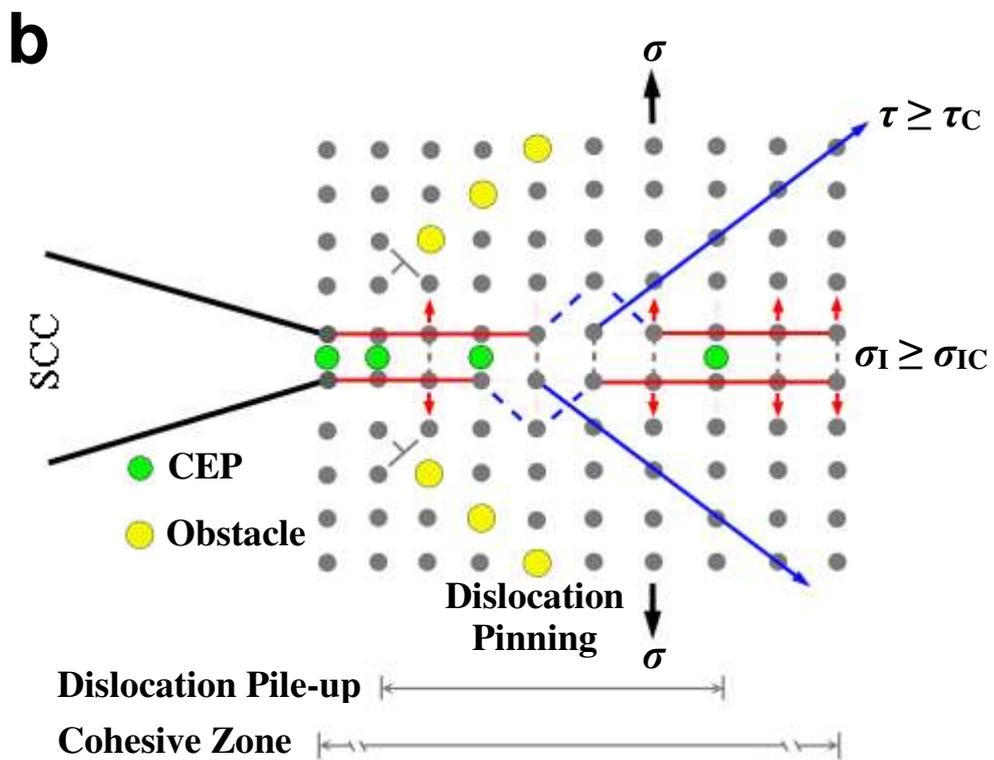
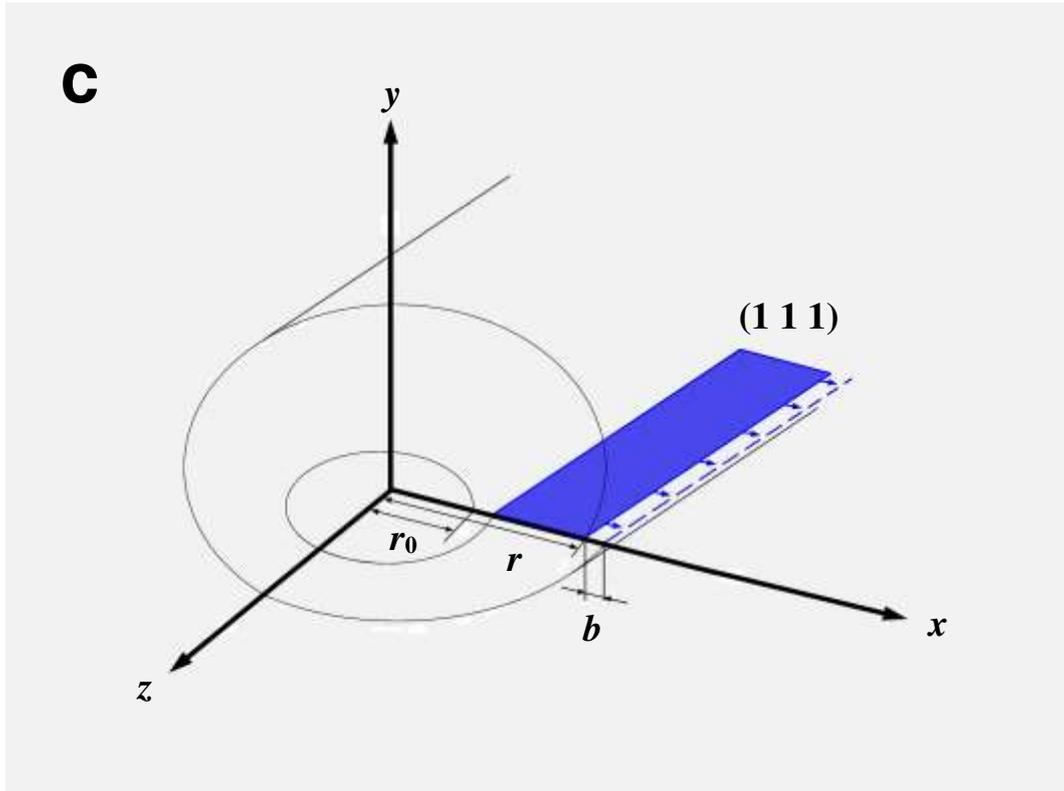
Figure 7

Fig. 7 The mechanism model of an IG- mixed TGSCC process. a A SCC crack on two cleavage facets consisting of a crystal plane and a grain boundary. **b** Synergistic effects of the CEP assisted cleavage on $\sigma_I \geq \sigma_{IC}$ and the ductile shear on $\tau \geq \tau_C$ in the elastic-plastic cohesive zone, in which some dislocations are pinned by the obstacles or pile up ahead of the SCC crack tip. **c** A slip plane (1 1 1) gliding by a Burgers vector, b , in a canister-like strain field induced by an edge dislocation. Wherein, the CEPs are composed of the hydrogen atoms and the electronegative ions such as the chloride ions for the chloride-solution SCC of the austenitic stainless steel, while the obstacles contains the grain boundaries, the CEPs, the precipitates, the Cottrell or Snoek atmospheres and the L-C dislocation locks.

where b is the Burgers vector, β is the coefficient of the Burgers vector related to x , $0 \leq \beta \leq 1$, ν is the Poisson's ratio. As shown in Fig. 7b, if the strain field around the edge dislocation approximates to a canister with the internal diameter of r_0 and the external diameter of r , the surrounding strain energy, $W_{\text{surrounding}}$, can be given by:

Fig. 7 The mechanism model of an IG- mixed TGSCC process. a A SCC crack on two cleavage facets consisting of a crystal plane and a grain boundary. **b** Synergistic effects of the CEP assisted cleavage on $\sigma_I \geq \sigma_{IC}$ and the ductile shear on $\tau \geq \tau_C$ in the elastic-plastic cohesive zone, in which some dislocations are pinned by the obstacles

or pile up ahead of the SCC crack tip. **c** A slip plane (1 1 1) gliding by a Burgers vector, b , in a canister-like strain field induced by an edge dislocation. Wherein, the CEPs are composed of the hydrogen atoms and the electronegative ions such as the chloride ions for the chloride-solution SCC of the austenitic stainless steel, while the obstacles contains the grain boundaries, the CEPs, the precipitates, the Cottrell or Snoek atmospheres and the L-C dislocation locks.
