Retention of Bovie scratch pad radio-opaque marker during VATS pleurodesis

Case report

Keywords: Pleurodesis, pneumothorax, bovie, scratch pad, foreign body

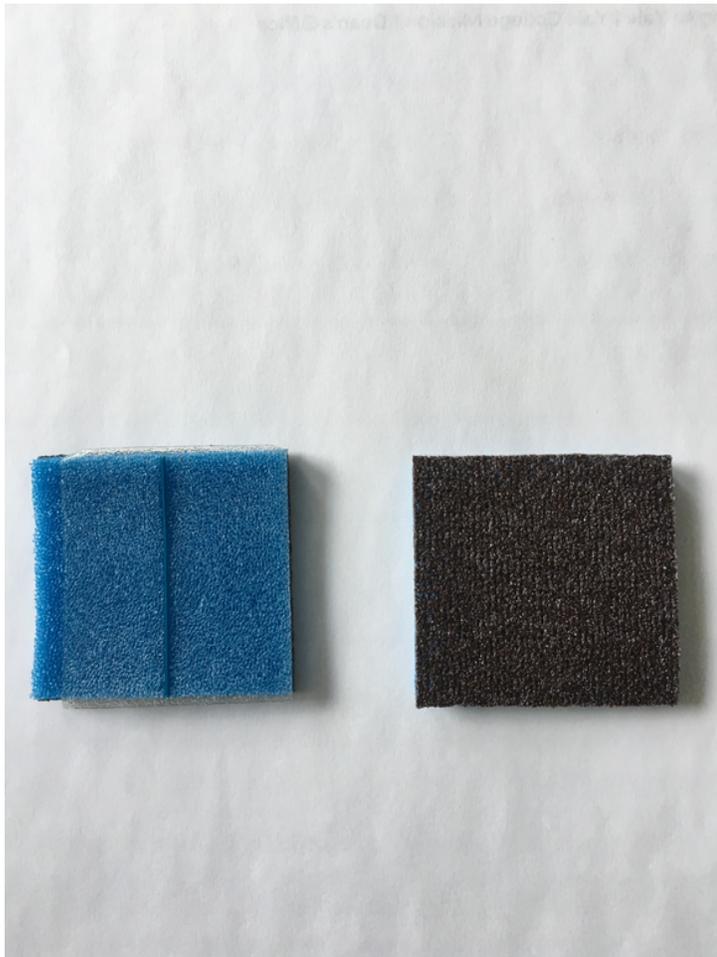
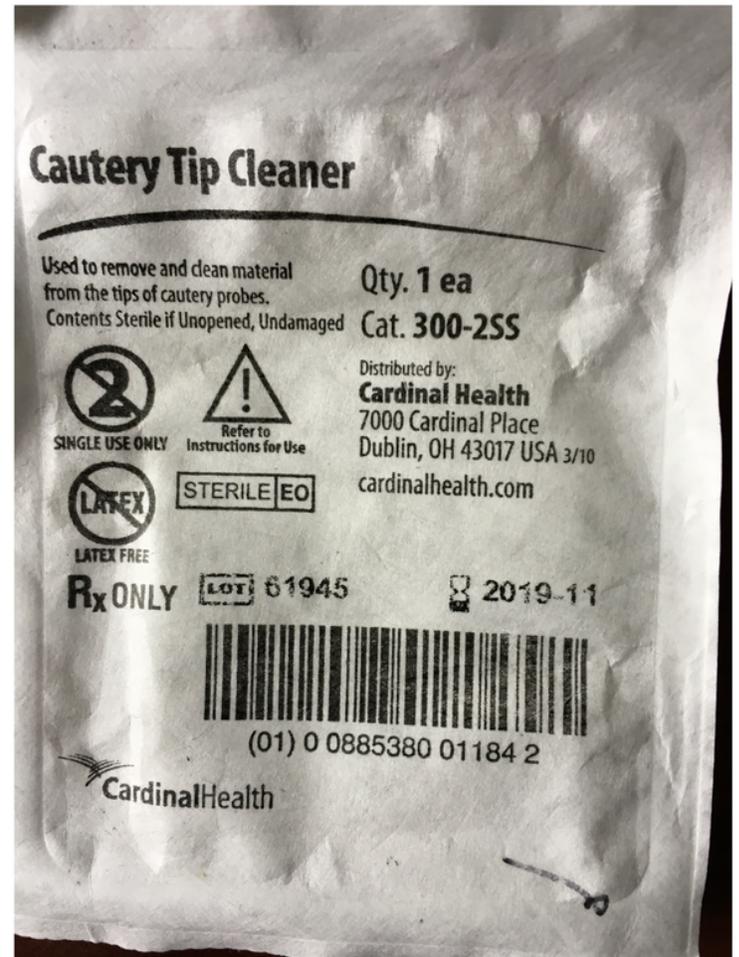
Figure 1

a: Front of Bovie scratch pad. b: Back of Bovie scratch pad with central blue radio-opaque marker.

Mechanical pleurodesis is frequently accomplished by using the Bovie scratch pad, an off-label application (fig.1). It is intended to clean the electro-cautery tip when needed; however, its universal presence, low cost and ease of use have led many thoracic surgeons to use them for pleurodesis. Its use has been reported by others and described in the training manual of the Society of Thoracic Surgery (STS).⁵ We have successfully carried out this practice for many years without any adverse effects.

It was formerly customary for us to cut the scratch pad in half for easier introduction through the small VATS incision. This perhaps “weakened” the product and permitted the marker to separate from the pad, as it is difficult to remove it from an intact and uncut pad. One thought was to remove the marker off the cut pad prior to its insertion into the chest. This perhaps may create a worse problem of retaining an unmarked pad that cannot be detected radiographically in case of an incorrect count. It is also against

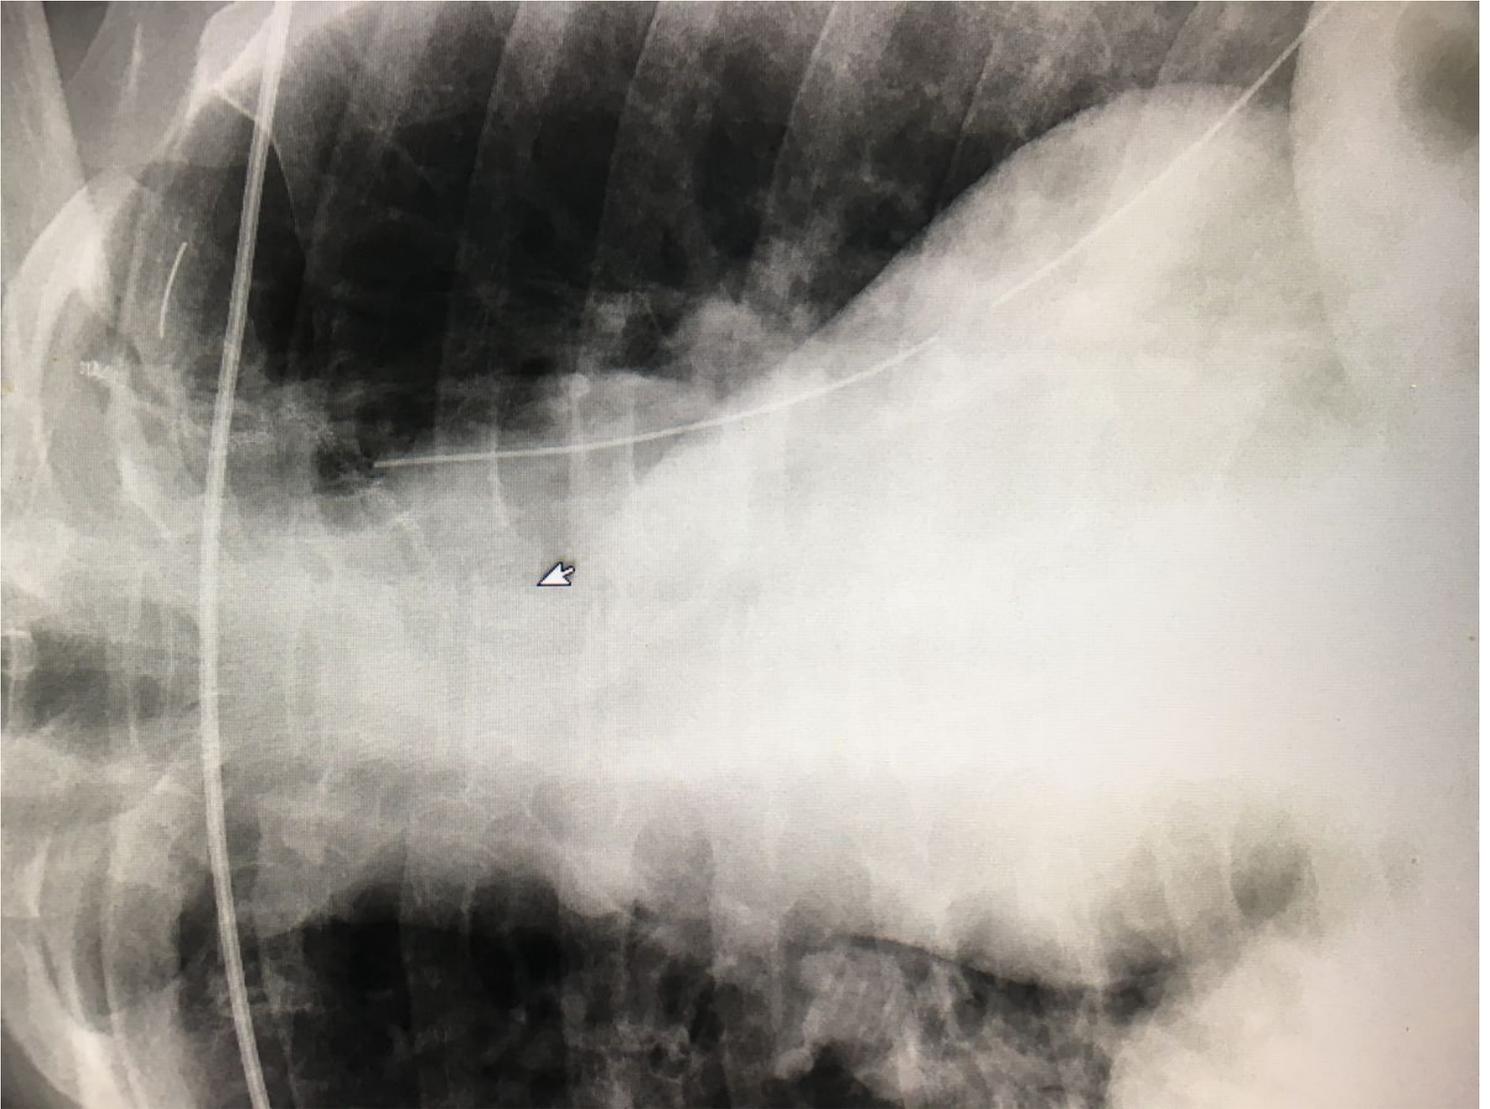
Figure 2

Postop chest x-ray showing radio-opaque marker close to staple line.

The instrument count at the conclusion of the operation was correct, as the counted item was the pad itself and not the marker. The radiological report of the immediate portable postop chest x-ray did not mention the FB, although in retrospect it can be visualized. The marker was in close proximity to the parenchymal staple line and thought to be part of it (fig.2). It became more apparent when an apical pneumothorax, following chest tube removal on day three, moved the staple line away from the marker (fig.3). Our index of suspicion was high that the abnormality seen was the marker but could not be absolutely certain, as the pad had been already discarded as one might expect.

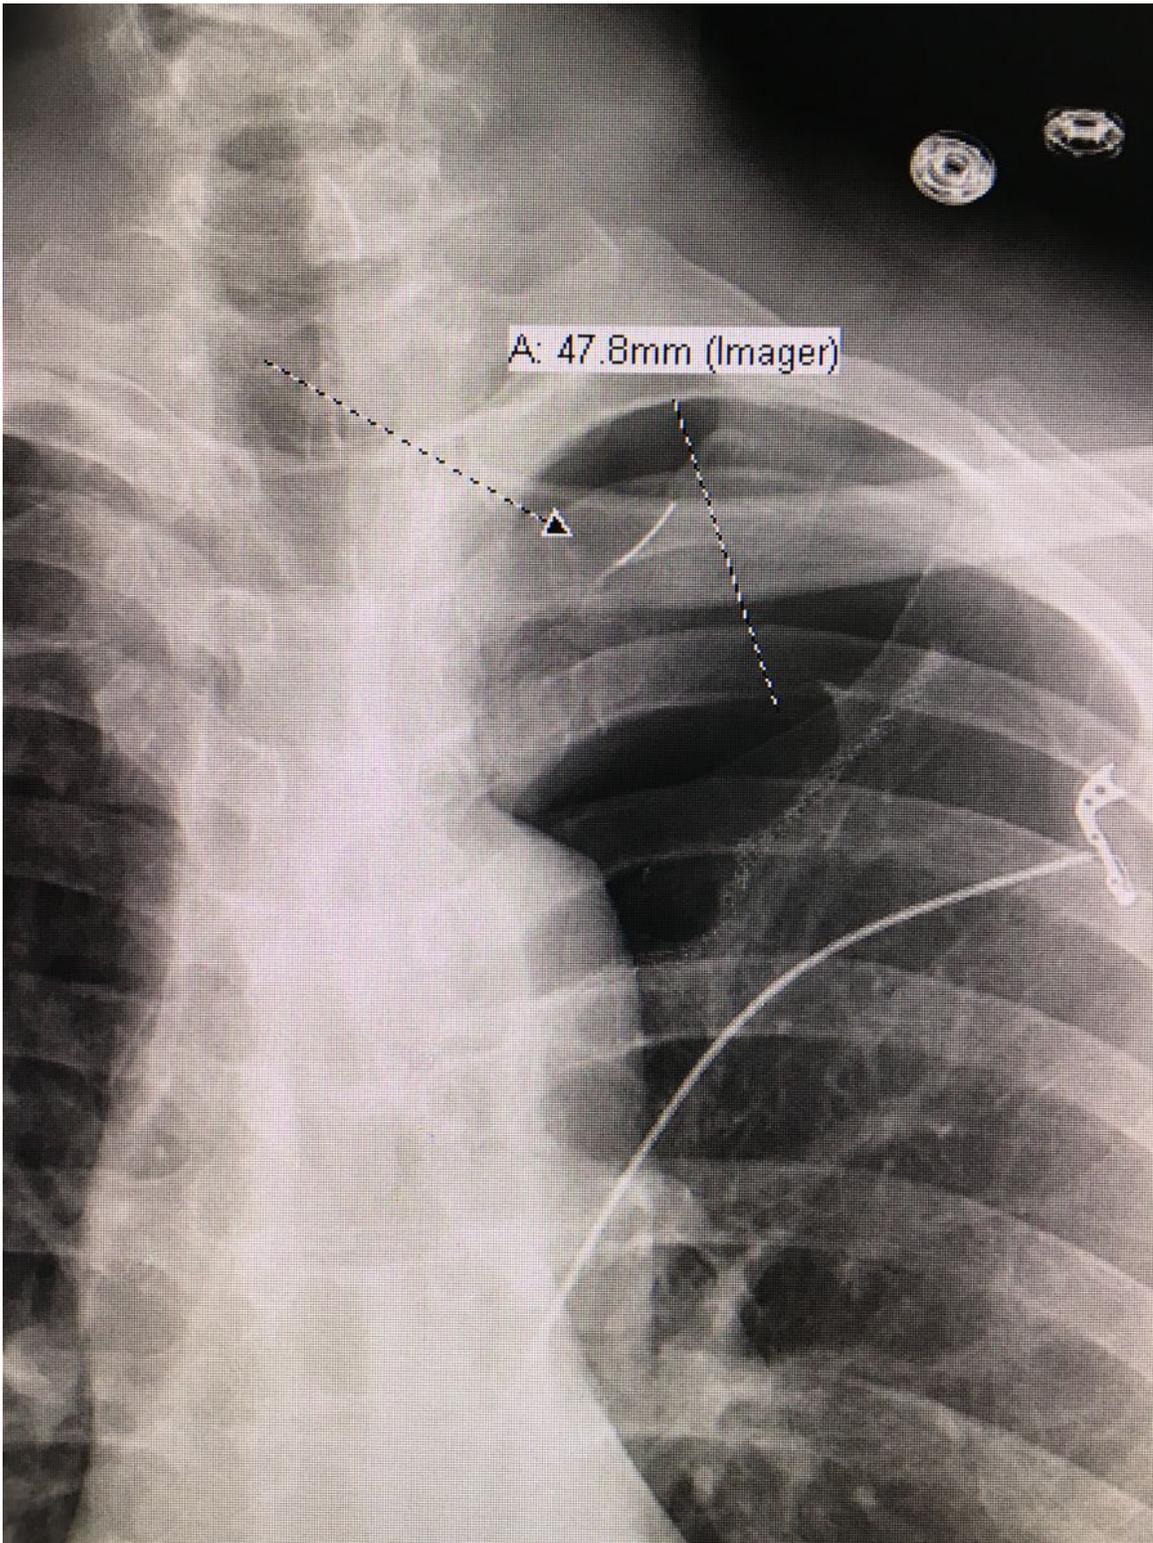
Figure 3

Chest x-ray after chest tube removal with apical pneumothorax and foreign body (FB).

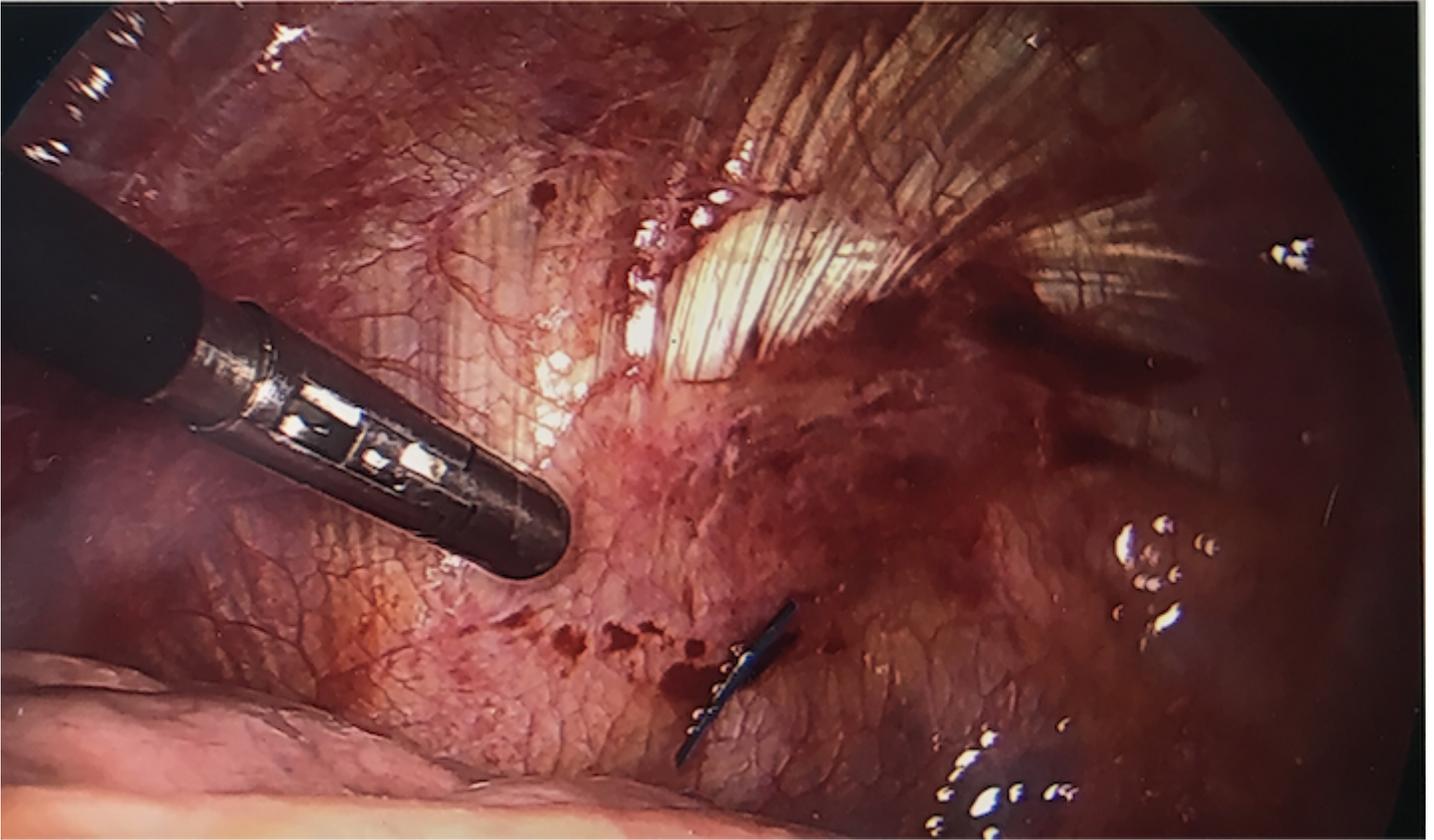
Figure 4

Intraoperative photo with instrument pointing to blue radio-opaque marker in apex of hemithorax.

Our current practice is to use a full (uncut) folded pad and continue to perform pleurodesis per STS guidelines, unless further studies corroborate the work by Min et al. showing no difference in recurrence rates in patients with and without pleurodesis.⁶ A conscious effort is also made at the end of each case to specifically identify the marker within the scratch pad at time of instrument count.
