Characterization of the physical origins of acoustic emission (AE) from natural fiber reinforced polymers (NFRPs) machining processes

Abstract Natural fiber reinforced polymers (NFRPs) are environmentally friendly and are receiving growing attention in the industry. However, the multi-scale structure of natural fibers and the random distribution of the fibers in the matrix material severely impede the machinability of NFRPs, and real-time monitoring is essential for quality assurance. This paper reports a synchronous in-situ imaging and acoustic emission (AE) analysis of the NFRP machining process to connect the temporal features of AE to the underlying dynamics and process instability, all happen within milliseconds during the NFRP cutting. This approach allows directly observing the surface modification and chip formation from a high-speed camera (HSC) during NFRP cutting processes. The analysis of the HSC images suggests that the complex fiber structure and the random distribution introduce an unsteady, almost a freeze-and-release type motion pattern of the cutting tool with varying depths of cut at the machining interface. More pertinently, a prominent burst pattern of AE from

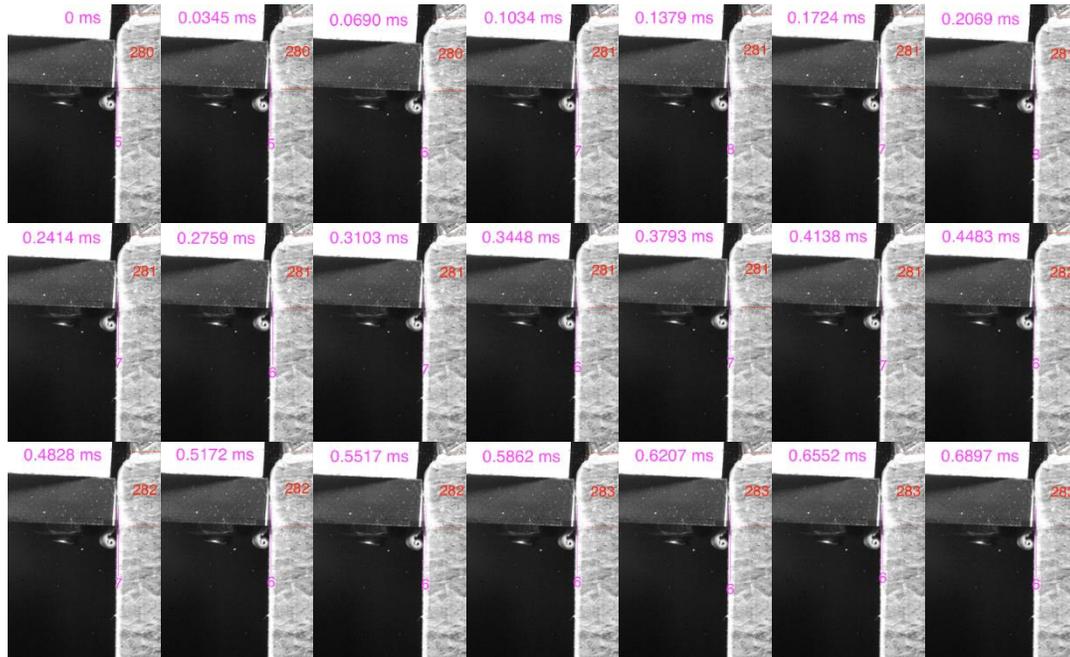
Fig. 8. Successive screenshots that contain the *pixel value* as the criterion to indicate the behavior change in the cutter for Spike 7 in the cutting process with $v = 6 \text{ m/min}$ and $FOA = 90^\circ$.

As noted earlier, the recording under the condition of $v = 6 \text{ m/min}$ and $FOA = 90^\circ$ acquired $\sim 100,000$ total data points (the process lasted for about 100 ms). The cutting process in the HSC video started at 3.2s and ended at 14.4s. Fig. 8 presents successive screenshots from the start to the end of Spike 7, with the tool-tip location in the cutting process specified in pixel values. The variations in DoC and tool tip displacement along the cutting direction (in pixel values) are plotted in Fig. 9 a) and b) with synchronously aligned AE spikes shown in Fig. 9c). It may be noticed that the AE waveform reaches its highest peaks/valleys in Spike 7 [see Fig. 9 c)] when a sudden increase in DoC occurs. On the other hand, the AEs exhibit continuous waveform patterns (smooth oscillation without sharp peaks and/or valleys) when the DoC's are relatively constant [as suggested by the tail part of Spike 7 shown in Fig. 9 a) and c)].

From observing the recording snapshots before and after this spike, one can notice that an abrupt change in

DoC occurs because the cutting tool tip penetrates the workpiece surface, which results in a possible sharp increase in cutting force and in turn introduces a stagnant motion (or freeze and release motion) during the NFRP machining. Evidence can be found in Fig. 9 b): this segment (frame 4 to frame 13) has a constant displacement right after the abrupt increase in the DoC, suggesting that a stagnant/freeze motion is introduced because the cutting tool penetrates and the resultant increase in uncut materials [with random bundle(s) of the reinforced elements] prevent a smooth and stable cut. After the cutting tool penetrates the material, the tool tip goes back to its original position before Spike 7 emerges, and the DoC decreases to its original value. As a result, because there is less uncut material, the AE waveform decreases after a certain number of oscillations. Hence, the uncut material (and associated chip flow) plays a significant role in the resulting AE waveform pattern.

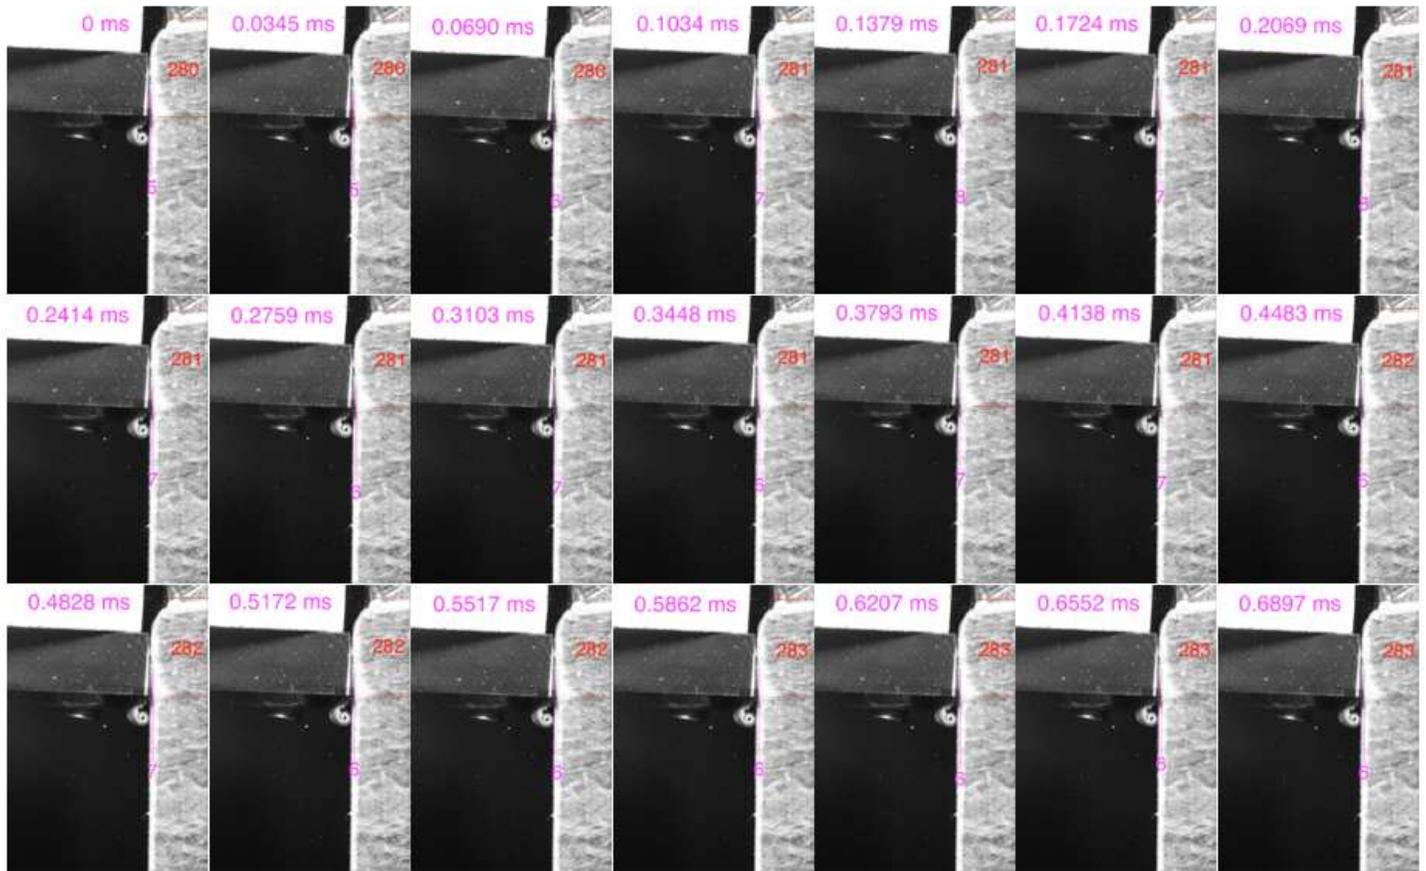
Figure 8

Successive screenshots that contain the pixel value as the criterion to indicate the behavior change in the cutter for Spike 7 in the cutting process with $v=6$ m/min and $FOA=90^\circ$.
