Cholera Outbreak Caused by Drinking Unprotected Well Water Contaminated with Feces from an Open Storm Water Drainage – Kampala City, Uganda, January 2019

Research article

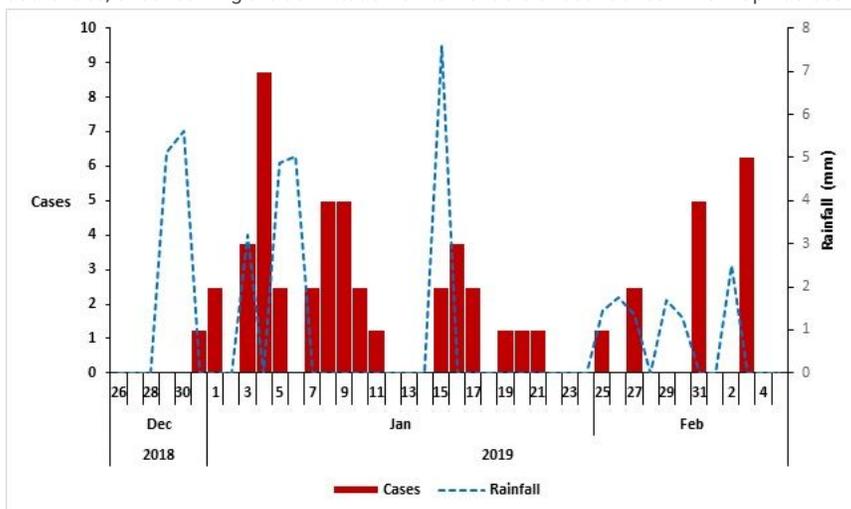
Meteorological data showed that the peaks of the cholera outbreak were preceded by heavy rainfall (Fig. 2). Following declaration of the outbreak on 10 January 2019, the MoH implemented a number of interventions, including community awareness campaigns and distribution of chlorine to households, the number of cases reduced after subsequent rainfall. There were no new cases following blockage of Well C outlets by the Village Local Council on 3 February 2019.

Figure 2
 Distribution of symptom onset dates of cholera cases and rainfall: Kampala City, Uganda, December to January 2019.

The median age of case-patients was 20 years; with the most affected age-group 5–14 years. Females and males were similarly affected (Table 1). The epidemic curve showed several point-source outbreaks (Fig. 2).

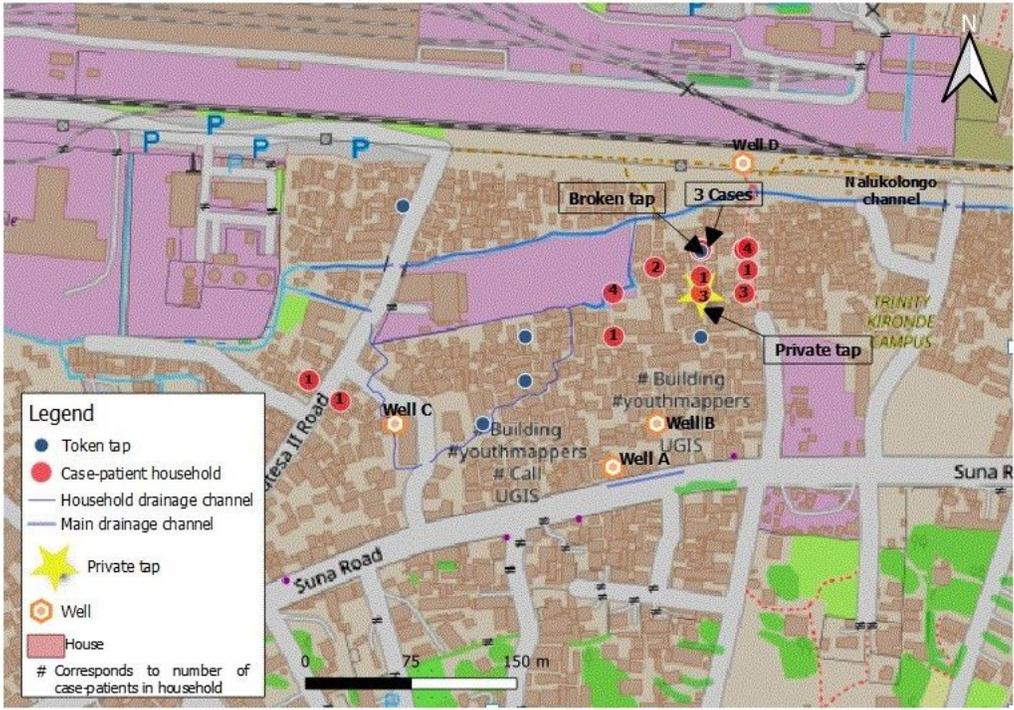
Figure 3
 Map showing location of affected households affected by cholera in Sembule village, Kampala, January 2019. Note: The designations employed and the presentation of the material on this map do not imply the expression of any opinion whatsoever on the part of Research Square concerning the legal status of any country, territory, city or area or of its authorities, or concerning the delimitation of its frontiers or boundaries. This map has been provided by the authors.

All five divisions of Kampala, including Kampala Central, Kawempe, Makindye, Lubaga, and Nakawa were affected (Fig. 1 inset), with Lubaga division being the most affected (AR: 6.5/100,000) followed by Central Division (AR: 2.1/100,000). All affected case-patients in Lubaga division came from Sembule village, where the first cases were reported (Fig. 3).

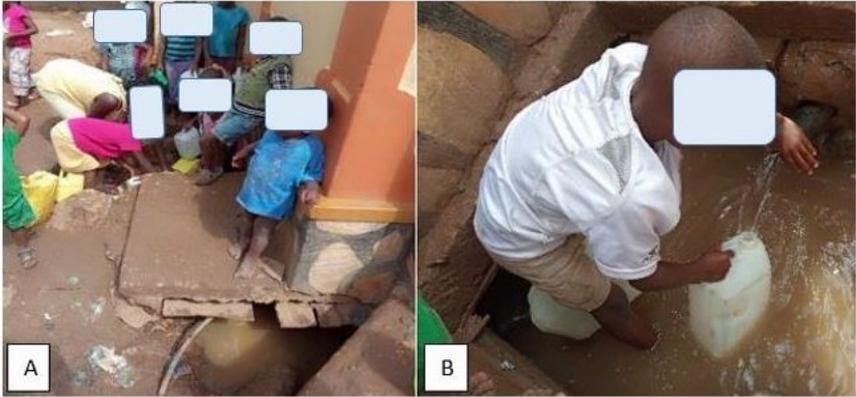
Well C comprised a small, shallow, unconfined outlet for water coming from a below-ground aquifer. Water flowed into Well C from a pipe fitted perpendicular to the outlet, just above the surface (Fig. 4). The well did not have a permanent cover and the water was flowing continuously into the well from the aquifer. The output pipe from unprotected Well C was approximately 0.3 m above the bottom of an open, informal drainage channel. Most of the community pit latrines were constructed along the drainage channel, to facilitate disposal of waste. Community members often dumped fecal matter into the drainage channel when it rained, to facilitate the washing-away of the waste. Flooding of the drainage channel that resulted from the rain water mixed with the contents of the drainage channel and allowed flow into other nearby areas, including the outlet pipe of unprotected Well C. We found evidence of release of fecal matter into the drainage channel from at least one of the pit latrines constructed along the drainage channel.

Figure 4
 (A) shows children collecting water from well C; (B) shows the outlet pipe of Well C

Conclusions: Drinking contaminated water from an unprotected well was associated with this cholera outbreak. We recommended emergency chlorination of drinking water, fixing the broken token tap, and closure of Well C.

In conclusion, this was a cholera outbreak in an urban slum associated with drinking contaminated well water. Fecal contamination of well water likely resulted from the practice of emptying pit latrines into drainage channels during heavy rainfalls. The following public health actions were taken to contain the outbreak: the Ministry of Health distributed chlorine tablets for household water disinfection 9 January 2019, Kampala Capital City Authority emptied pit latrines in Sembule village from 15 to 30 January 2019, the village local council closed Well C on 3 February 2019, and we provided health education to Sembule village residents on prevention of cholera. We recommended treatment and boiling of drinking water. We also recommended increasing the number of public token taps to increase access to safe water, enforcement of Chap. 281 of the Public Health Act, and provision of inexpensive latrine-emptying options to dissuade people from releasing fecal matter into open drainages. In addition, to sustainably address the cholera outbreaks in crowded urban settings, Uganda needs to make significant investments in safe water, sanitation and hygiene as prescribed in the *End Cholera-Global Roadmap to 2030*.
